PU-21-048
Bridger Pipeline, LLC
South Bend 16-inch Crude Oil
Pipeline
Reclamation Inspection Report

File No. 227705201

May 23, 2024

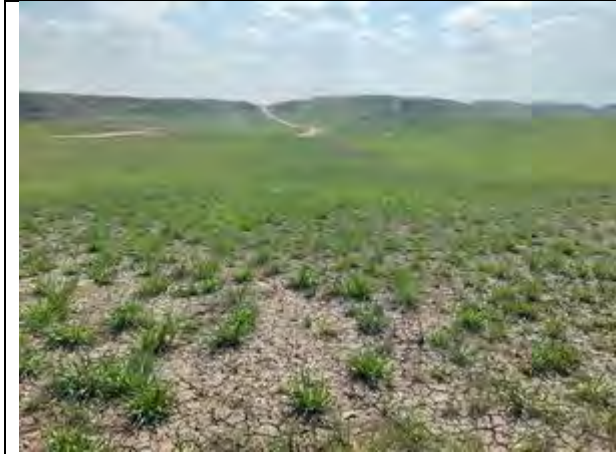
Photo ID: 7

Annual weeds are far more prevalent within the Project ROW than noxious weeds with prickly Russian thistle being predominant. Prickly Russian thistle was observed in abundance at **Observation Points 7, 9, 13 (Appendix A)**.

Weed management is recommended throughout portions of the ROW. Thistle was observed in abundance at **Observation Points 7, 9, 13**. Kochia was also observed is recommended to be sprayed once in the spring when the plants emerge, and later in the summer when late-germinating plants begin emerging (NDSU Extension Service, 2016). Kochia and prickly Russian thistle have seed viability of ~1 year, so adequate control for one growing season may significantly reduce weed presence in following years. Other annual weeds should be monitored along the ROW in hay lands and rangelands per landowner preferences. Stantec recommends one or two years of mowing or herbicide application in June or July prior to weed seed ripening. This would reduce the annual weed seed bank within a year or two and allow the desired grass cover to better establish.

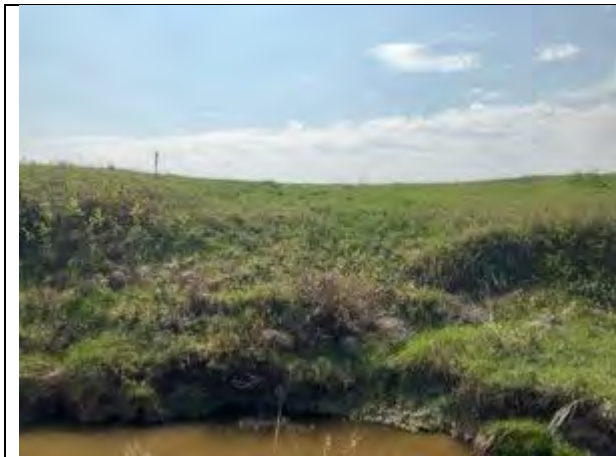
Photo ID: 11

One stream/wetland crossing (Cherry Creek) was observed where the HDD crossing method was used (**Appendix A; Observation Points 11-13**). The boring area was observed to be appropriately reclaimed and contained adequate topsoil replacement. Vegetation was still establishing but was colonizing with acceptable perennial vegetation where planted seeds are often slow to establish.

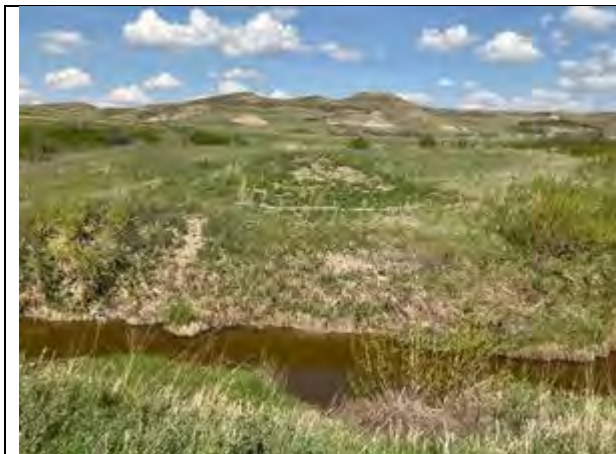
Photo ID: 12

Photo Description: Grassland area revegetation trending towards pre-project conditions along Cherry Creek access road.

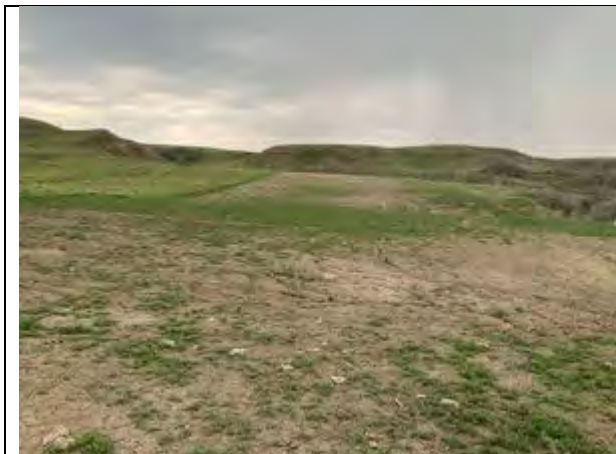
Photo ID: 15

Soil erosion was evident at multiple locations along the project ROW, including **Observation Points 1, 15-18 and 35**, resulting in lack of pre-project vegetation cover. This issue was most extensive adjacent to Cherry Creek in Section 6, Township 149 North and Range 97 West, where evidence of rill erosion and bare ground was common coinciding with relatively steep slopes. Stantec recommends re-stabilizing the slopes here and installing erosion BMPs to mitigate soil erosion along with re-seeding efforts. The extent of current erosion suggests that previous seed has likely washed away, and Stantec recommends installing fabric, mulch, or use of other methods to properly stabilize steeper slopes in conjunction with re-seeding.

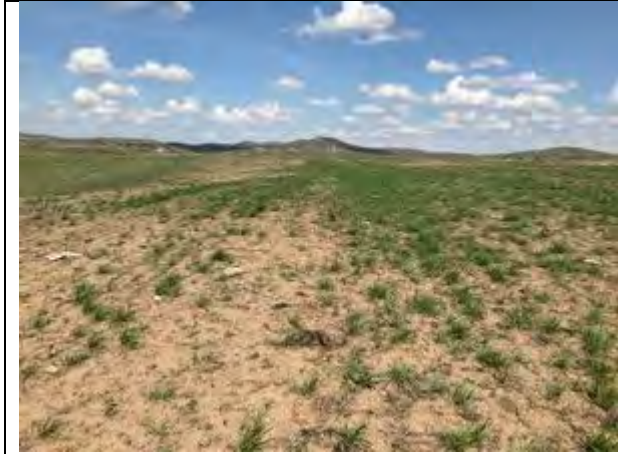
Photo ID: 19

Photo Description: Vegetation coming in better on areas lesser slopes.

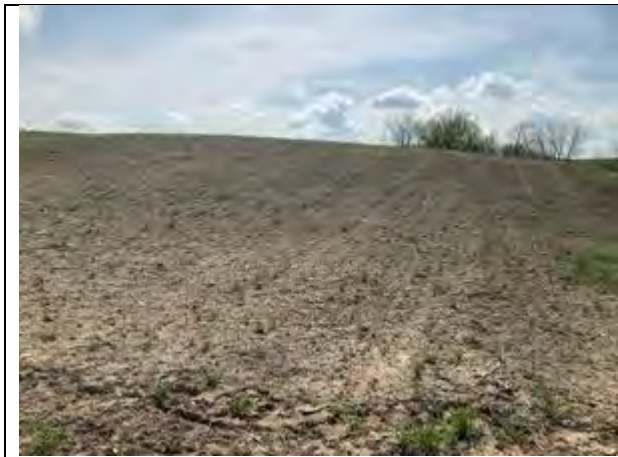
Photo ID: 20

Photo Description: Some erosion at low point. Seeded grasses are coming in rows sparsely.

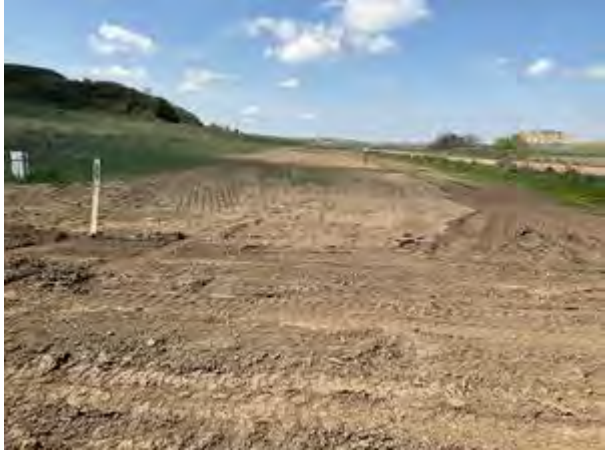
<p>Photo ID: 32</p> <p>Direction Photo is Taken: West</p> <p>Photo Description: Vegetation visible in rows, slowly establishing. Significant bare ground.</p> <p>Latitude: 47.48628441</p> <p>Longitude: -103.71920421</p>
--	---

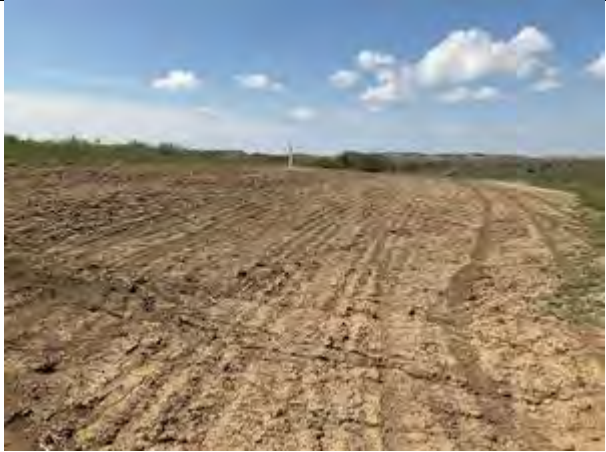
<p>Photo ID: 33</p> <p>Direction Photo is Taken: Southwest</p> <p>Photo Description: Appears to be recently contoured and seeded. Abundant bare ground.</p> <p>Latitude: 47.48603762</p> <p>Longitude: -103.72148725</p>
---	---

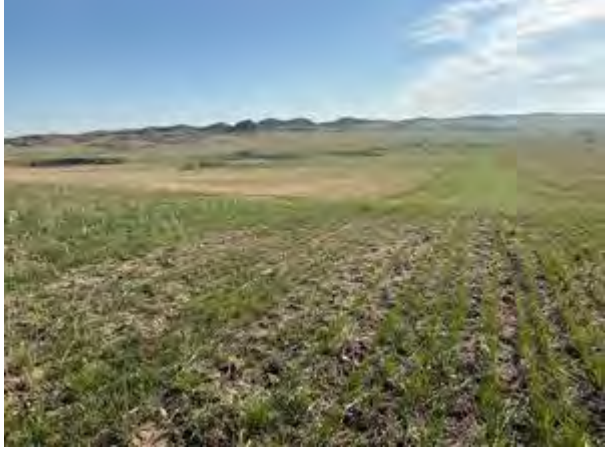
<p>Photo ID: 47</p> <p>Direction Photo is Taken: Northeast</p> <p>Photo Description: Seeded grass visible in rows.</p> <p>Latitude: 47.26315469</p> <p>Longitude: -104.04261429</p>
--	--
