BEK Consulting, LLC

Re: PU-21-377

I am responding to your letter of September 1st concerning Case Number PU-21-377 regarding a ND One Call Complaint Against BEK Consulting submitted by tana Dakota Utilities. Corresponding locate ticket for PU-21-377 is 21103481.

2021 ROADWAY IMPROVEMENTS PROJECT
ALEXANDER, NORTH CAROLINA
STORM SEWER PLAN & PROFILE - BRUEGGER ST III

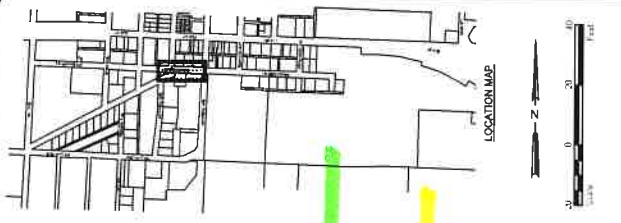
STS-19

Attached is a copy of the plan sheet of where the utility hit occurred. The red line is the approximate location the service line, and the green line indicates where the existing gas main actually was. Per the plan sheet, the gas main was shown on the opposite side of the street. The yellow line is where MDU relocated the gas main behind the curb line in the existing ditch line. Down at the intersection of Brugger St and Richards Ave, MDU went down 8 feet to get under the existing sewer and water mains, but the gas main was not buried anywhere near that depth where the gas service line came across the street to connect to the main.
