Public Service Commission

State of North Dakota

June 13, 2019

The North Dakota Public Service Commission (Commission) has reviewed your filing, dated May 15, 2019, regarding your land located in the NW $\frac{1}{4}$ of Section 34, T146N, R88W.

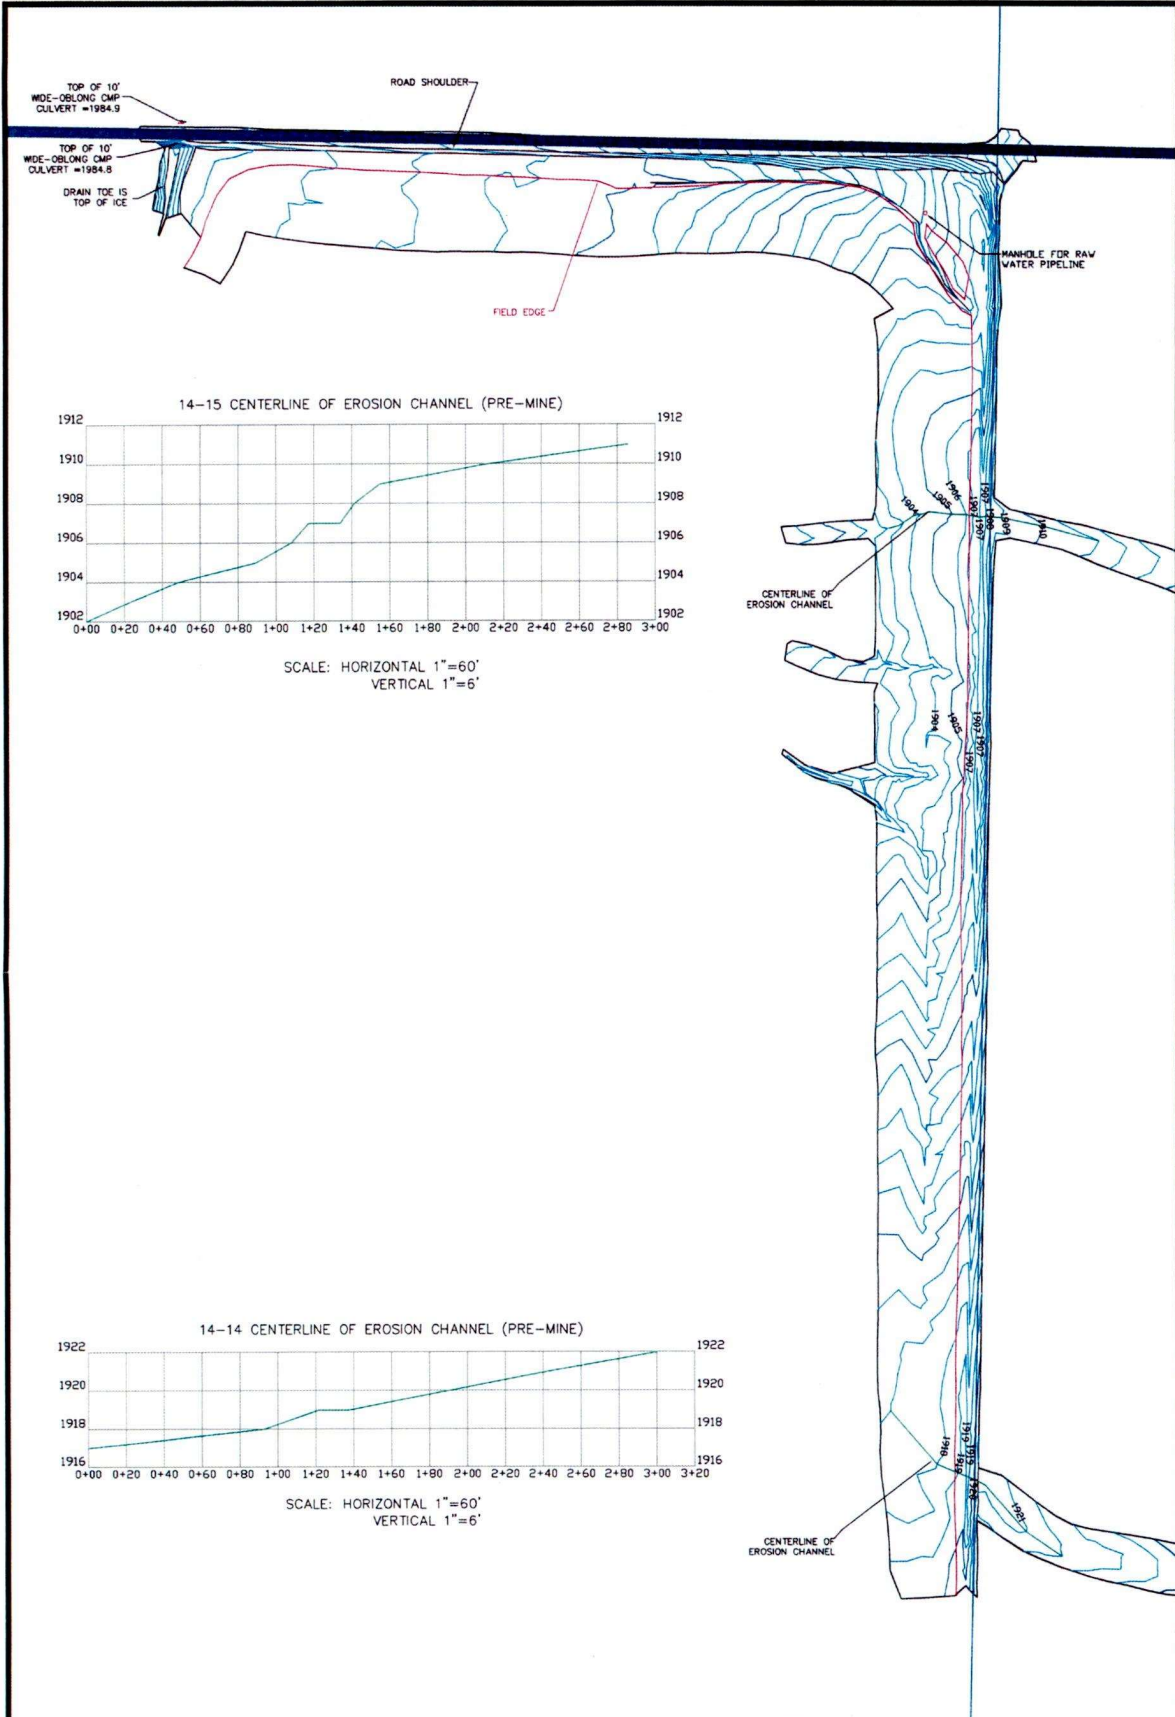
It should be noted that flows during mining and following mining are less than the flows which occurred pre-mining. It should also be noted that erosion and flooding occurred in the subject field long before mining, as can be shown by viewing aerial photos, including Figures 1 and 2, dating back several decades prior to Coteau entering the area.
