Public Service Commission State of North Dakota

INSPECTION REPORT

DATE OF INSPECTION: April 26, 2018
TYPE OF INSPECTION: Partial
PERMITTEE - MINE: Coteau Properties Company - Freedom Mine
PERMITS INSPECTED: NACT-9501
PERSONS ACCOMPANYING INSPECTORS: Clyde Eisenbeis, Jerome Boeshans and Jaymie Boeshans
INSPECTION CONDITIONS: The inspection was conducted between 10:00 a.m. and 12:30 p.m. CDT. Skies were clear and the temperature was near 55° F. Access was unrestricted.

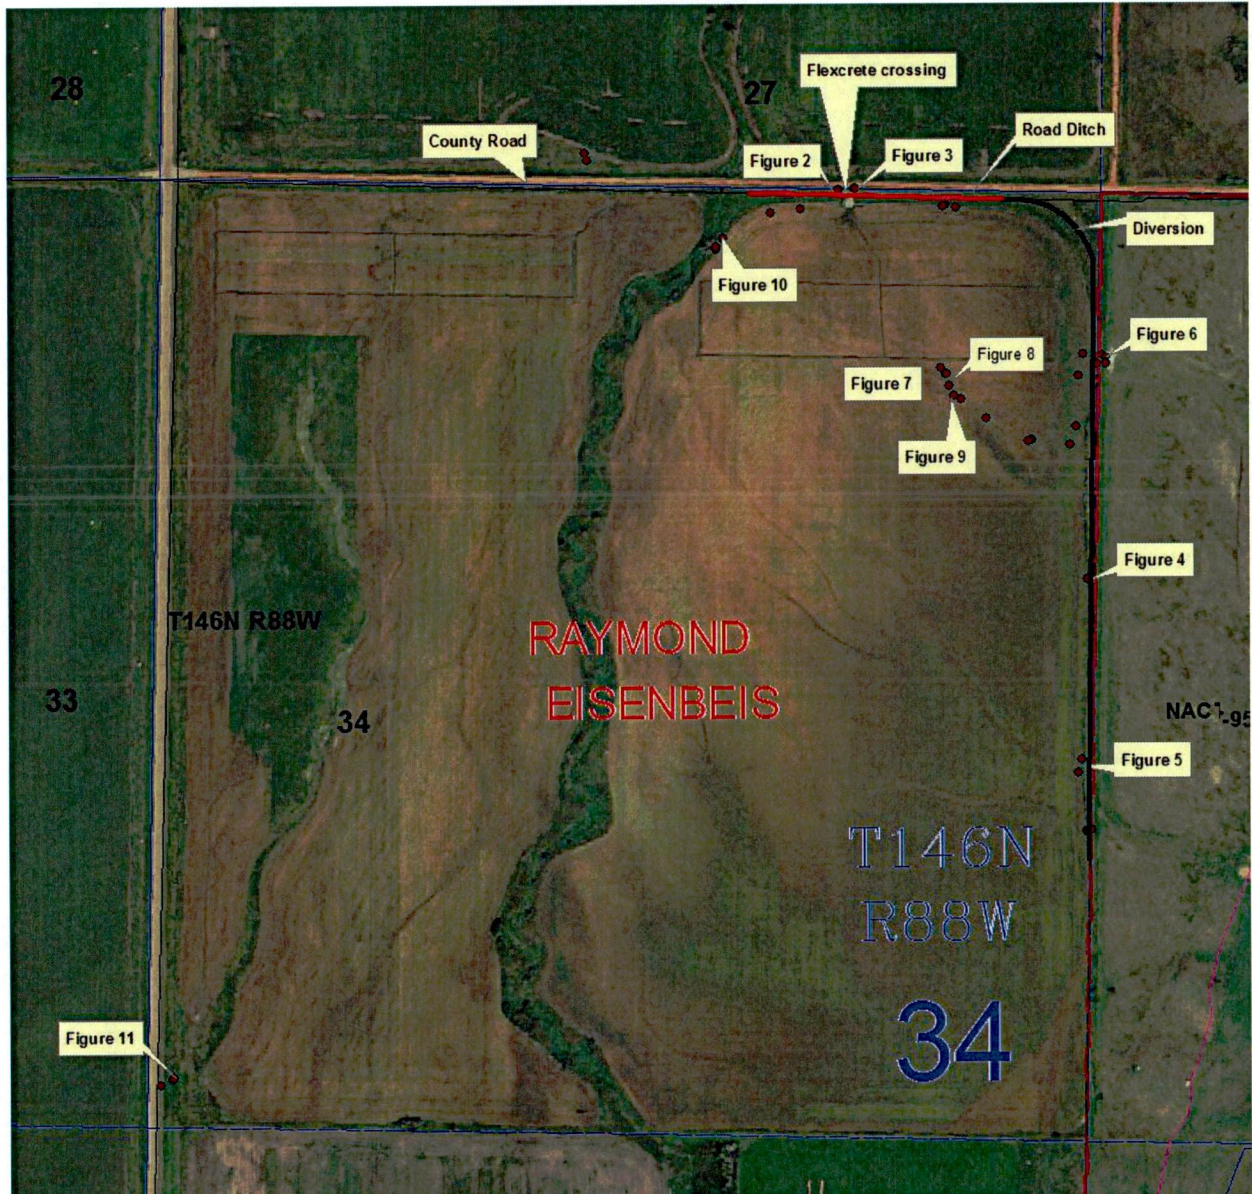
1. Figure 1 also depicts the locations where the photographs in Figures 2 through 11 were taken. Figures 2 and 3 are photographs of the Flexcrete crossing. Mr. Eisenbeis claims Coteau did not have the proper authorization to reconstruct the diversion on his property and the deeper road ditch now limits equipment access to his land. Mr. Eisenbeis said one potential renter was not interested in leasing his cropland because of poor access to his field.

Figure 1. Location of the diversion, road ditch, Flexcrete crossing and photographs taken in the NW¼ of Section 34
