Principal Investigator Wesley Mathews
Acting Accident Investigation Director Chris Ruhl
Date of Report May 26, 2022
Subject Failure Investigation Report - Denbury Gulf Coast
Pipelines, LLC – Pipeline Rupture/ Natural Force Damage

Date of Failure February 22, 2020
Commodity Released Carbon Dioxide
City, County and State Satartia, Yazoo County, MS
OpID and Operator Name 32545, Denbury Gulf Coast Pipelines, LLC
Unit # and Unit Name 75379 – MS-2
WMS Activity ID 20-176125
Milepost (MP) / Location MP 6.6 / Pipeline Stationing 348+63
Type of Failure Natural Force Damage
Fatalities None
Injuries None
Description of Area Impacted Rural, “Could Affect” High Consequence Area (HCA) -
Other Populated Area
Total Costs \$ 3,947,009

Failure Investigation Report – Denbury Gulf Coast Pipelines LLC
Pipeline Rupture/Natural Force Damage
February 22, 2020

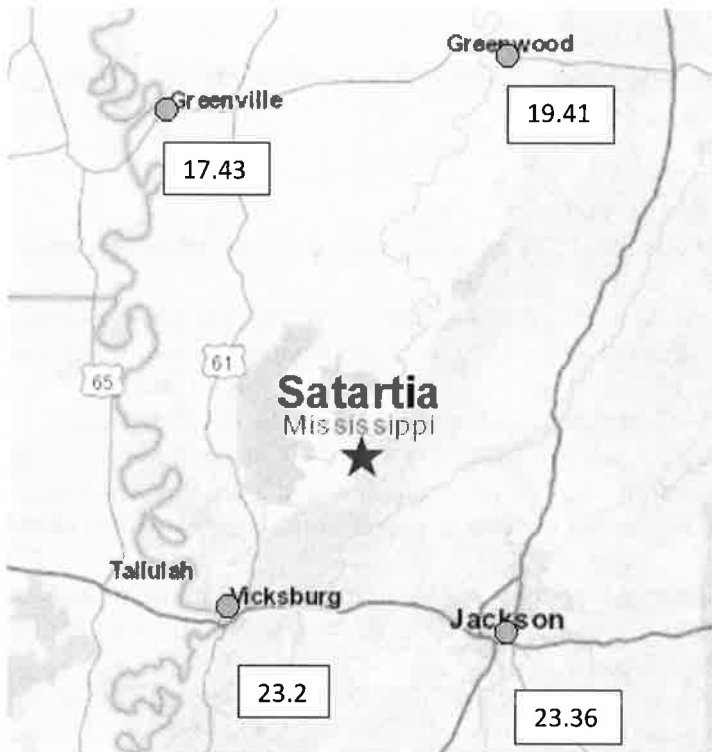
According to the National Weather Service (NWS), accumulated rainfall data between January 1, 2020, through February 29, 2020 (60 days) for each of the cities of Greenville, Greenwood, Vicksburg, and Jackson, Mississippi – which form a relative square (Figure 1) around Satartia and Yazoo County³ – was 17.43 inches, 19.41 inches, 23.2 inches, and 23.36 inches of rain, respectively. The amount of rain recorded in these four cities was between 7.44 and 13.63 inches above the annual historical average for the same 60-day timespan. Significant variations in environmental/climate conditions such as ambient temperatures and rainfall can impact soil stability and erosion patterns. Landslides are typically associated with periods of heavy rain, particularly in susceptible areas with the right combination of slope and soil-type. On May 26, 2022, PHMSA issued an updated Advisory Bulletin to remind operators of gas and hazardous liquid pipelines of the importance of identifying and mitigating risks caused by changes in environmental and geological conditions on their pipeline facilities.

Figure 1: Map of Cities Relative to Satartia and Their Respective Rain Totals Between January 1, 2020, and February 29, 2020

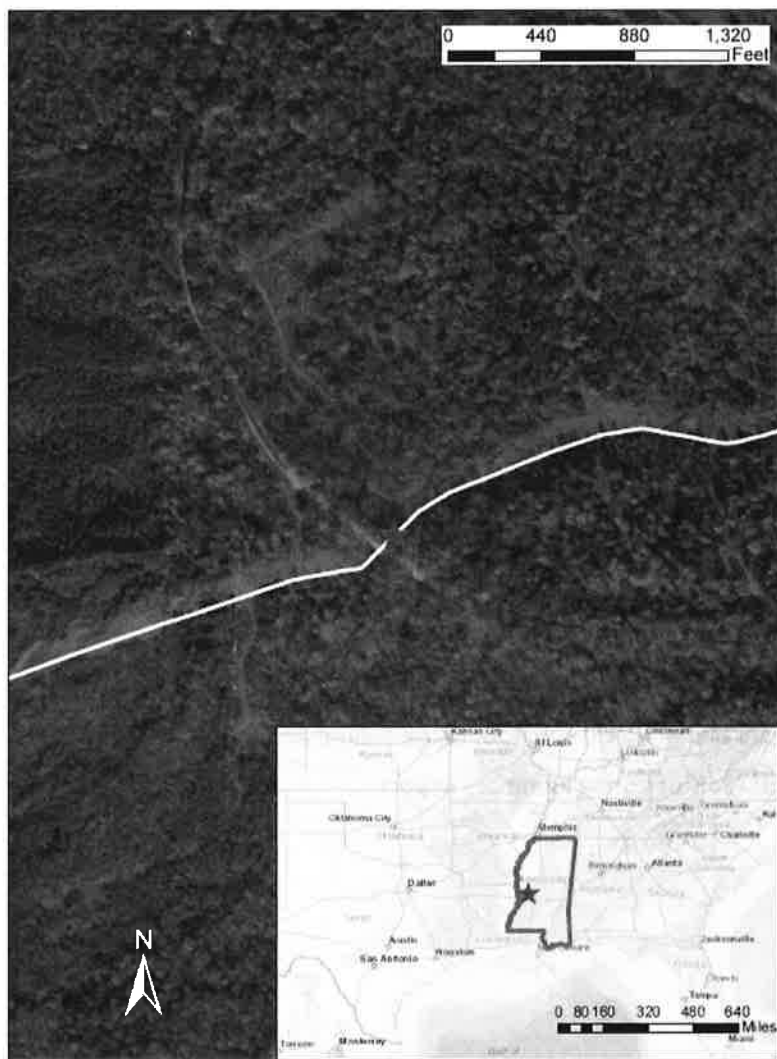
Figure 7: An ArcGIS-generated Satellite Map with the Site of the Rupture Marked by the Red Star (the Insert Map on the Bottom Right Shows the Rupture Site Location Within the State of Mississippi)
