Phase II Landslide Assessment
Proposed Carbon Capture Pipelines
North Dakota

Project Number TXG0484

August 15, 2023

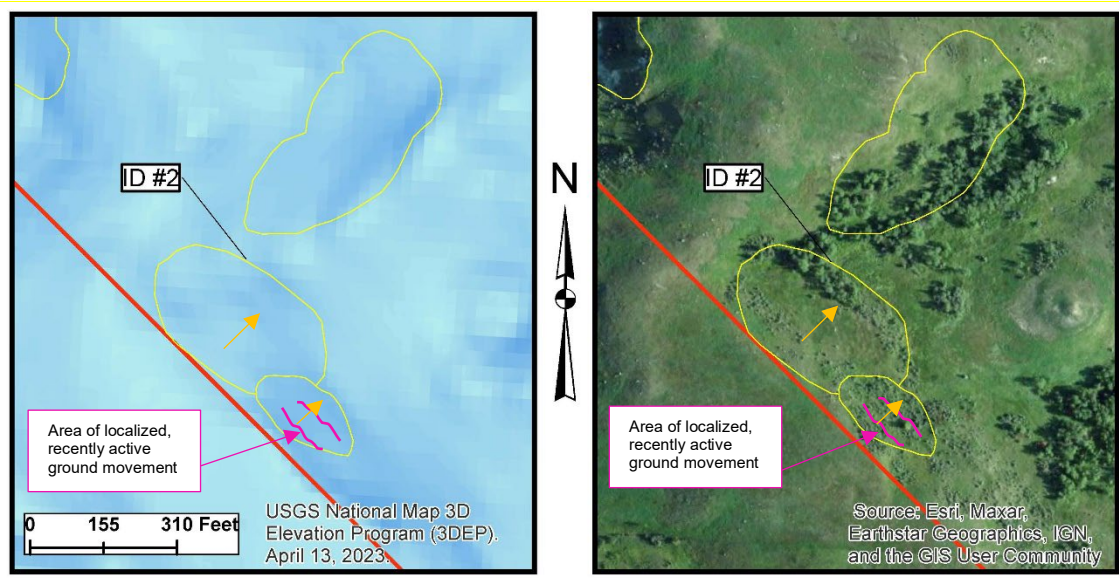
The morphology observed at Site #2 appears consistent with a dormant landslide on a northeast facing slope. The landslide boundary mapped by the NDGS was approximately 250 feet long and 450 feet wide. The direction of landslide movement was northeast and perpendicular relative to the proposed pipeline centerline. The mapped and observed landslide headscarp intersected the proposed pipeline centerline over an approximate length of 130 feet and was less than 1 foot high while appearing to be highly weathered, rounded, and subdued. Downslope of the proposed pipeline centerline, the landslide body exhibited rounded and subdued hummocks less than 1 foot high while lateral flanks were indistinct. The rounded and subdued landslide toe was 2 to 3 feet high and located greater than 100 feet from the proposed pipeline centerline. No sharp or fresh landslide features were identified. The inferred landslide depth was estimated to be less than 4 feet based on the size and condition of the landslide features observed. At the time of the visit the feature was uniformly vegetated with mixed grasses and wooded shrubs less than 4 ft high. Another, smaller landslide boundary mapped by the NDGS that is located adjacent to, and southwest of, Site #2 was similarly evaluated due to its proximity to the proposed pipeline centerline. The landslide boundary mapped by the NDGS was approximately 135 ft long and 250 ft wide. The direction of landslide movement was northeast and perpendicular relative to the proposed pipeline centerline. The mapped and observed landslide headscarp was located approximately 15 feet downslope of the proposed pipeline centerline and was less than 1 foot high while appearing to be highly weathered, rounded, and subdued. Approximately 50 feet downslope of the proposed pipeline centerline, a series of distinct internal scarps approximately 2 to 3 feet high were observed within the mapped landslide boundary. The condition of the observed internal scarps suggests this area of the slope may have experienced localized ground movement in the past 10 years. The mapped landslide toe was 2 to 3 feet high and appeared rounded and subdued. The inferred landslide depth was similarly estimated to be less than 4 feet based on the size and condition of the landslide features observed. This evaluation was conducted by Geosyntec on 7/11/2023.

Five landslide sites are categorized as Class B landslides: Sites #2, #12, #14, #15, and #17. The landslides observed at Site #2 occur on a gentle side slope that is partially crossed by the proposed pipeline centerline. However, the area immediately upslope of the observed landslides is a broad and flat hilltop that contains sufficient workspace area. Geosyntec understands that SCS will propose a micro-reroute of the pipeline alignment approximately 75 to 100 feet to the west-southwest of the landslide. A small reroute would avoid intersecting the landslide and therefore the site is categorized as a Class B. Without a micro-reroute around the landslide, Site #2 would be considered a Class C site.

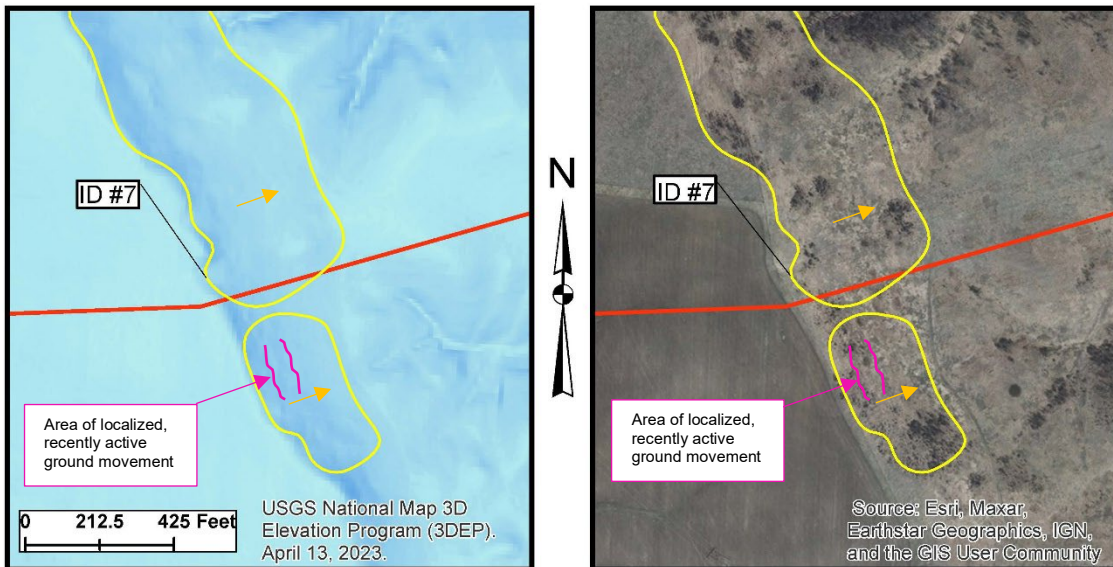
The morphology observed at Site #7 may be related to a highly weathered and subdued dormant landslide on a gentle east facing slope. The questionable landslide is crossed axially by the proposed pipeline centerline near the right lateral flank mapped by the NDGS. The landslide boundary mapped by the NDGS was approximately 400 feet long and 1150 feet wide. The only questionable landslide feature observed within 100 feet of the proposed pipeline centerline was a rounded hummock-type feature less than 1 ft high across the proposed pipeline centerline location that could be the remnants of a highly weathered and subdued right lateral flank or landslide toe. No other discernible features that appeared consistent with landslide morphology were observed within Site #7 near the proposed pipeline centerline. The mapped headscarp of Site #7 was located along a subtle slope break adjacent to a flat farm field. At the time of the visit the landslide was vegetated with mixed grasses up to 2 ft, wooded brush up to 3 ft and patches of trees up to 6 inches in diameter. The inferred depth of the questionable landslide is assumed to be less than 4 feet in the vicinity of the proposed pipeline centerline due to the lack of landslide features exhibited. Another, smaller landslide boundary mapped by the NDGS that is located near, and south of, Site #7 was similarly evaluated due to its proximity to the proposed pipeline centerline. The landslide boundary mapped by the NDGS was approximately 260 feet long and 515 feet wide. The direction of landslide movement was northeast and parallel relative to the proposed pipeline centerline. Within the mapped landslide boundary, a distinct landslide scarp 1 to 2 feet high and a distinct landslide toe 1 to 2 feet high were identified approximately 120 feet south of the proposed pipeline centerline. The condition of the observed features and their visibility in recent aerial imagery suggests this area of the slope likely experienced localized ground movement in the past 10 to 15 years. The inferred landslide depth was estimated to be less than 3 feet based on the based on the size and condition of the landslide features observed. The evaluation was conducted by Geosyntec on 7/11/2023.

Two landslide sites are categorized as Class A landslides: Site #7 and NDM-106 (MP 145.3-145.4). Site #7 exhibited questionable dormant landslide morphology while the adjacent mapped landslide to the south exhibited more definitive, but inactive landslide features. The landslide observed near the proposed NDM-106 pipeline between MP 145.3 and 145.4 appeared to be a relatively small and inactive surficial failure about 20 feet north of the proposed pipeline. Based on the inferred estimated depths of less than 4 feet for the landslides observed at Site #7, and less than 2 feet for the landslide observed at NDM-106 (MP 145.3-145.4), it is likely that any landslide morphology intercepted within the construction limits of disturbance would be removed by standard construction practices and no additional mitigative action is recommended beyond implementation of BMPs for pipeline construction along steep slopes, as warranted.

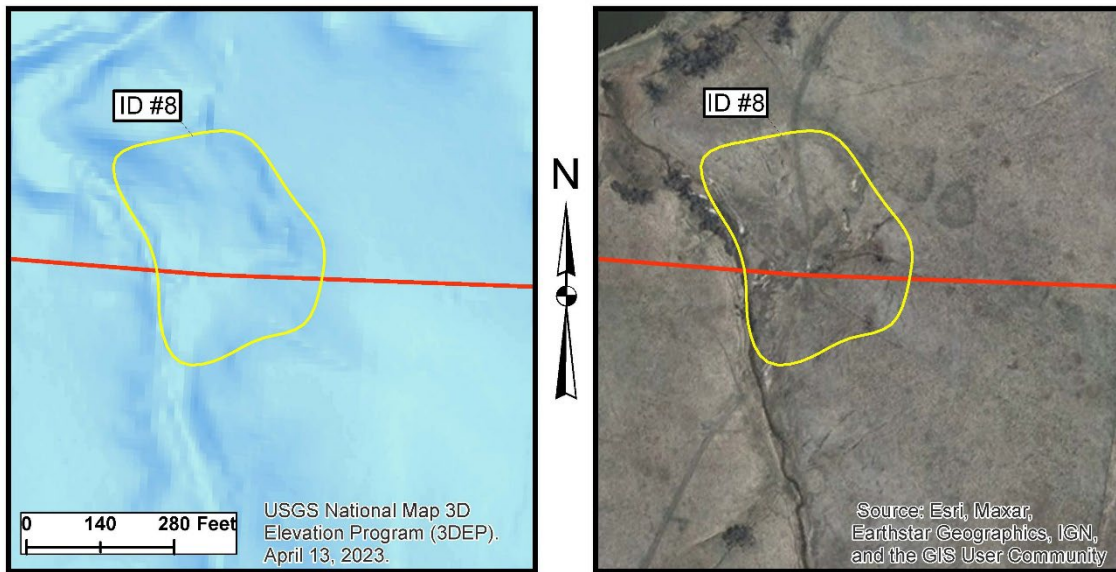
Based on the Phase II evaluation, the landform observed at Site #8 did not appear to be consistent with landslide morphology. No discernible landslide features were identified at the time of evaluation. The landform observed at Site # 8 comprised a gradual convergent slope having multiple converging erosional channels. The upper portion of the boundary mapped by the NDGS did not appear consistent with a landslide headscarp and appeared to be related to cattle trails and surface erosion. The lower portion of the mapped boundary did not exhibit features consistent with a landslide toe as the slope was uniformly gradual with no area of landslide deposition observed. The terrain crossed by the proposed pipeline centerline generally appeared to be smooth apart from cattle trails and erosion channels. Although it does not appear consistent with landslide morphology, the landform does appear to be unusual relative to surrounding areas, which may be a reason for it being mapped as a landslide by the NDGS. However, the landform could possibly be related to groundwater sapping and/or differential weathering due to some variation in the underlying geologic materials relative to surrounding areas. At the time of the site visit the vegetation within the landform consisted of grass up to 2 ft high. The evaluation was conducted by Geosyntec on 7/12/2023.

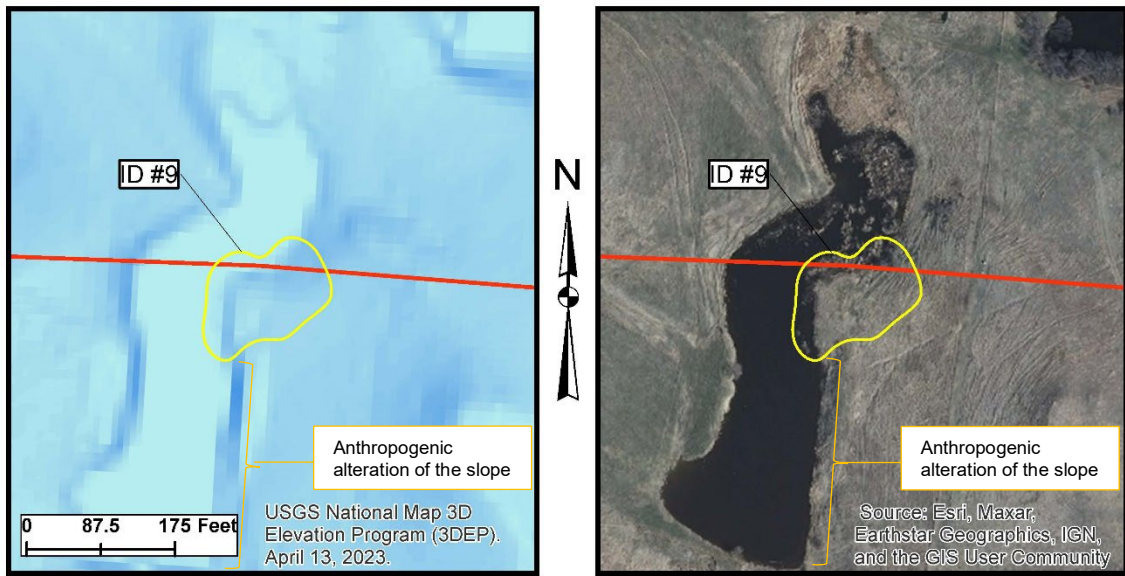
Based on the Phase II evaluation, the landform observed at Site #9 did not appear consistent with landslide morphology. No discernible landslide features were identified at the time of evaluation. The landform observed at Site # 9 appeared as a generally smooth and gradual slope near an anthropogenic pond that was bordered by cattails. No features indicative of a landslide headscarp or landslide toe were exhibited within or surrounding the boundary mapped by the NDGS. Based on aerial imagery, the lower portion of the mapped boundary appears to protrude westward relative to the slope to the south, which may be a reason for it being mapped as a landslide by the NDGS. However, this apparent protrusion is unnatural and caused by anthropogenic alteration of the slope south of the mapped boundary to widen the area used for the retention pond: the eastward cut and regrading of the slope south of the mapped boundary gives the appearance of westward protrusion at the lower portion of the mapped boundary. At the time of the site visit the vegetation within the mapped boundary consisted of grass up to 2 ft high, wooded bushes up to 5 feet high, and cattails up to 6 feet high along the edge of the pond. The evaluation was conducted by Geosyntec on 7/12/2023.

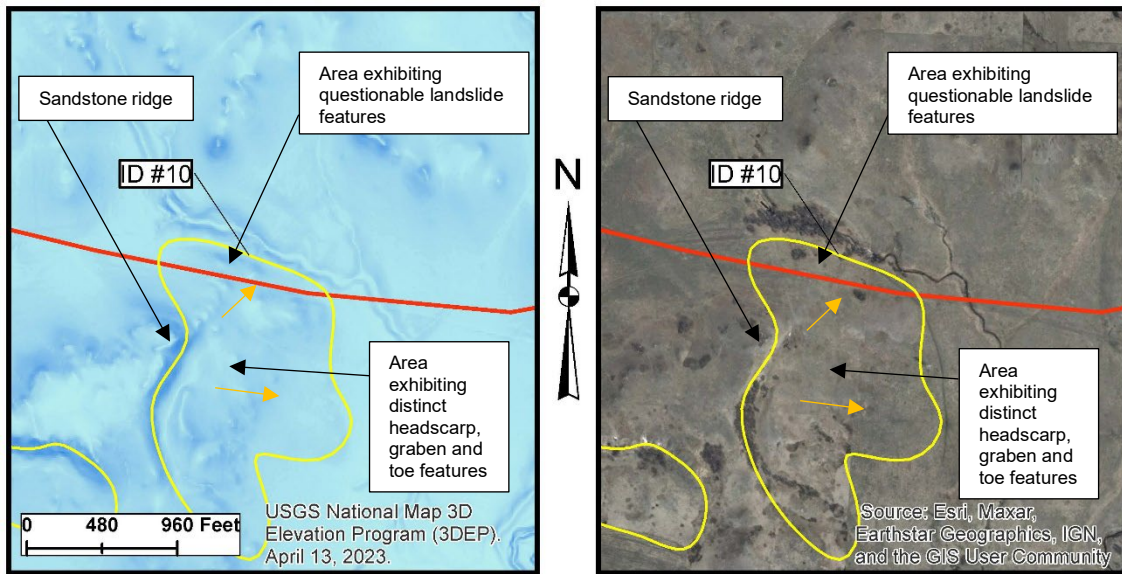
The morphology observed at Site # 10 appears consistent with a possible dormant landslide complex on an east- and northeast-facing slope. The landslide boundary mapped by the NDGS was approximately 1300 feet long and 2100 feet wide. The direction of landslide movement was east and northeast, and both axial and oblique relative to the proposed pipeline centerline. The proposed pipeline centerline crosses the mapped landslide boundary near the mapped left lateral flank and toe. Due to the large scale of the possible landslide the only feature observed in the vicinity of the proposed pipeline centerline was a possible rounded and subdued toe up to 30 feet high adjacent to the proposed pipeline centerline. The rounded and subdued condition of the morphology observed suggests this portion of the possible landslide complex is likely dormant and has not moved in hundreds, if not thousands, of years. No discernible evidence of recent landslide morphology was observed in the vicinity of the proposed pipeline centerline. The terrain crossed by the proposed pipeline centerline generally comprises a gradual and smooth slope. At the time of the visit, the vegetation in the vicinity of the proposed pipeline centerline consisted of mixed grasses up to 3 feet high. Areas of exposed sandstone bedrock were observed upslope of the proposed pipeline centerline along a ridgeline that trends southwest to northeast. The possible landslide morphology northwest of this ridge and crossed by the proposed pipeline centerline appeared more subdued and questionable than the area immediately downslope and east of the ridge, which exhibited stronger evidence of correlative landslide features. The inferred depth of the landslide could not be estimated due to the scale and condition of the observed landslide features. The evaluation was conducted by Geosyntec on 7/12/2023.

One landslide site was categorized as a Class C landslide: Site #10. The landslide observed at Site #10 exhibits questionable dormant landslide morphology where the mapped boundary is crossed

by the proposed pipeline centerline, and the depth of the landslide is not well constrained in the vicinity of the proposed pipeline centerline due to the scale and weathered condition of the landslide morphology observed. The terrain crossed by the proposed pipeline centerline is gradual and thus major grade alterations do not appear necessary to accommodate pipeline construction within the mapped landslide boundary of Site #10.

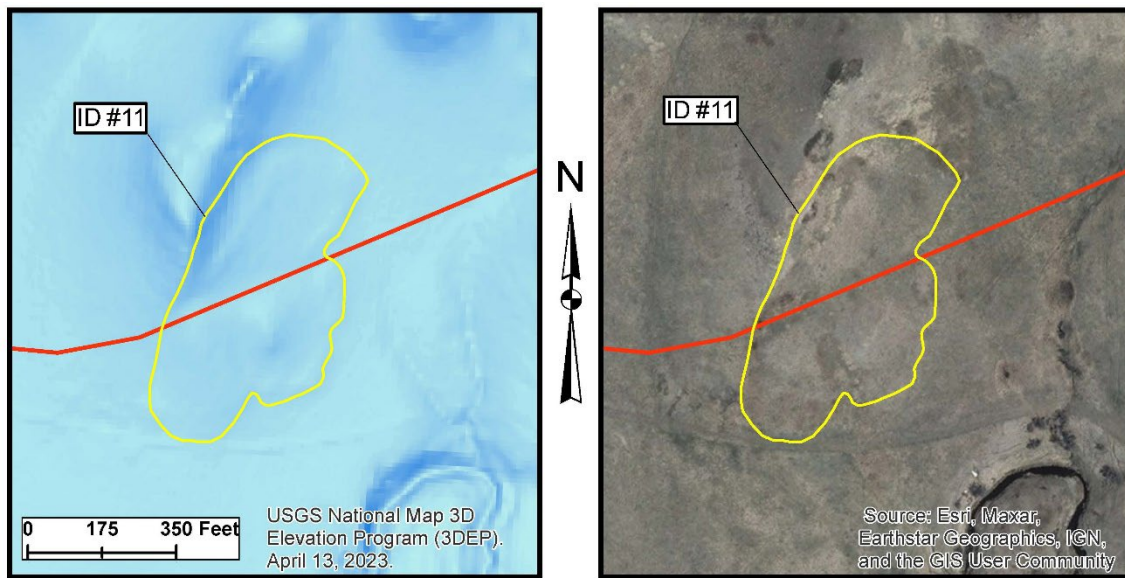
Based on the Phase II evaluation, the landform observed at Site #11 did appear to be consistent with landslide morphology. No discernible landslide features were identified at the time of evaluation. The landform at Site #11 comprised a generally uniform and smooth side-slope with some localized erosion near a ridgetop along the headscarp boundary mapped by the NDGS. No evidence of landslide deposits was identified along the mapped toe boundary. Based on aerial imagery, the vegetation that persists during dry seasons forms arcuate bands below the natural ridge possibly in response to seeps and/or moisture retention along the base of the ridge. It is possible that the arcuate appearance of dry-season vegetation accumulated below the natural ridgetop and variation of vegetation along the mapped toe boundary is a reason for this landform to be mapped as a landslide by the NDGS. However, no evidence of landslide disturbance could be identified. The proposed pipeline centerline crosses the mapped feature obliquely along a relatively gentle and smooth side-slope which becomes progressively steeper nearest to the ridge that is north of the centerline. At the time of the site visit the vegetation along the proposed pipeline centerline was a mix of grass and bushes up to 2 feet high. The evaluation was conducted by Geosyntec on 7/12/2023.

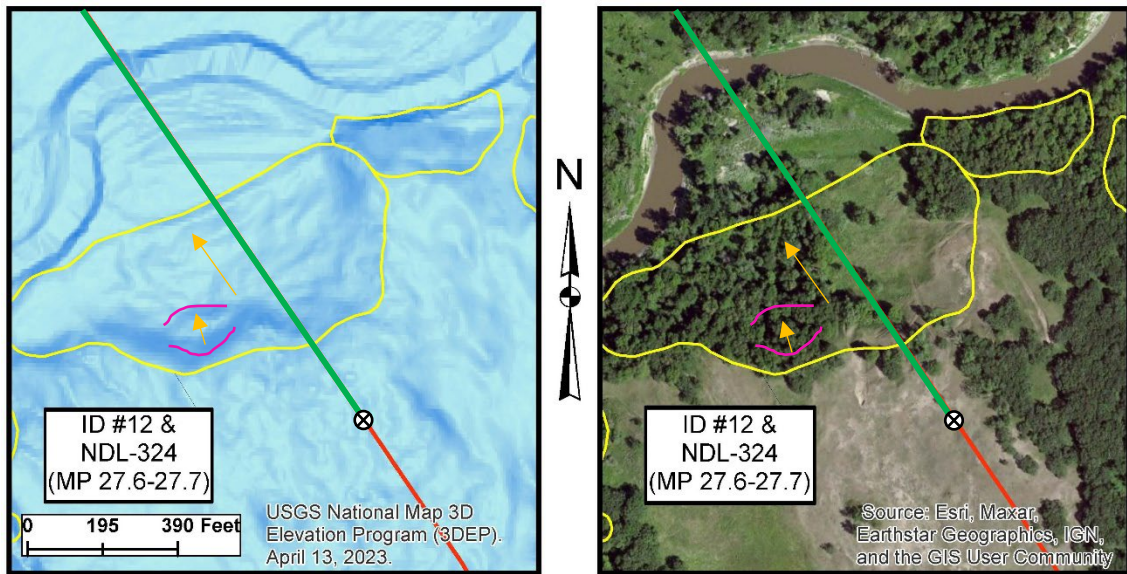
The morphology observed at Site # 12 appears consistent with a dormant landslide on a northwest-facing slope. The landslide boundary mapped by the NDGS was approximately 460 feet long and 1100 feet wide. The direction of landslide movement was northwest and axial relative to the proposed pipeline centerline. The proposed pipeline centerline crosses the center of the mapped landslide boundary. The observed landslide features were generally distinct but rounded with no discernible evidence of recent movement. The slope corresponding with the mapped headscarp was 10 to 12 feet high in the vicinity of the proposed pipeline centerline. Observed hummocks downslope of the mapped headscarp were rounded and approximately 4 feet high. The mapped landslide toe was up to 6 feet high and appeared to be modified or truncated by fluvial processes related to the Sheyenne River. West of the proposed pipeline centerline, a rounded headscarp up to 15 feet high and a rounded internal toe up to 10 feet high were observed with backward leaning trees up to 24 inches in diameter situated on the internal landslide body. The vegetation along the proposed pipeline centerline mostly consisted of grass up to 2 feet high with occasional deciduous trees. The inferred landslide depth was estimated to be 20 to 30 feet deep in the vicinity of the proposed pipeline centerline based on the size and condition of observed landslide features. A proposed HDD crossing for the Sheyenne River is planned for this location. Based on Geosyntec's review of the proposed HDD site plan and profile, including the proposed entry and exit points, the landslide morphology observed at this location would be avoided by the proposed pipeline as a result of HDD construction beneath the landslide. The evaluation was conducted by Geosyntec on 7/14/2023.

Proposed HDD crossings are planned for the Sheyenne River coinciding with Site #12 and the Maple River coinciding with Site #14. Based on our review of the proposed HDD site plans and profiles, including the proposed entry and exit points for these river crossings, the landslides at Site #12 and Site #14 would be avoided through HDD construction beneath the landslides. The landslide observed at Site #15 is located about 98 feet away from the proposed pipeline centerline and there appears to be sufficient workspace area on both sides of the proposed pipeline centerline to avoid intercepting this landslide. Similarly, the landslide at Site #17 is located about 70 feet west of the proposed pipeline centerline, and there appears to be sufficient workspace on the east side of the proposed centerline such that avoidance of this landslide appears feasible. Therefore, we recommend that temporary workspace delineations do not intercept the landslides at Sites #15 and #17.

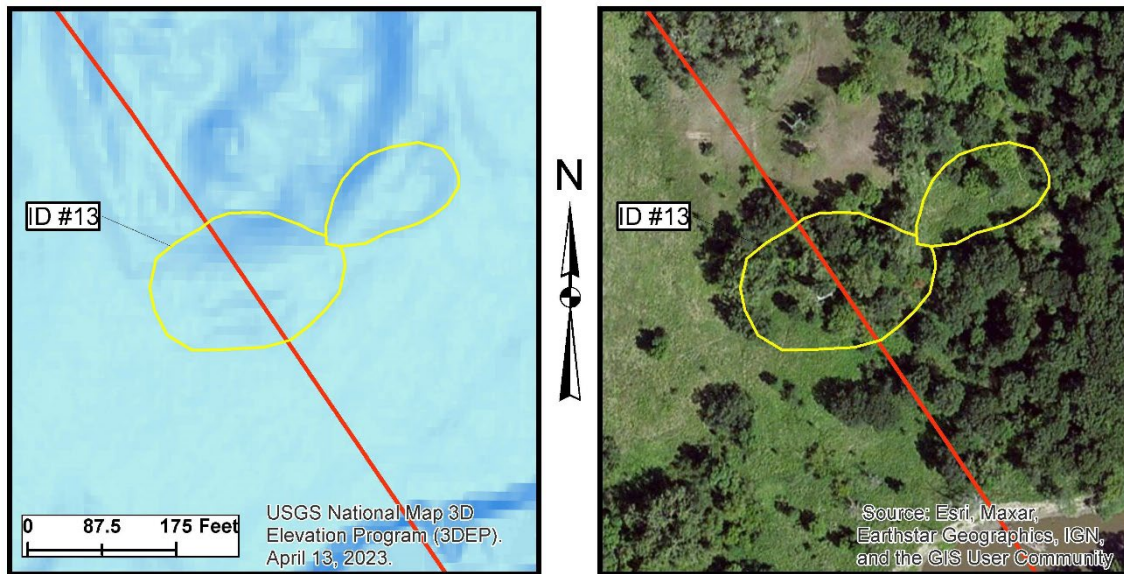
Based on the Phase II evaluation, the landform observed at Site #13 did not appear to be consistent with landslide morphology. No discernible landslide features were identified at the time of evaluation. The landform at Site #13 appeared as a generally smooth and gradual slope with some bare soil exposed by erosion along a natural slope break that corresponds with the headscarp boundary mapped by the NDGS. A mound of material observed at the mapped toe boundary appeared to be unrelated to landslide activity. It is possible that the combination of the natural slope break and mound may be reasons for this landform to be mapped as a landslide by the NDGS. However, these features do not appear to be landslide related and may be related to differential weathering relative to surrounding areas. At the time of the visit, the vegetation along the proposed pipeline centerline was a mix of forest with mature trees and open areas containing grass up to 2 feet high. The evaluation was conducted by Geosyntec on 7/14/2023.

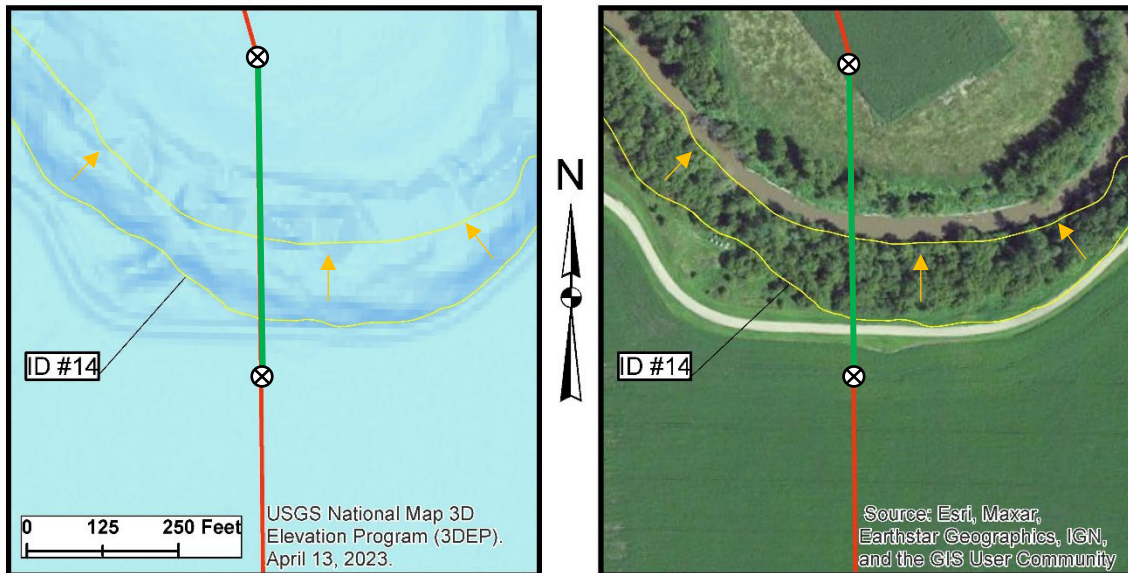
The morphology observed at Site #14 appears consistent with a series of inactive, localized bank slumps located along an outer meander bend of the Maple River. The curved landslide boundary mapped by the NDGS was approximately 130 feet long by 1,350 feet wide, and encompasses multiple localized banks slumps. The proposed pipeline centerline crosses the mapped landslide boundary near the apex of the meander bend. The direction of landslide movement was north and axial relative to the proposed pipeline centerline. A possible headscarp of a localized bank slump crossed by the proposed pipeline centerline measured approximately 3 feet high and may have been exaggerated by a berm along a dirt road to the south. The lateral flanks corresponding with the possible headscarp were indistinct, but a questionable toe feature downslope of the possible headscarp measured approximately 2 feet high. The landslide morphology observed appeared to be rounded and subdued. The inferred depth of the landslide was estimated to be less than 4 feet deep based on the observed size and condition of landslide features and the topography of the riverbank. At the time of the site visit, the landslide was vegetated with mixed grass up to 4 feet tall and deciduous trees and shrubs. The slope gradient along the proposed pipeline centerline was generally moderate near the headscarp region and low in the vicinity of the toe region. The dirt road upslope of the headscarp appeared undisturbed at the time of the assessment. A flood plain associated with the Maple River was observed downslope of the toe. A proposed HDD crossing for the Maple River is planned for this location. Based on Geosyntec's review of the proposed HDD site plan and profile, including the proposed entry and exit points, the landslide observed at this location would be avoided by the proposed pipeline as a result of HDD construction beneath the landslide. The evaluation was conducted by Geosyntec on 7/13/2023.

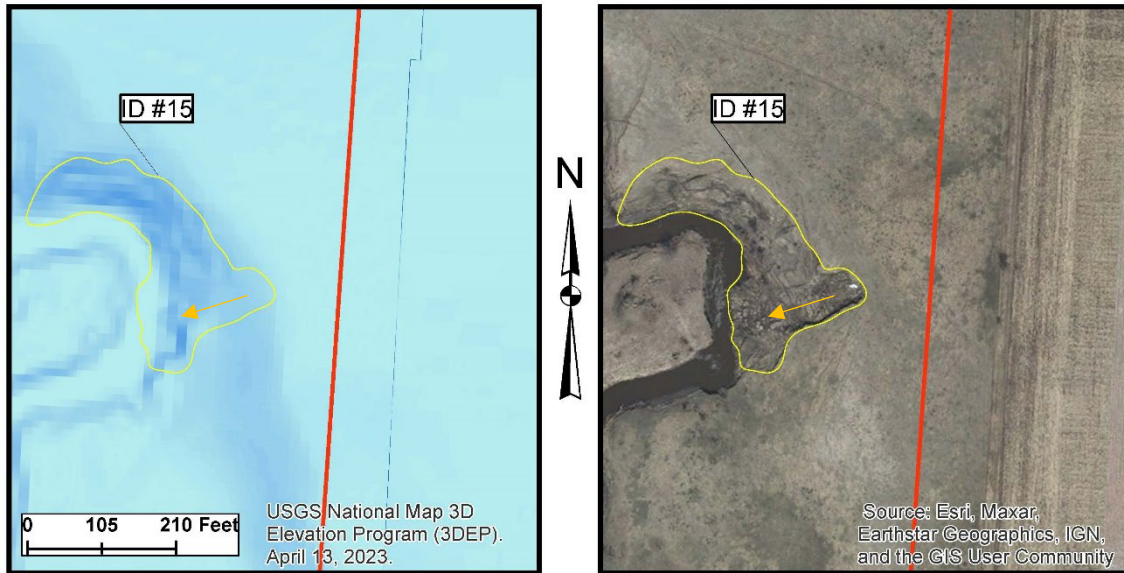
Site # 15 appears to be an inactive landslide located on a west-facing slope at the outer meander bend of a stream. The curved landslide boundary mapped by the NDGS measured approximately 200 feet long by 430 feet wide. The landslide was located approximately 98 feet west of the proposed pipeline centerline at its nearest approach. The direction of landslide movement was west-southwest and oblique relative to the proposed pipeline centerline. The landslide headscarp was approximately 5 to 6 feet high and the right and left lateral flanks were 4 to 5 feet high. The landslide toe was not visited due to the distance from the proposed pipeline centerline, but appeared to encroach into the stream bed. The landslide morphology appeared to be distinct and sharp along the southern portion of the mapped feature and rounded and subdued along the northern portion of the mapped feature, suggesting the southern features are relatively younger than the northern features. Based on aerial imagery and the observed morphology, the landslide appears to be 10-15 years old. The inferred landslide depth was estimated to be 6 to 10 feet deep based on the observed size and condition of the landslide features and topography of the streambank. At the time of the site visit, the landslide and the area in the vicinity of the proposed pipeline was uniformly vegetated with mixed grasses up to 2 feet high. The slope gradient along the proposed pipeline centerline was generally low to flat. Based on the topography observed, the landslide appears unlikely to retrogress across the path of the proposed pipeline centerline. The evaluation was conducted by Geosyntec on 7/13/2023.

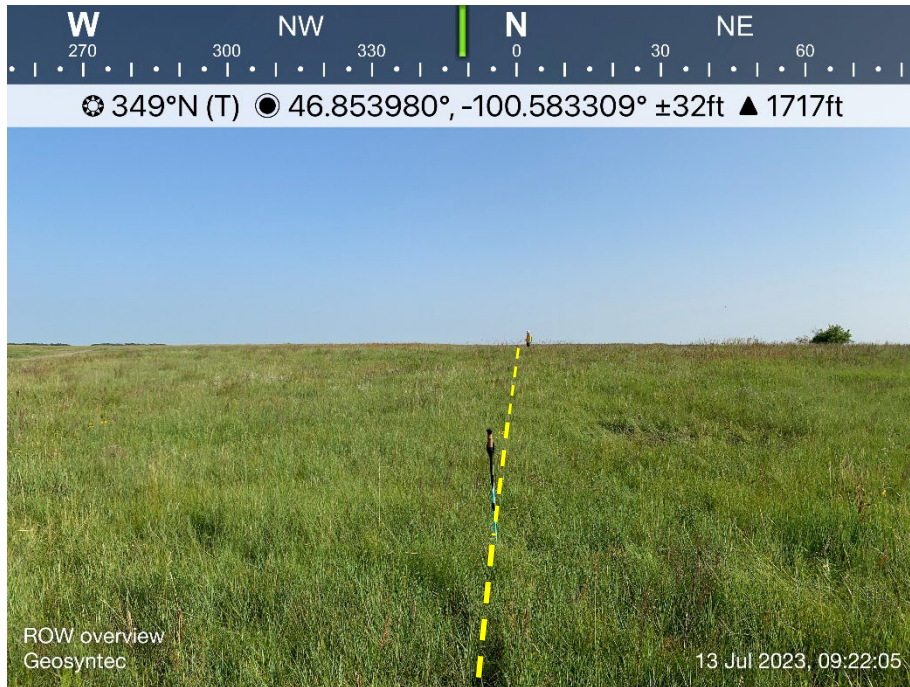
Looking north along the proposed pipeline centerline. The approximate proposed pipeline location is represented by the dashed yellow line.

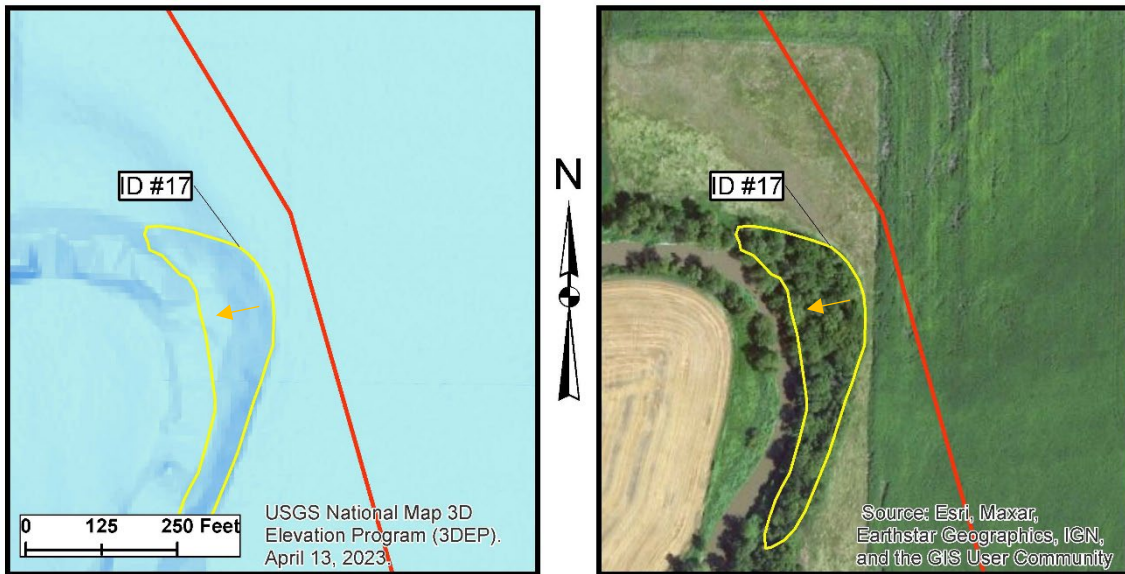
The morphology at Site #17 appears consistent with multiple, inactive bank slumps located along the outer meander bend of the Maple River. The curved landslide boundary mapped by the NDGS was approximately 130 feet long by 630 feet wide. The mapped headscarp was located approximately 70 feet from the proposed pipeline centerline. The direction of landslide movement was west-southwest and perpendicular relative to the proposed pipeline centerline. The observed headscarp and toe features nearest to the proposed pipeline centerline appeared rounded and subdued and measured approximately 3 feet high. The inferred depths of the bank slumps were estimated to be less than 4 feet based on the size and condition of the observed landslide features and topography of the riverbank. A flood plain for the Maple River was observed downslope of Site #17. At the time of the site visit, the area in the vicinity of the proposed pipeline was a cultivated soybean farm field and Site #17 was vegetated mixed grasses up to 4 feet high and undisturbed deciduous trees up to 12 inches in diameter. Dense vegetation may have obscured some landslide geomorphology at the time of the site assessment. The slope gradient along the proposed pipeline centerline was generally low. Based on the topography observed, Site #17 appears unlikely to expand across the path of the proposed pipeline centerline. The evaluation was conducted by Geosyntec on 7/14/2023.

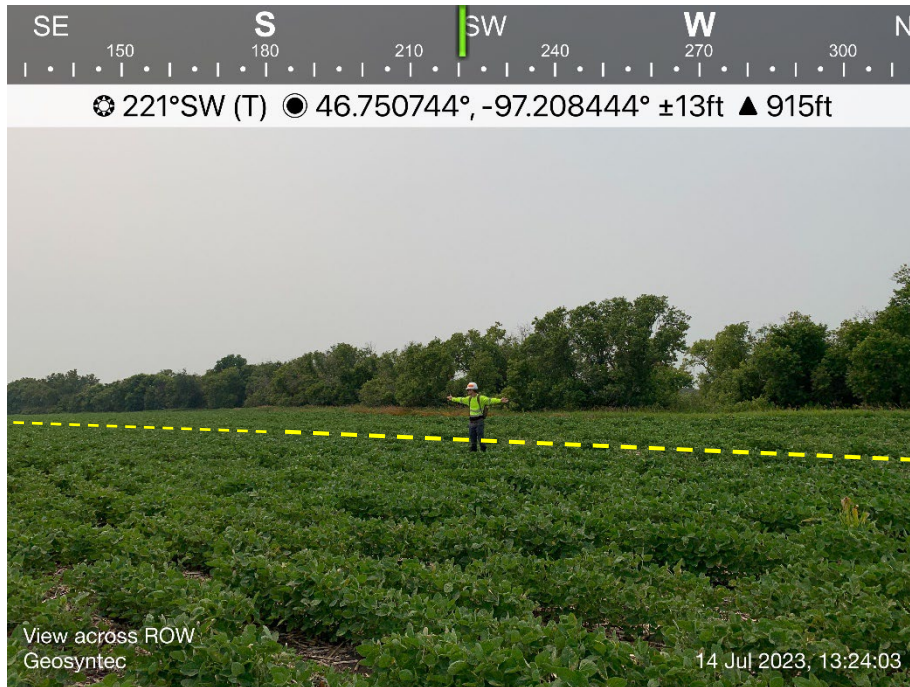
Looking southwest across the slope. The approximate proposed pipeline is located in the center of the image (dashed yellow line). Site #17 was located beyond the tree line in background of photo.

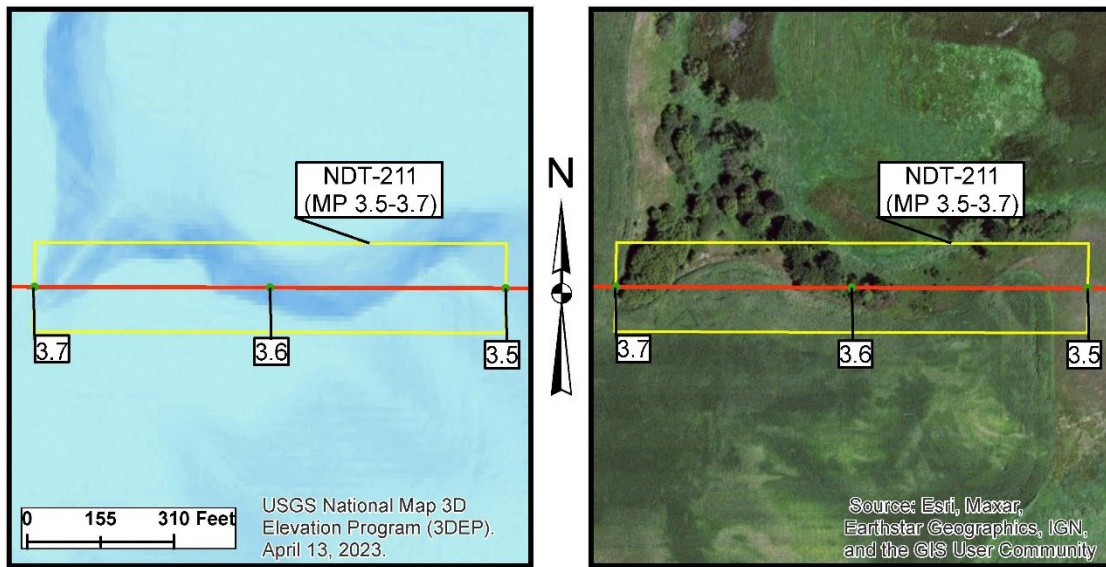
Based on the Phase II evaluation, no landslide morphology was identified along the proposed NDT-211 pipeline between MP 3.5 and 3.7. The features identified between MP 3.5-3.7 appeared to be flat terrain surrounding a natural slope break and rounded drainage gully, which were densely vegetated at the time of the assessment. The gradients of the sloped areas were generally low to moderate, and were generally smooth except where traversed by deer trails. At the time of the site visit, the sloped areas crossed by the proposed pipeline centerline were densely vegetated with mixed grasses up to 4 ft high and dispersed trees and shrubs. Downslope of the proposed pipeline centerline, cattails and ponded water were observed in a wetland area. The evaluation was conducted by Geosyntec on 7/13/2023.

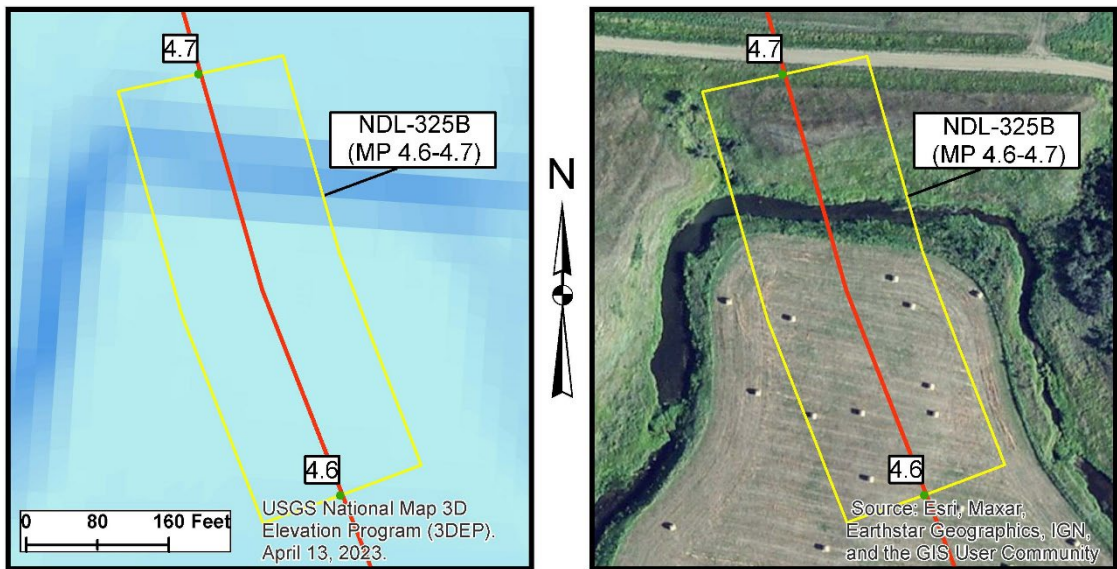
Based on the Phase II evaluation, no landslide morphology was identified along the proposed NDL-325B pipeline centerline between MP 4.6 and 4.7. The features observed between MP 4.6 and 4.7 included a steep slope adjacent to a small stream, an area of exposed soil likely related to minor erosion that was located to the west of the proposed pipeline alignment, and a drainage gully located to the west of the proposed pipeline. At the time of the site visit, the area crossed by the proposed pipeline centerline was uniformly vegetated with mixed grasses up to 2 ft high. The slope gradient along the proposed pipeline centerline was generally moderate to the north and low to the south. It is possible that the observed erosion features may have been misidentified as possible indicators of landslide activity as they resemble scarps or tension cracks when viewed in aerial imagery. The evaluation was conducted by Geosyntec on 7/11/2023.

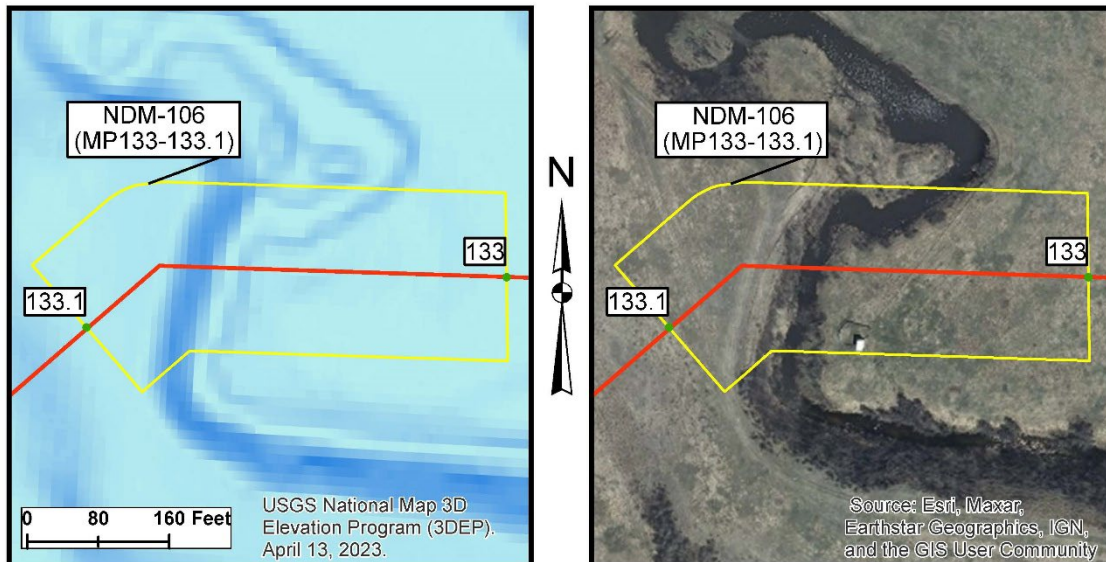
Based on the Phase II evaluation, no landslide morphology was identified along the proposed NDM-106 pipeline between MP 133 and 133.1. The features observed between MP 133 and 133.1 included flat terrain surrounding a steep embankment along a meander bend of a shallow oxbow lake. At the time of the site visit, the area crossed by the proposed pipeline centerline was uniformly vegetated with mixed grasses and shrubs up to 4 ft high, and trees dispersed along the edge of the oxbow lake. The slope gradient along the proposed pipeline centerline was generally steep along the western embankment of the oxbow lake, and low to flat on the eastern side of the oxbow lake. Cattle tracks were observed throughout the section of the steep slope and along the flat fields to the west and east of the oxbow lake. It is possible that the cattle tracks may have been misidentified as possible indicators of landslide activity as they resemble scarps or tension cracks when viewed in aerial imagery. The evaluation was conducted by Geosyntec on 7/12/2023.

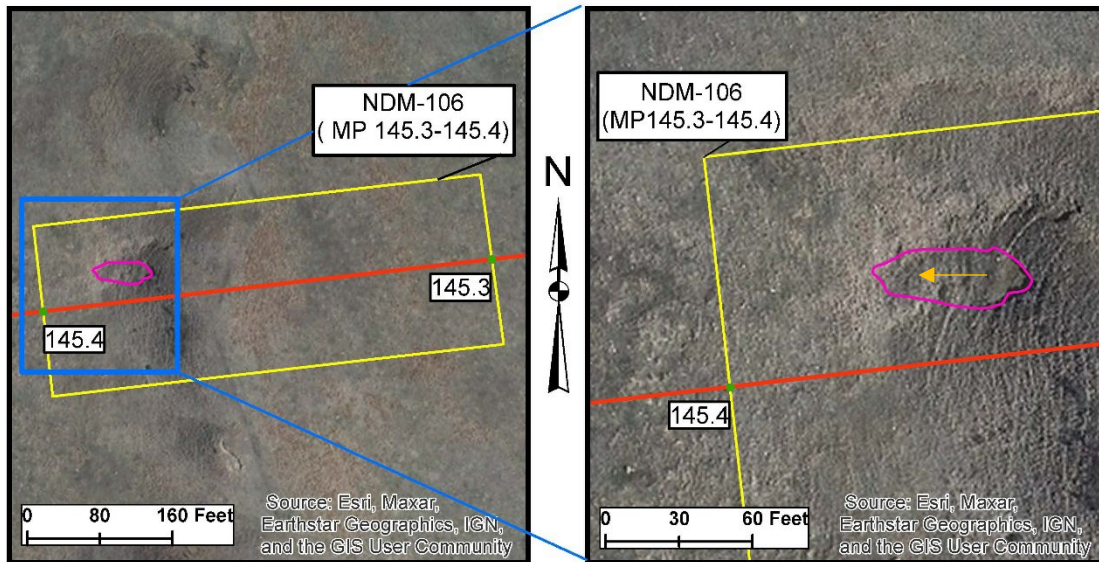
Based on the Phase II evaluation along the proposed NDM-106 pipeline between MP 145.3 and 145.4, a shallow landslide was observed on a west facing slope approximately 20 feet north of the proposed pipeline centerline. The landslide was relatively small and measured approximately 70 feet long by 25 feet wide. The direction of ground movement was west and axial relative to the orientation of the proposed pipeline centerline. The headscarp measured approximately 2 feet high, the left and right lateral flanks measured approximately 2 ft high, and the toe measured approximately 1-foot high. The landslide appeared to be inactive (>10 years old) based on the condition of the morphology observed. The landslide was estimated to be 1-2 feet deep based on the observed size of the landslide features and topography. At the time of the site visit, the landslide was uniformly vegetated with mixed grass up to 2 feet tall except where recent cattle activity had exposed bare soil within and around the landslide. The slope gradient along the proposed pipeline centerline was generally moderate and increased from west to east. The evaluation was conducted by Geosyntec on 7/11/2023.

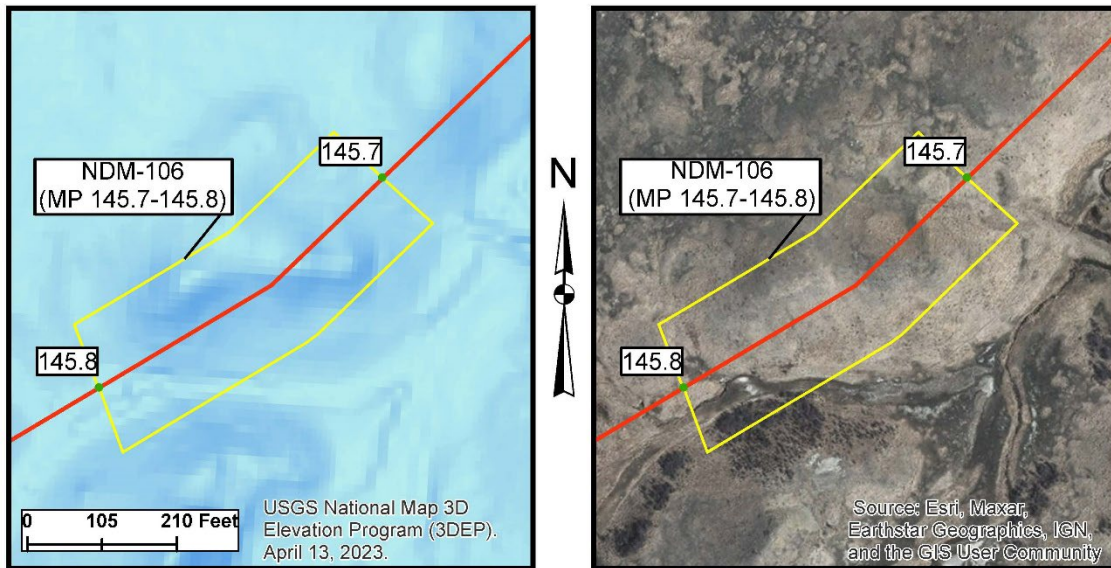
Based on the Phase II evaluation, no landslide morphology was identified along the proposed NDM-106 pipeline between MP 145.7 and 145.8. The topography between MP 145.7 and 145.8 consisted of a rounded knoll with gentle to moderately steep slope gradients that exhibited minor erosion along the upslope portions of the hilltop. At the time of the site visit, the area crossed by the proposed pipeline centerline was uniformly vegetated with mixed grasses up to 2 ft high. Overgrown cattle trails were common along the slopes in the vicinity of the proposed pipeline centerline. It is possible that the cattle trails may have been misidentified as indicators of landslide activity as they may resemble scarps or tension cracks when viewed in recent aerial imagery. The evaluation was conducted by Geosyntec on 7/11/2023.
