In the Matter of the Application of SCS Carbon Transport LLC for Certificate of Corridor Compatibility and Route Permit for the Midwest

Case No.: PU-22-391

# DIRECT TESTIMONY OF JACK WILLINGHAM

A. I am sponsoring Willingham Direct Exhibit 1, which is a copy of the May 26, 2022, PHMSA Failure Investigation Report related to the CO2 pipe rupture in Satartia, Mississippi, that occurred in February 2020. I am also sponsoring Willingham Direct Exhibit 2, which is a statement from the Shelby County Iowa Board of Health, as an exemplar of County concerns and issues that can confront any county, detailing its public health concerns related to pressurized CO2; Willingham Direct Exhibit 3 is a true and accurate copy of my live sworn testimony during the Iowa IUB hearing; Willingham Direct Exhibits 4 and 5 are true and accurate recordings of 911 emergency calls my department received during the Satartia CO2 pipeline rupture. Willingham Direct Exhibit 6 is testimony filed with the IUB from Debrae Burns, regarding his experience being exposed to CO2 during the 2020 pipe rupture.

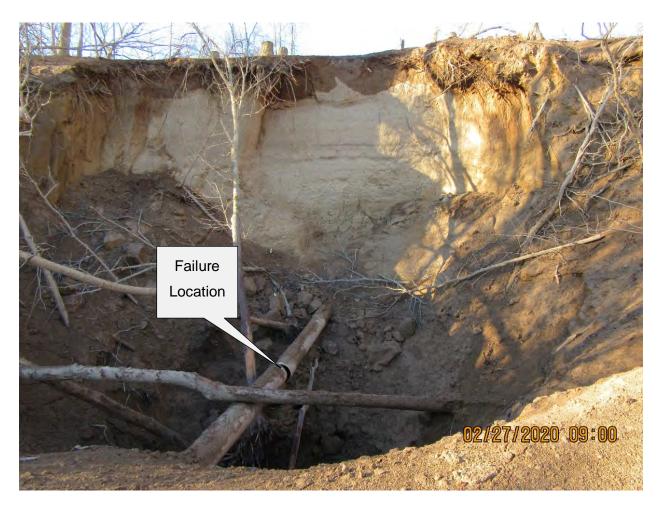
Figure 6. Failure Location (Upstream to Downstream)

Figure 6 and Figure 7 show the view of the release location as-found on February 27, 2020.

Personnel were unable to access the pipe at the failure location due to the depth of the crater and instability of the soil on the downstream side of the crater.

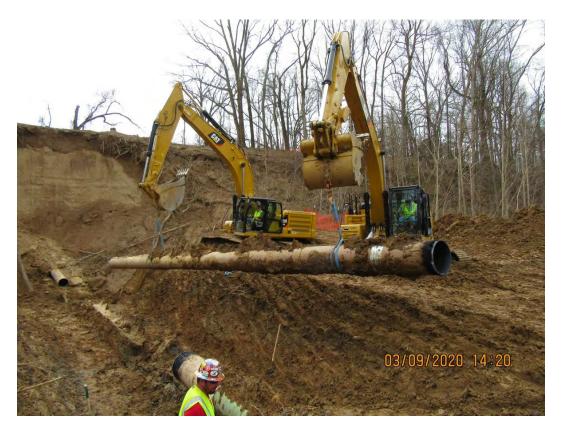
Figure 9. Upstream Pipe Section During Removal

Figure 9 shows the upstream pipe section being removed from the site.

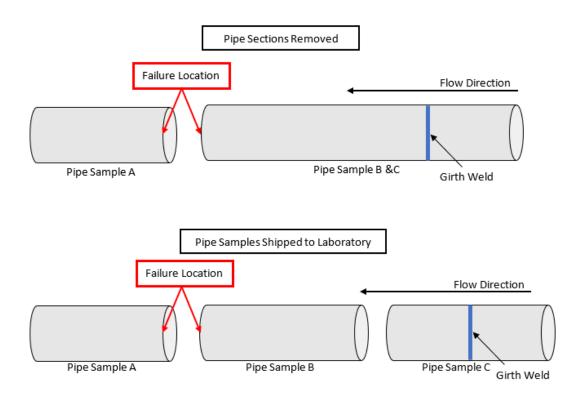
Figure 10. Overview of Pipe Sections and Samples

Once moved to an accessible location, the pipe sections were documented, samples were cut and prepared for shipment to the laboratory. Figure 10 provides an overview of the pipe sections as removed and prepared for shipment.

Visual inspection of the external surface of the pipe sections identified an area of coating damage near the failure, which appeared to have occurred as a result of the failure (no pitting, attached solids, and apparent adhesive failure). No external corrosion was observed and the pipe coating on the remainder of the section appeared to be in excellent condition.

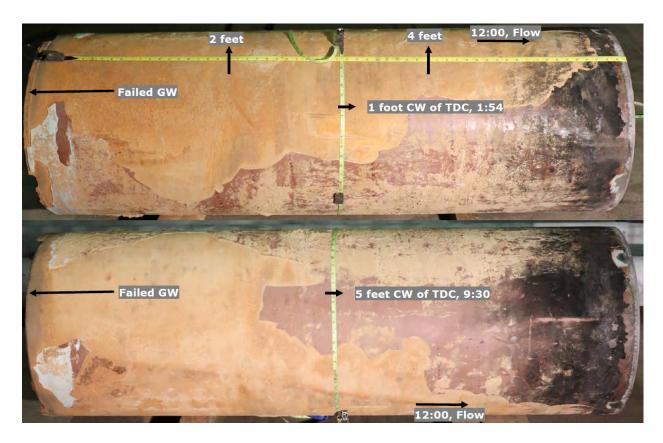
Figure 12. Pipe Sample A (PS A)

The pipe adjacent to the fracture surfaces and failed girth weld were visually inspected. The fractured surface was flat and generally at a 180-degree angle with no thinning and/or reduction of the affected area. The fracture path traversed or crossed over the weld at various locations.

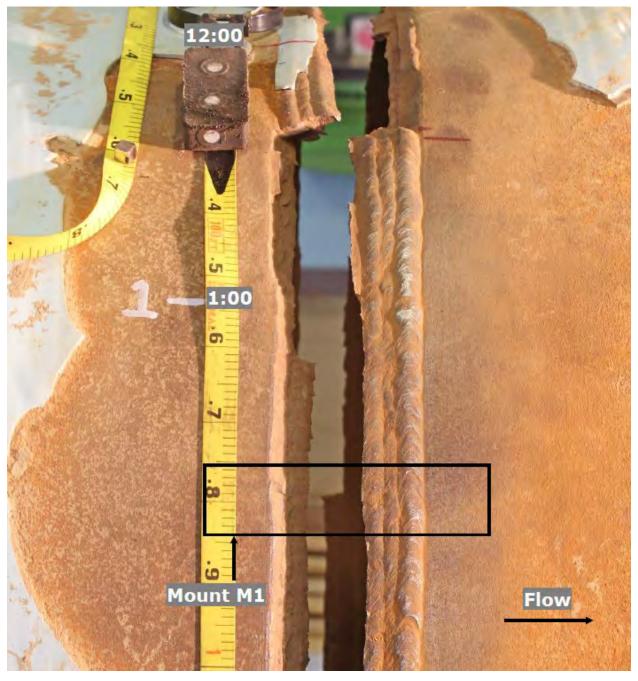
Figure 19. Overview of Mount M1

Sample M1 contains a fracture path at a shear angle. This sample was removed from the girth weld at the 1:35 o'clock orientation (see Figure 19).

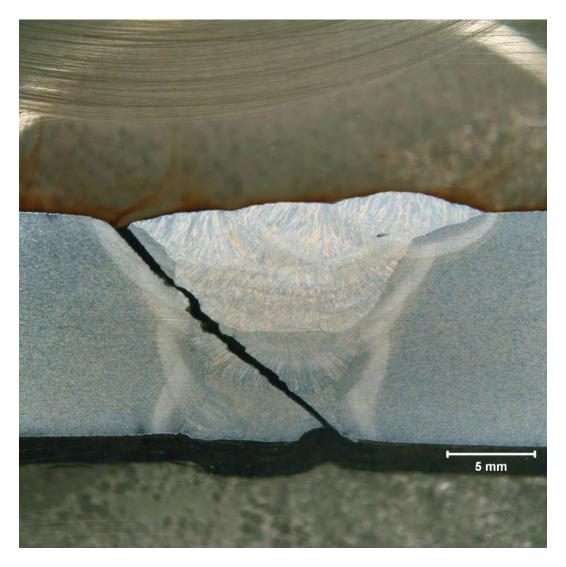
Figure 20. Representative Cross-Section from Sample M1

The fracture path of this sample is located in the HAZ near the toe of the weld at the OD surface. An image of the cross section of sample M1 is provided in Figure 20.

There is no indication of excessive porosity and/or inclusions. It shows a slight misalignment of the high-low weld of approximately 4.3% of the NWT. Higher magnifications are provided in the laboratory report which show grain elongation due to the cold work that took place during the rupture process. This is consistent with ductile overloading. The microstructure is typical of modern X80 line pipe. A close-up of sample M1 is provided in Figure 21.

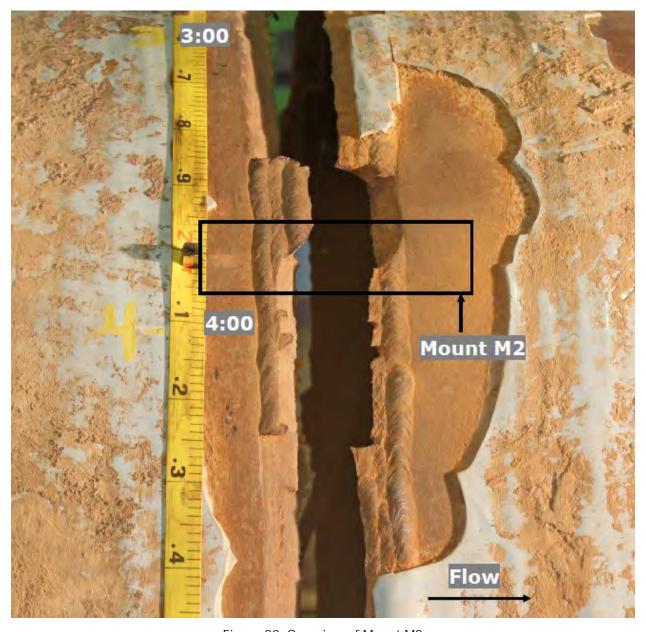
Figure 22. Overview of Mount M2

Sample 2 contains regions where the fracture path is perpendicular to the free surface and regions of shear failure. This sample was taken from the GW at the 3:55 o'clock orientation (see Figure 22).

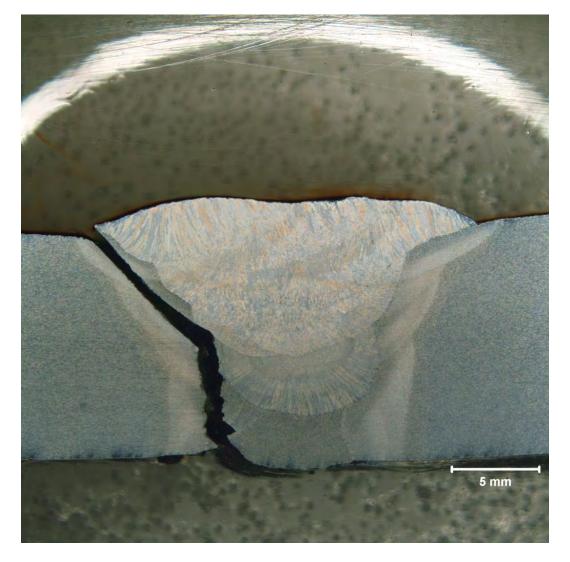
Figure 23. Representative Cross-Section from Sample M2

The cross section of M2 includes both the weld metal and HAZ. The cross section of sample M2 is provided in Figure 23.

There are both smooth and rough regions in this sample. The high-low weld misalignment at this location is approximately 6.9% of the NWT. The fracture path at this location was mainly located at the HAZ. Fractography in the SEM shows the presence of a smooth region containing dimples (typical of ductile behavior) and cleavage facets (typical of brittle behavior) in the rough region. Some fissures were also found in the area where cleavage facets were located. These fissures are usually seen in girth weld overload areas (see Figure 24).

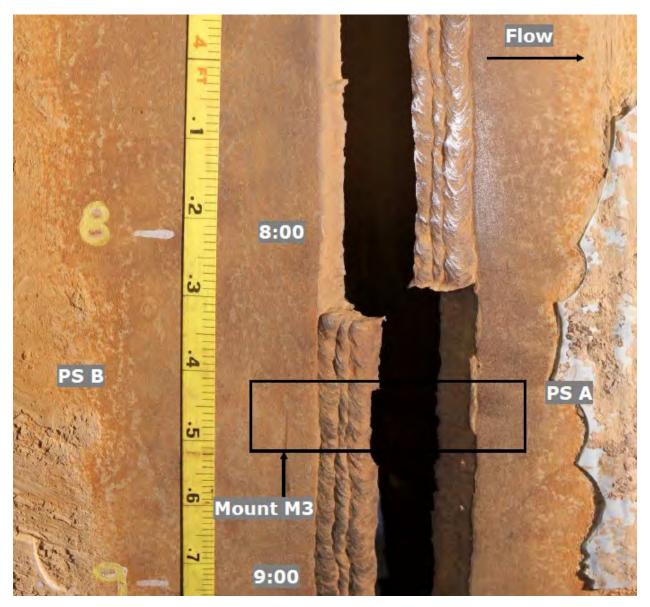
Figure 25. Overview of Mount M3

This sample was removed from the failed GW at the 8:35 o'clock orientation (Figure 25).

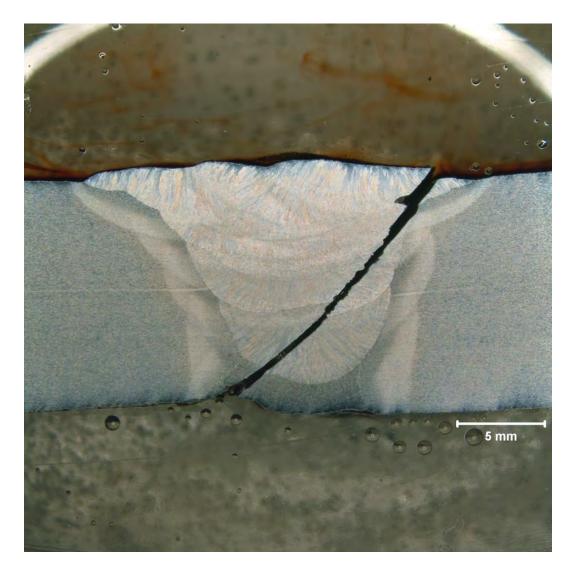
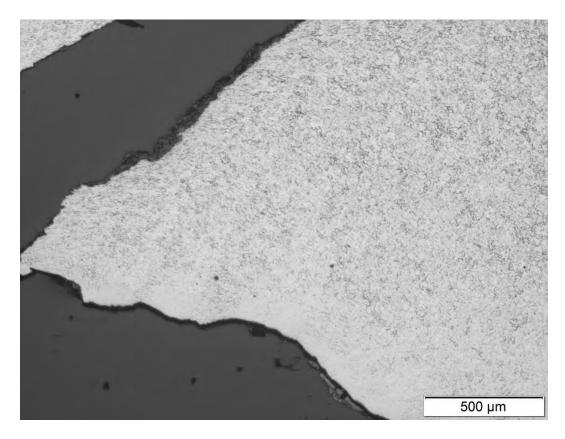
The fracture path is at a shear angle and mainly located in the weld metal. The morphology of the weld is similar to samples M1 and M2. The high-low weld misalignment at this location was approximately 2.6% of the NWT. The microstructure is consistent with the findings in samples M1 and M2 (see Figure 26 and Figure 27).

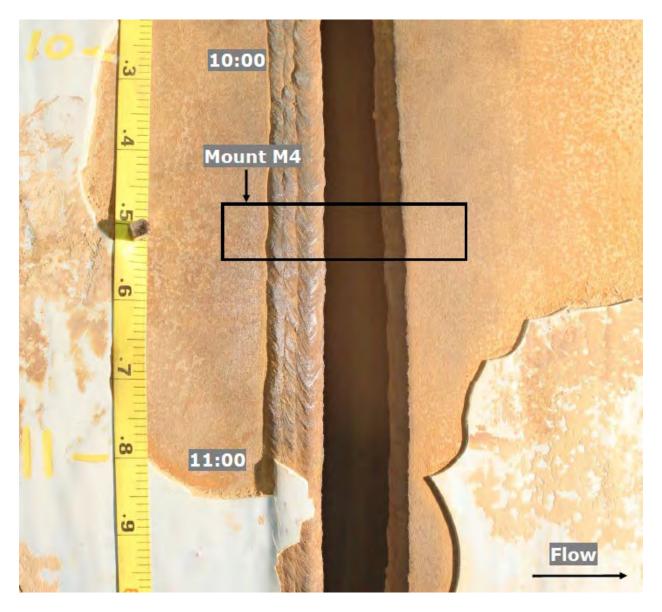
Figure 28. Overview of Mount M4

Sample M4 was removed from the failed GW at the 10:24 o'clock orientation. An overview of sample M4 is provided in Figure 28.

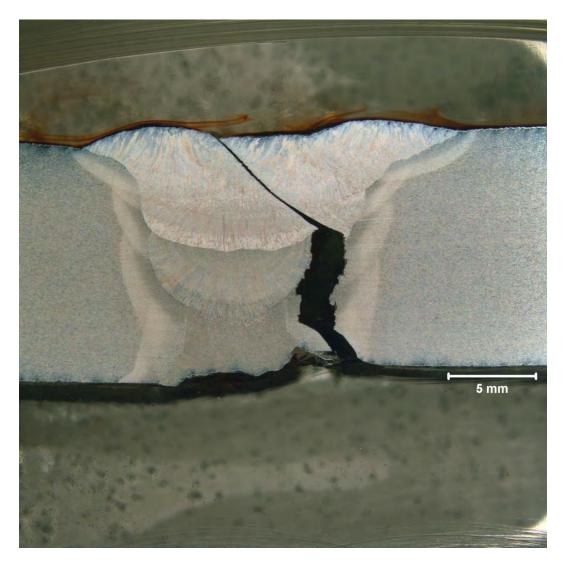
Figure 29. Representative Cross-Section from Sample M4

There is a smooth shear angle region and a rough region. The fracture path at this location is mainly in the HAZ. (see Figure 29).

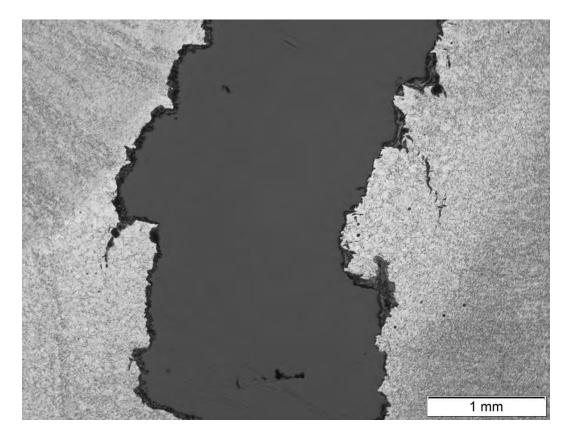
Figure 30. Close-Up of Sample M4

The sample shows grain elongation and an inclusion orientated parallel to the fracture surface which is consistent with ductile overload. There are also fissures in this sample that have the same morphology shown in M2 sample. A close-up of the M4 sample is provided in Figure 30.

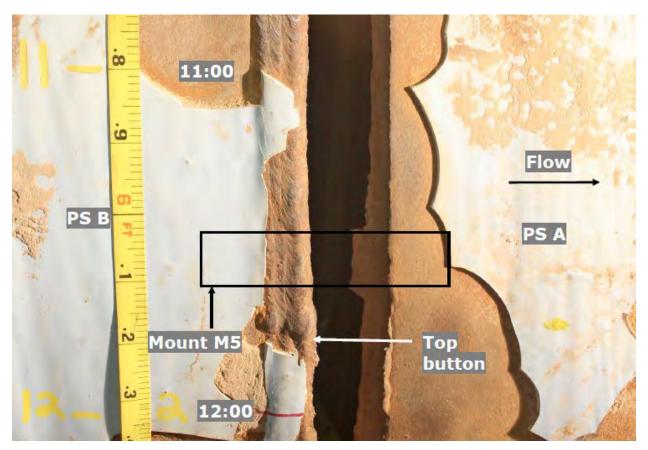
Figure 31. Overview of Mount M5

Sample 5 was removed from the failed GW at the 11:37 o'clock orientation (see Figure 31).

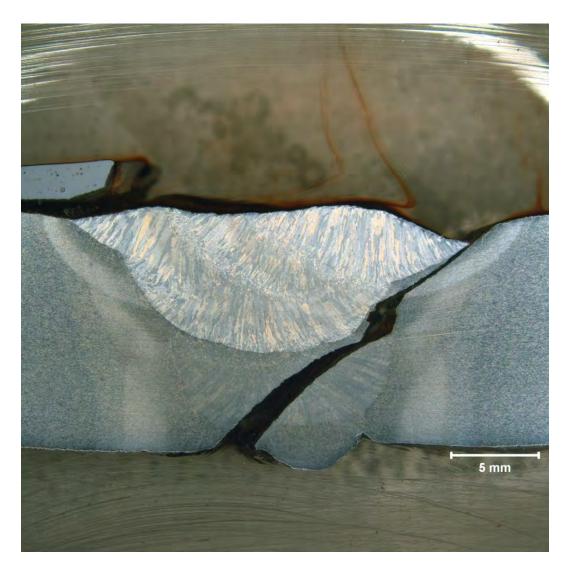
Figure 32. Representative Cross-Section from Sample M5

This sample has a smooth shear region on most of the fracture surface, located in both the weld metal and base metal. There is a shallow flaw between the weld metal and HAZ which is consistent with incomplete fusion. The high-low weld misalignment at this location was approximately 4.6% of the NWT. There is no evidence of crack extension at the flaw in this sample. A view of the cross section of sample M5 is provided in Figure 32.

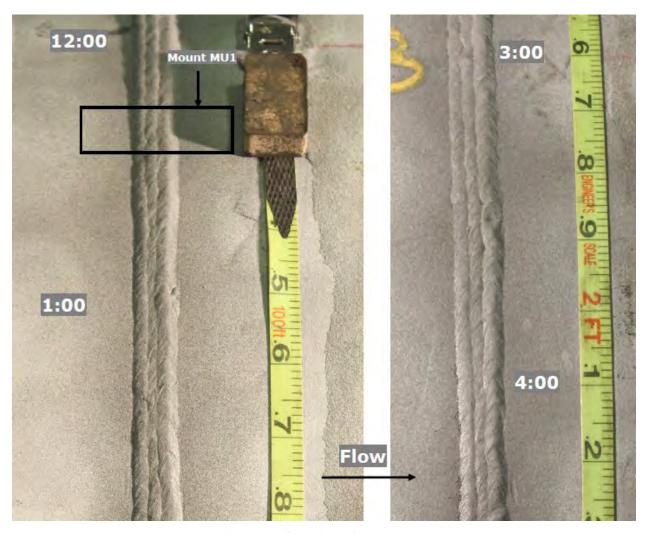
Figure 33. Overview of Mount MU1

Sample MU1 was removed from the intact girth weld. An overview of this sample is provided in Figure 33.

This sample was removed from the intact GW at the 12:24 o'clock position. The morphology is similar to the previous mounts. The high-low weld misalignment at this location is approximately 4.6% of the NWT. The figure shows a shallow incomplete fusion flaw (1.9% of the NWT) between the weld metal and the HAZ. An image of the cross section of sample MU1 is provided in Figure 34.

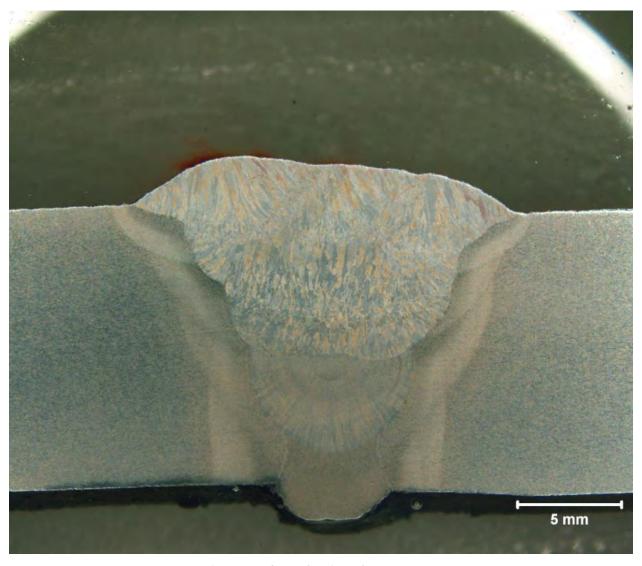
Figure 34. Cross Section of Mount MU1

A shallow flaw was identified between the weld metal and HAZ, with no evidence of cracking or extension of the flaw. A close up view of the flaw is provided in Figure 35.

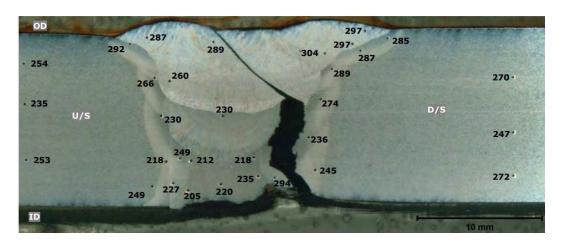
Figure 39: Light Photomicrograph of M2 Axial Cross-Section Showing Hardness Levels in HV

is harder than the weld metal. The axial tensile tests on the intact girth weld show similar failure to the actual fracture, further indicating that the lower hardness typical of the weld was the preferred location for the overload failure under applied axial stress. Hardness levels at varying points on sample M2 from the failed girth weld are shown in Figure 39.

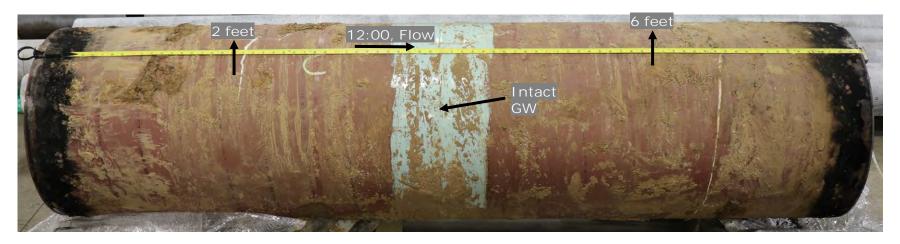
Figure 10. Photograph of PS C after removal of the protective wrappings. The tape measure indicates the distance from the U/S end of PS C.

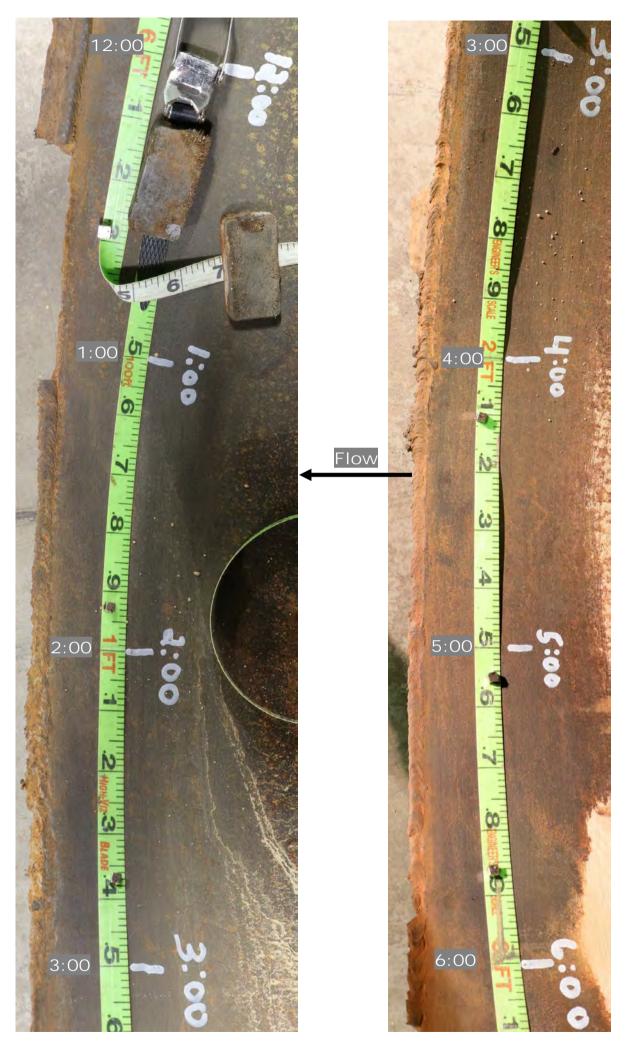
Figure 15. Photograph of the internal pipe surface adjacent to the fracture surface of PS B, between the 12 and 6 o'clock orientations. The tape measure indicates the approximate distance CW of TDC (looking D/S convention).

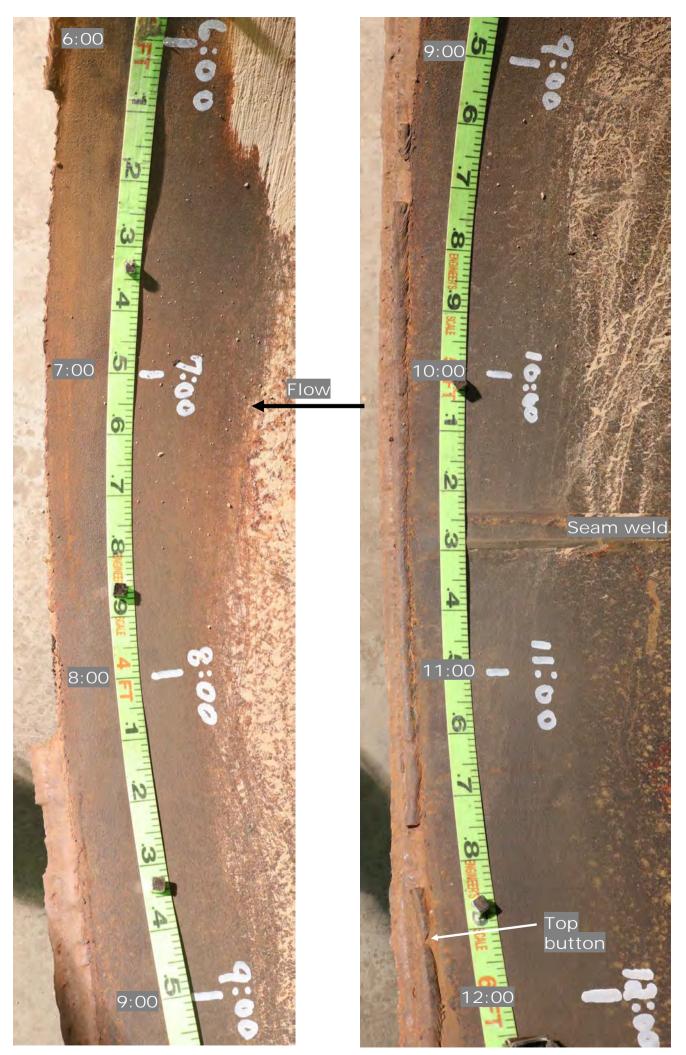
Figure 16. Photographs of the internal pipe surface adjacent to the fracture surface of PS B, between the 6 and 12 o'clock orientations. The tape measure indicates the approximate distance CW of TDC (looking D/S convention).

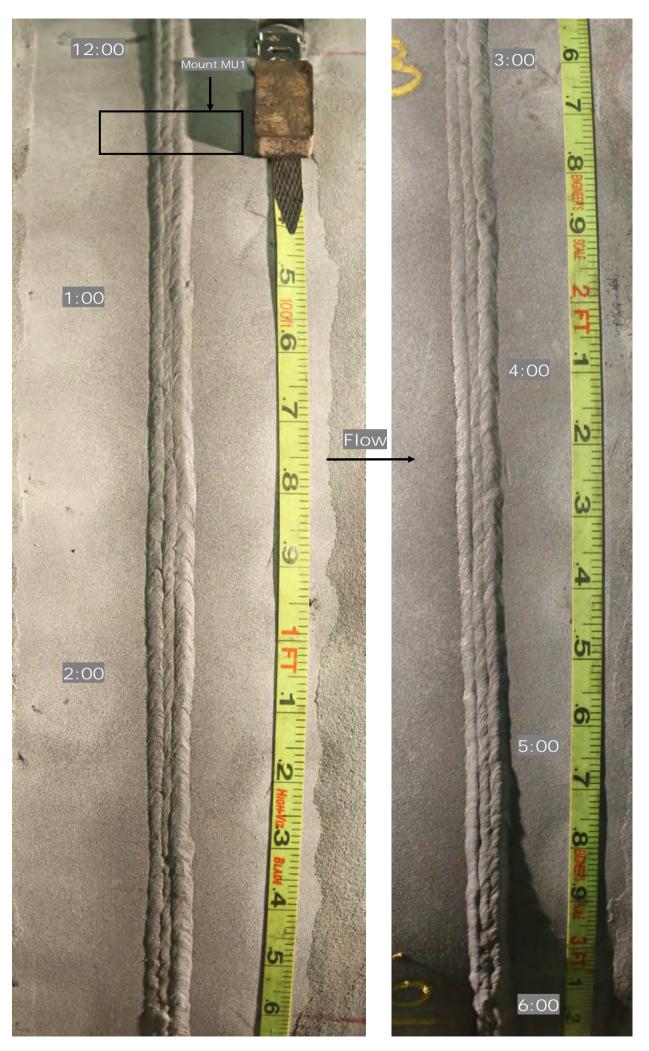
Figure 70 is a light photomicrograph of the axial metallographic cross-section (Mount MU1), which was removed from the intact GW at the 12:24 o'clock orientation; refer to Figure 1 and Figure 17 for the location. The morphology of the weld is similar to the previous mounts. The high-low weld misalignment at this location is approximately 0.011 inches (2.0% of the NWT). Figure 71 is a light photomicrograph of Mount MU1 adjacent to the ID surface. The figure shows a shallow (0.01 inches [1.9% of NWT] deep) flaw between the weld metal and HAZ. The location of the flaw is consistent with incomplete fusion (IF). Figure 72 is a high magnification light photomicrograph of Mount MU1 at the tip of the shallow IP flaw. The figure shows there is no evidence of crack extension at the flaw.

Figure 17. Photograph of the external pipe surface at the intact girth weld following grit blasting and MPI, between the 12:00 and 6:00 orientations. The tape measure indicates the approximate distance CW of TDC (looking D/S convention).

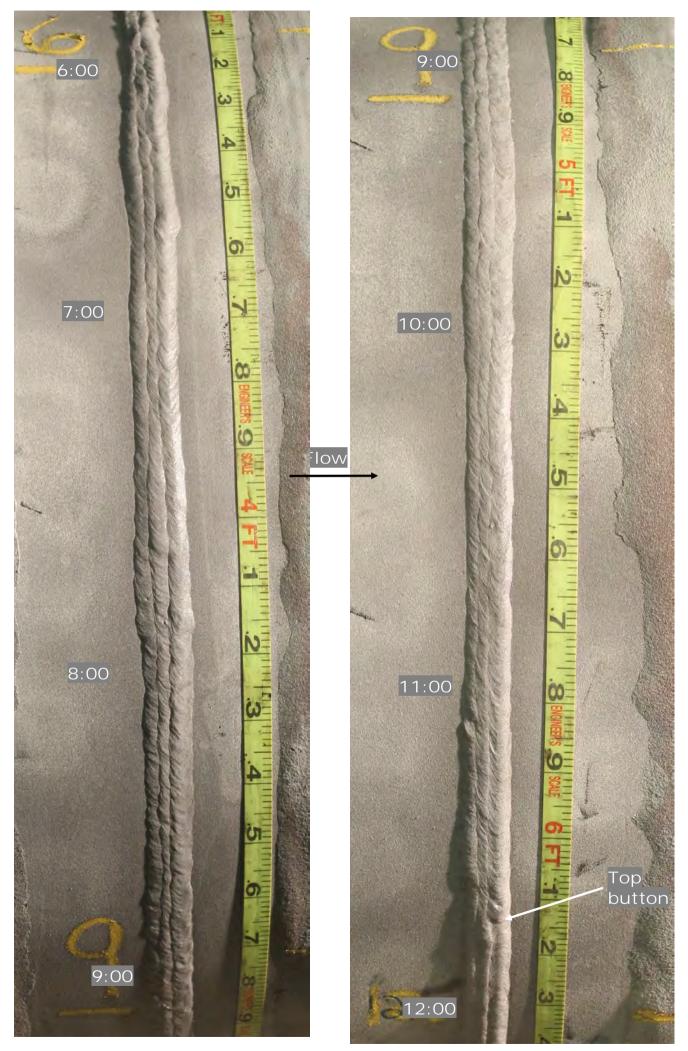
Figure 18. Photograph of the external pipe surface at the intact girth weld following grit blasting and MPI, between the 6:00 and 12:00 orientations. The tape measure indicates the approximate distance CW of TDC (looking D/S convention).

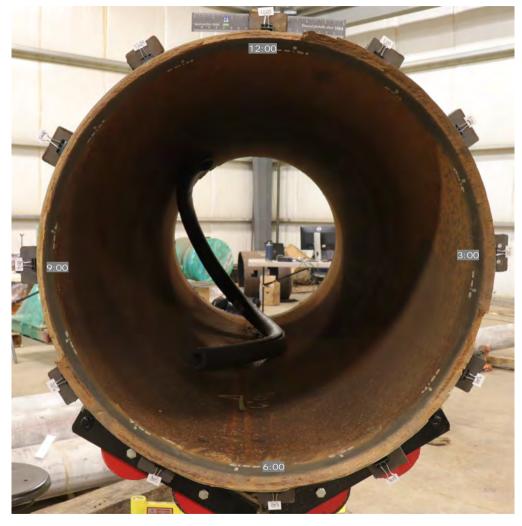
Figure 19. Photograph of the fracture surface and internal pipe surface of PS A. Flow direction is into the photograph. Labels on magnets indicate o'clock orientations.

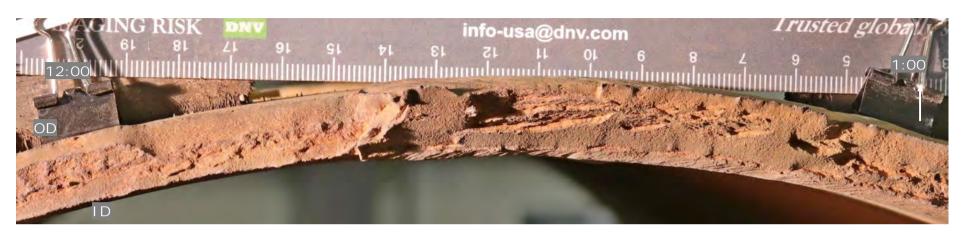
Figure 20. Photograph of the fracture surface of PS A between the 12 and 1 o'clock orientations. Units of ruler are in cm. Flow direction is into the photograph.

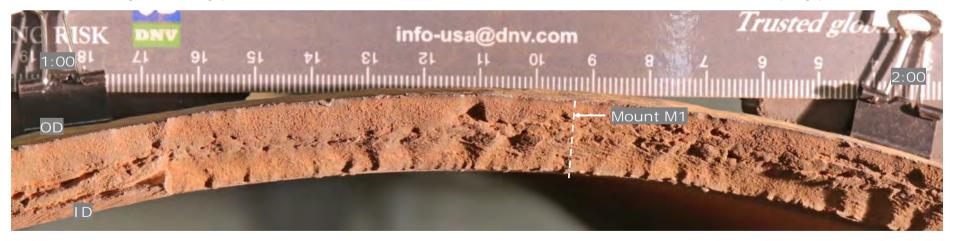
Figure 21. Photograph of the fracture surface of PS A between the 1 and 2 o'clock orientations. Units of ruler are in cm. Flow direction is into the photograph.

- d) Grain elongations due to the cold work that took place during the rupture process which is consistent with ductile overloading (see fig. 21 of the Mears report),

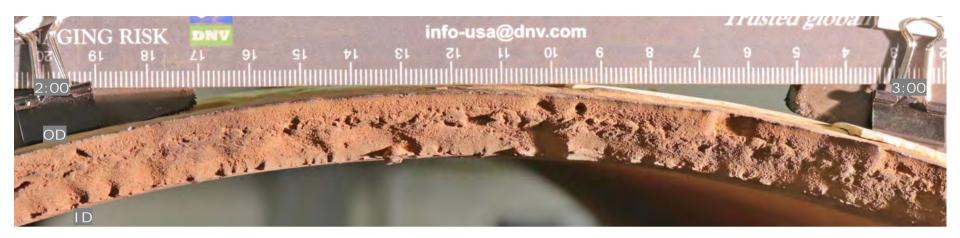
Figure 22. Photograph of the fracture surface of PS A between the 2 and 3 o'clock orientations. Units of ruler are in cm. Flow direction is into the photograph.

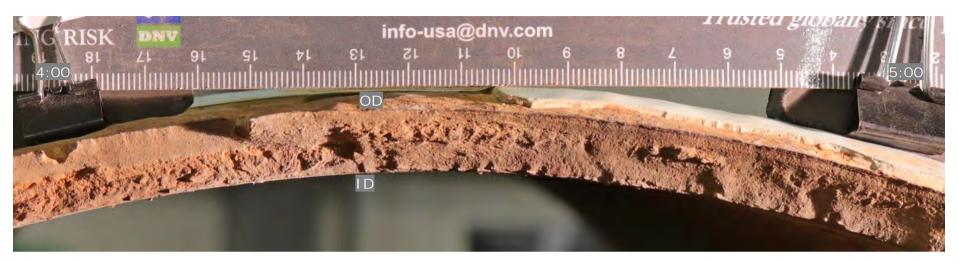
Figure 24. Photograph of the fracture surface of PS A between the 4 and 5 o'clock orientations. Units of ruler are in cm. Flow direction is into the photograph.

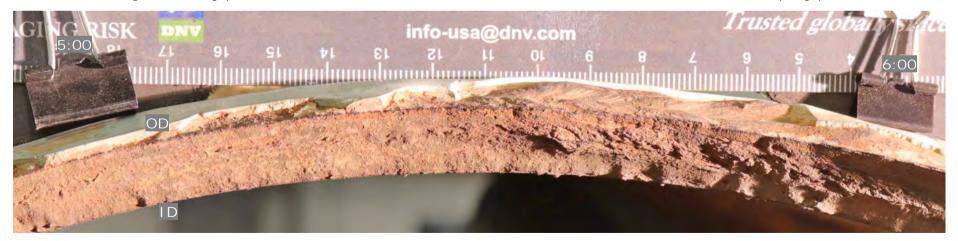
Figure 25. Photograph of the fracture surface of PS A between the 5 and 6 o'clock orientations. Units of ruler are in cm. Flow direction is into the photograph.

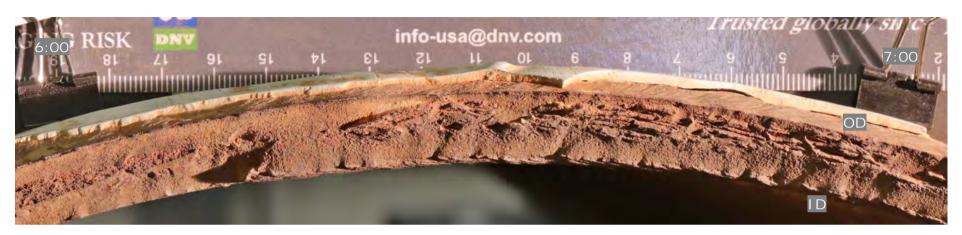
Figure 26. Photograph of the fracture surface of PS A between the 6 and 7 o'clock orientations. Units of ruler are in cm. Flow direction is into the photograph.

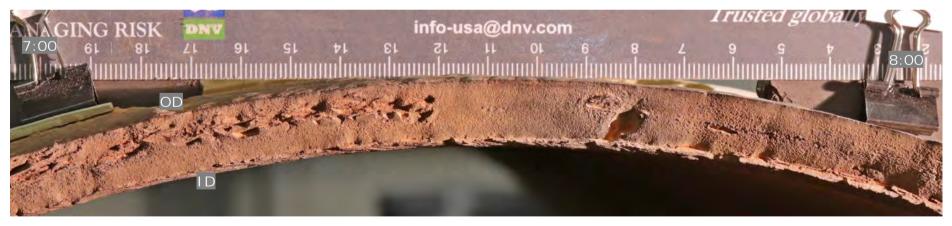
Figure 27. Photograph of the fracture surface of PS A between the 7 and 8 o'clock orientations. Units of ruler are in cm. Flow direction is into the photograph.

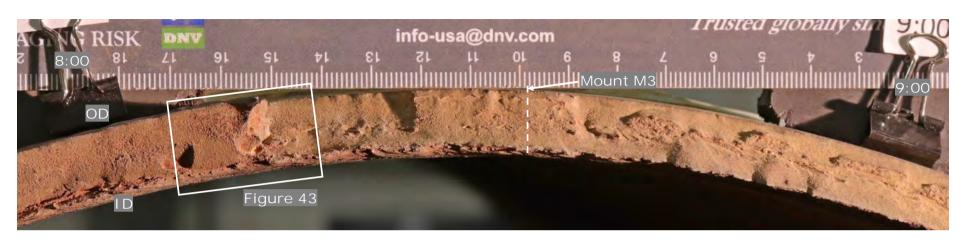
Figure 28. Photograph of the fracture surface of PS A between the 8 and 9 o'clock orientations. Units of ruler are in cm. Flow direction is into the photograph.

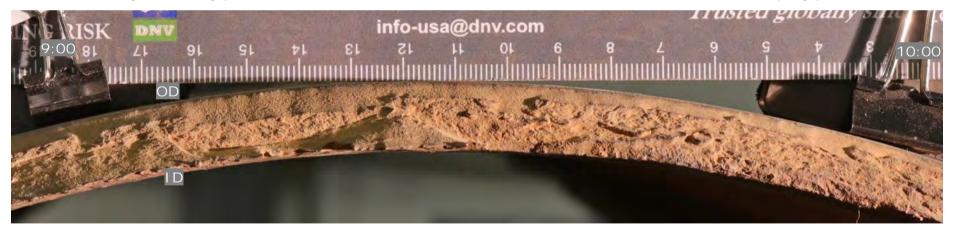
Figure 29. Photograph of the fracture surface of PS A between the 9 and 10 o'clock orientations. Units of ruler are in cm. Flow direction is into the photograph.

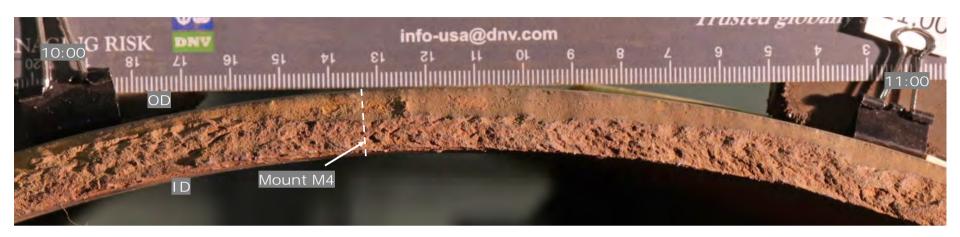
Figure 30. Photograph of the fracture surface of PS A between the 10 and 11 o'clock orientations. Units of ruler are in cm. Flow direction is into the photograph.

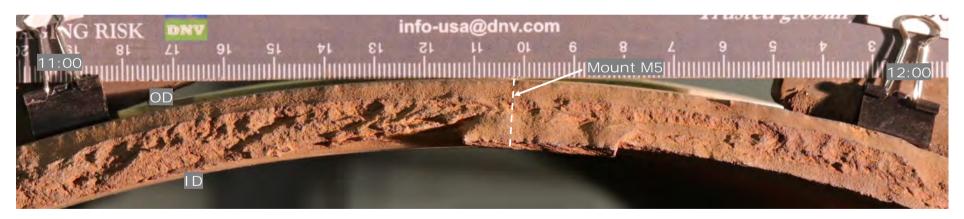
Figure 31. Photograph of the fracture surface of PS A between the 11 and 12 o'clock orientations. Units of ruler are in cm. Flow direction is into the photograph.

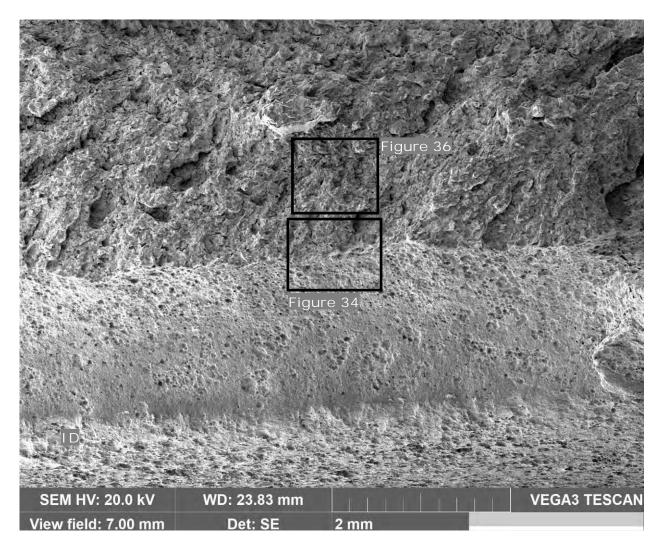
Figure 33. SEM image of Sample S2 adjacent to the ID surface; area indicated in Figure 32.

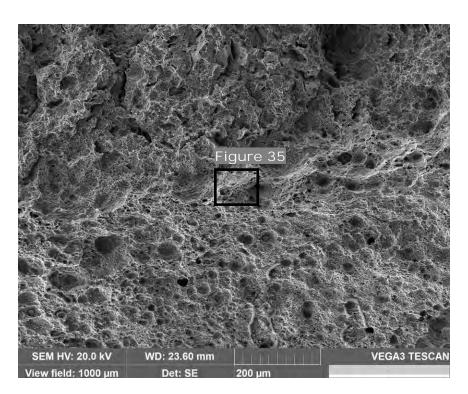
Figure 34. SEM image of Sample S2 at the interface of a macroscopically smooth and rough region; area indicated in Figure 33.

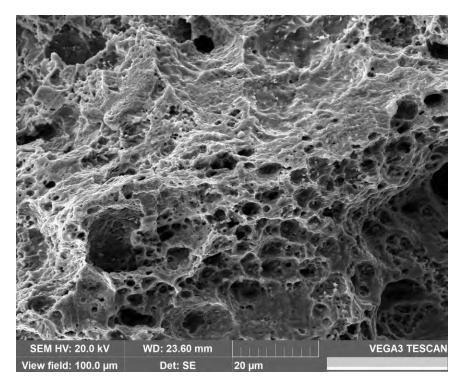
Figure 35. High magnification SEM image of Sample S2 in the macroscopically smooth region; area indicated in Figure 34.

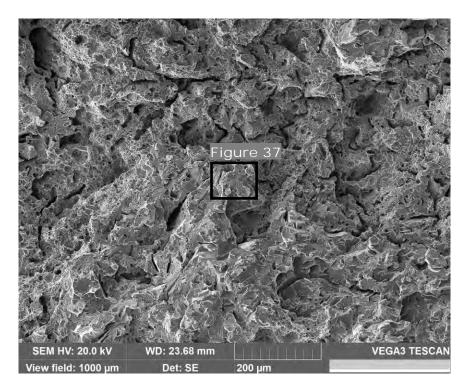
Figure 36. SEM image of Sample S2 in a macroscopically rough region; area indicated in Figure 33.

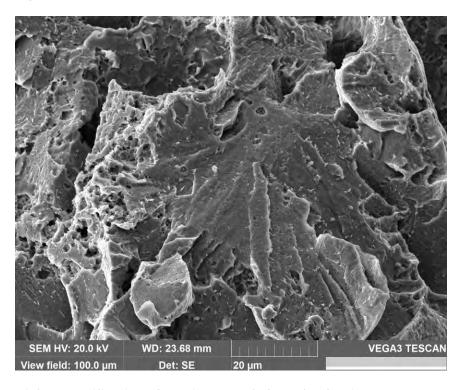
Figure 37. High magnification SEM image of Sample S2 in a macroscopically rough region; area indicated in Figure 36.

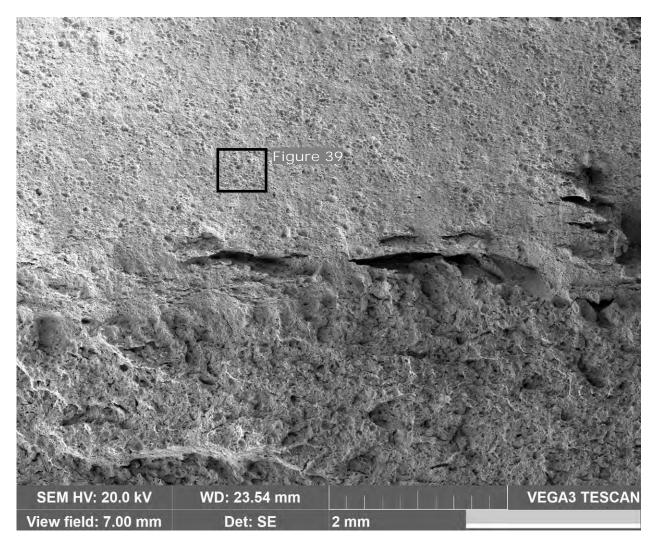
Figure 38. Sample S2 – Tears Mid-Wall (Smooth Region)

Figure 38. SEM image of Sample S2 midwall, showing macroscopically rough and smooth regions; area indicated in Figure 32.

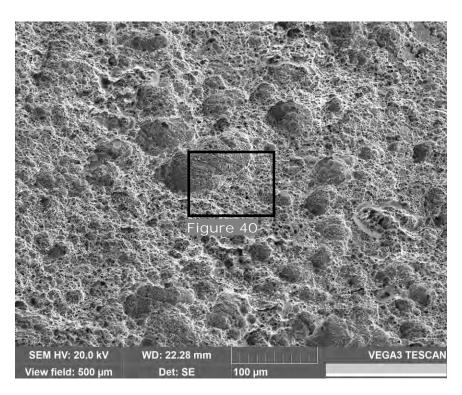
Figure 39. SEM image of Sample S2 in a macroscopically smooth region, near the OD surface; area indicated in Figure 38.

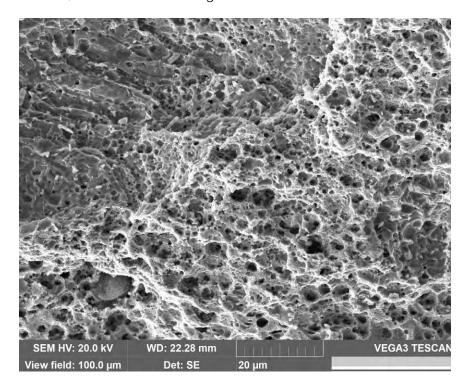
Figure 40. High magnification SEM image of Sample S2 in a macroscopically smooth region, near the OD surface; area indicated in Figure 39.

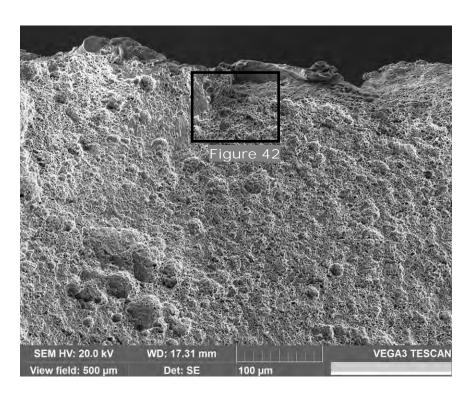
Figure 41. SEM image of Sample S2 adjacent to the OD surface; area indicated in Figure 32.

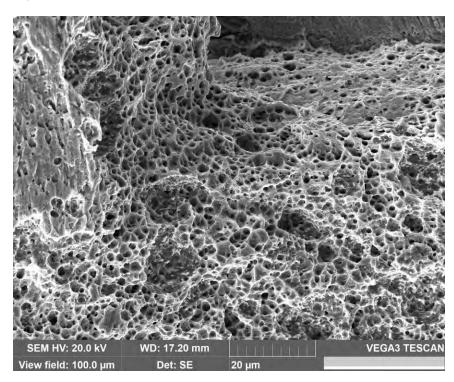
Figure 42. High magnification SEM image of Sample S2 adjacent to the OD surface; area indicated in Figure 41.

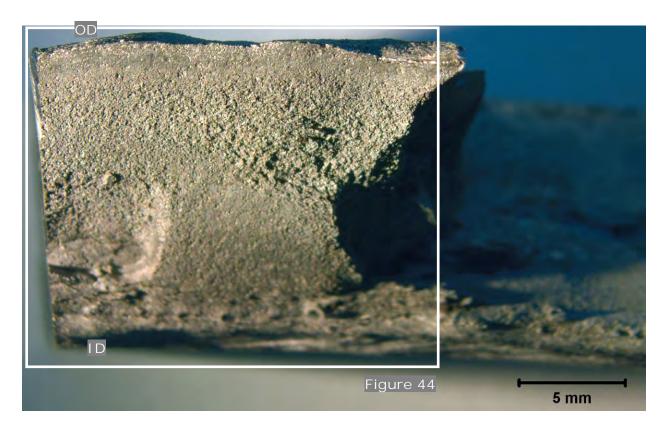
Figure 43. Light photomicrograph of the fracture surface of Sample S3, following cleaning in ENPREP® 214. The sample was removed near the 8:00 orientation; area indicated in Figure 28.

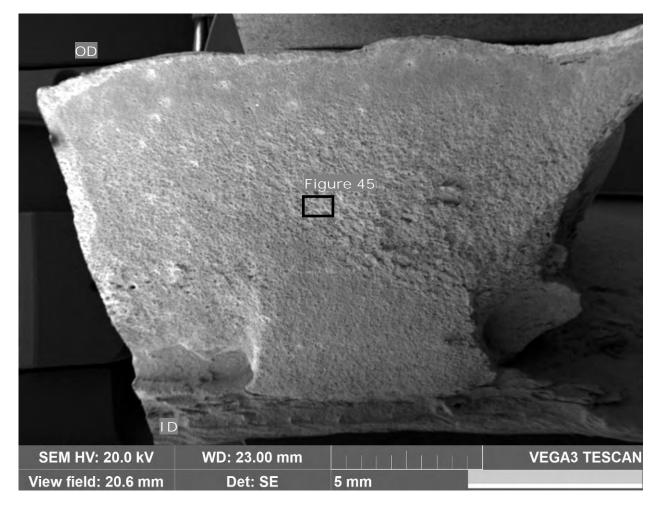
Figure 44. SEM image of Sample S3; area indicated in Figure 43.

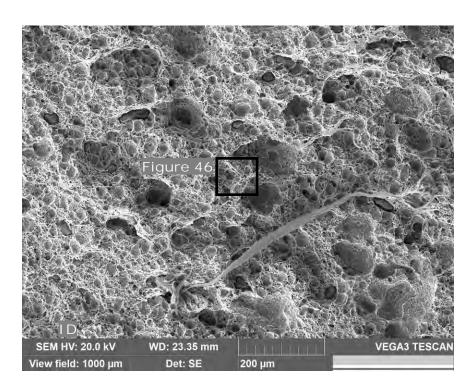
Figure 45. SEM image of Sample S3 midwall; area indicated in Figure 44.

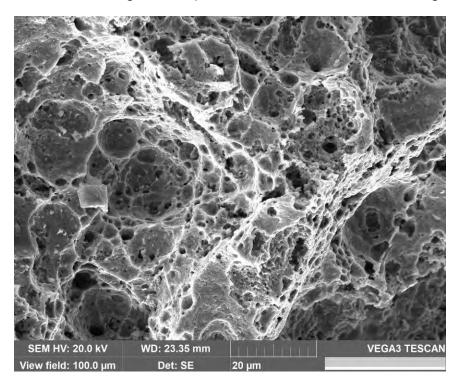
Figure 46. High magnification SEM image of Sample S3 midwall; area indicated in Figure 45.

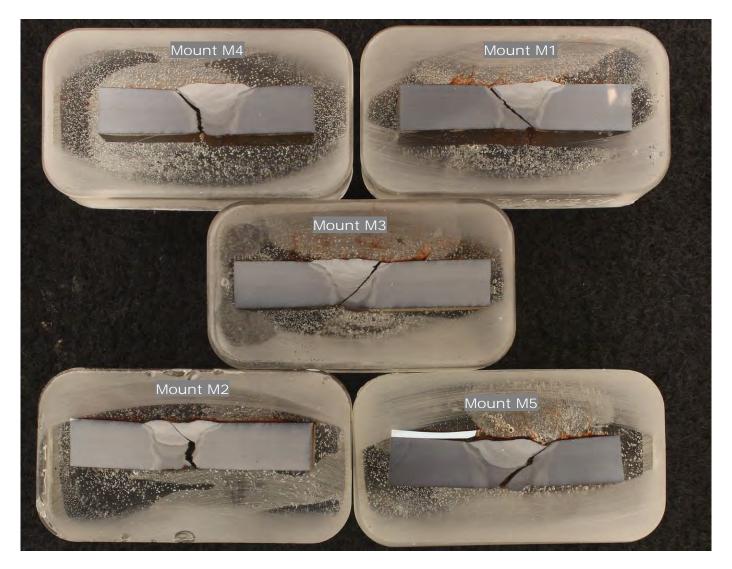
Axial (cross girth weld) cross-sections were removed from the failed girth weld (five total) and the intact girth weld (one total) for metallographic analysis. Figure 47 is a photograph of the mounts that were removed from across the failed girth weld. The figure shows that Mounts M1 and M3 contain fracture paths at a shear angle, which is indicative of ductile overload failure. Mounts M2 and M4 (and a small portion of M5) contain regions where the fracture path is perpendicular to the free surface and regions of shear failure. The perpendicular portions are where the fracture surfaces are rough and the shear angle portions are where the fracture surfaces are smooth.

Figure 47. Photograph of the mounts (M1, M2, M3, M4, and M5) that were removed across the failure opening (2% Nital Etchant).

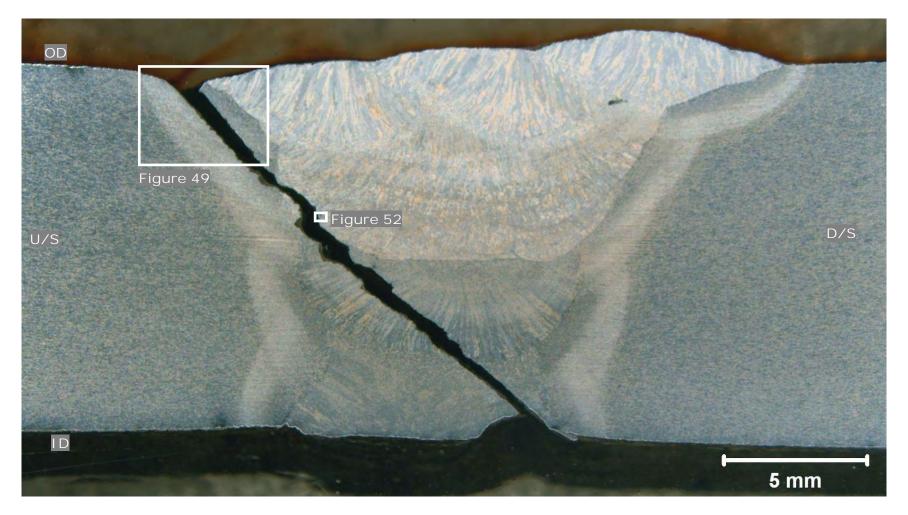
Figure 48 is a light photomicrograph of the axial metallographic cross-section (Mount M1), which was removed from the failed GW at the 1:35 o'clock orientation; refer to Figure 1 and Figure 11 for the location. The sequence of the welding is typical of a pipeline girth weld consisting of a root pass, a hot pass, several fill passes (depending on o'clock orientation), and cap passes. There is no evidence of excessive porosity or slag inclusions in the weld. The fracture path is at a shear angle and mainly located in the weld metal. The high-low weld misalignment at this location is approximately 0.023 inches (4.3% of NWT); note the misalignment is difficult to measure on the fracture cross-section and is an approximation.

Figure 48. Light photomicrograph of Mount M1 (axial cross-section), which was removed from the failed GW at the 1:35 orientation; refer to Figure 1, Figure 11, and Figure 21 for location (2% Nital Etchant).

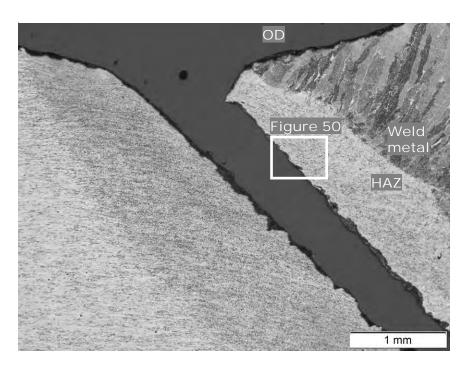
Figure 49 is light photomicrograph of Mount M1 adjacent to the OD surface. The figure shows the fracture path is located in the HAZ, near the toe of the weld at the OD surface. Figure 50 is a light photomicrograph of Mount M1 adjacent to the fracture surface, near the OD surface. The figure shows inclusions aligned at an oblique angle with the fracture surface. The orientation of the inclusions is a result of cold work from the failure. Figure 51 is a high magnification light photomicrograph of Mount M1 adjacent to the fracture surface. The figure shows some grain elongation adjacent to the fracture surface and inclusions. The presence of the grain elongation from cold work and orientation of the inclusions is consistent with ductile overload. Figure 52 is a high magnification light photomicrograph of Mount M1 midwall adjacent to the fracture surface. The figure clearly shows the change in the grain orientation and thus more grain elongation adjacent to the fracture surface.

Figure 49. Light photomicrograph of Mount M1 adjacent to the OD surface (2% Nital Etchant); area indicated in Figure 48.

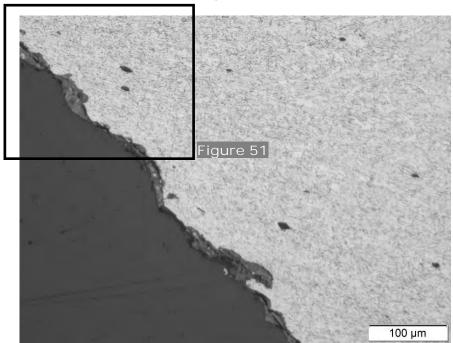
Figure 50. Light photomicrograph of Mount M1 showing inclusions in HAZ adjacent to the fracture surface; area indicated in Figure 49.

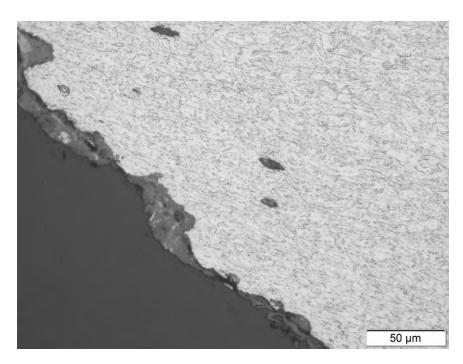
Figure 51. High magnification light photomicrograph of Mount M1 showing grain elongation adjacent to the fracture surface; area indicated in Figure 50.

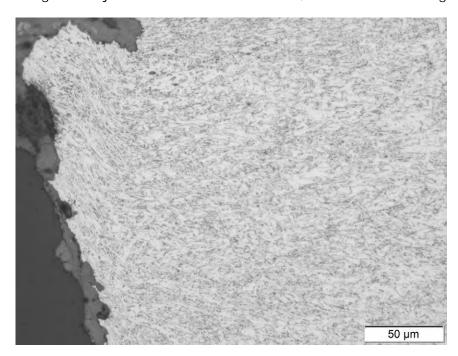
Figure 52. High magnification light photomicrograph of Mount M1 midwall adjacent to the fracture surface (2% Nital Etchant); area indicated in Figure 48.

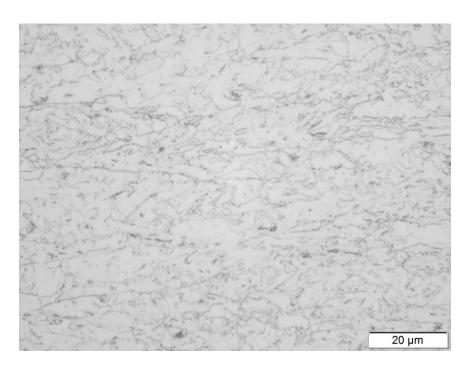
Figure 53 and Figure 54 are light photomicrographs showing the microstructures of the U/S and D/S Joints, respectively. The microstructures of the joints consist mainly of ferrite (white areas), which is consistent with modern X80 line pipe.

Figure 53. High magnification light photomicrograph of Mount M1 showing the typical base metal microstructure of the U/S Joint (PS B, 2% Nital Etchant).

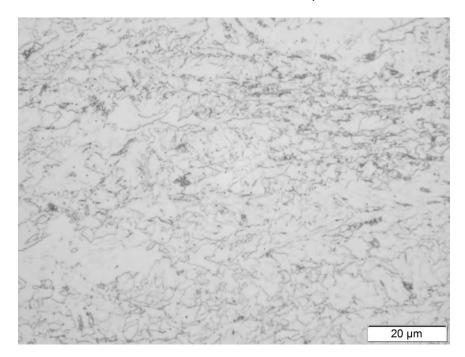
Figure 54. High magnification light photomicrograph of Mount M1 showing the typical base metal microstructure of the D/S Joint (PS A, 2% Nital Etchant).

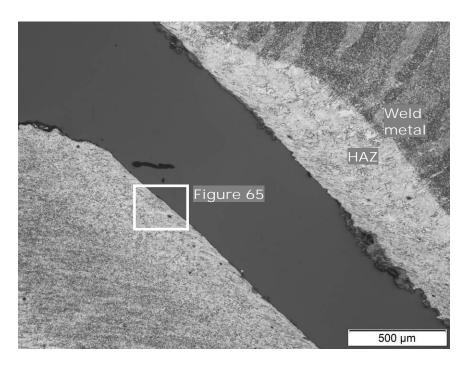
Figure 64 is light photomicrograph of Mount M4 adjacent to the OD surface. The figure clearly shows the fracture path is located in the HAZ. Figure 65 is a high magnification light photomicrograph of Mount M4 adjacent to the OD surface. The figure shows grain

Figure 63. Light photomicrograph of Mount M4 (axial cross-section), which was removed from the GW at the 10:24 orientation; refer to Figure 14, and Figure 30 for location (2% Nital Etchant).

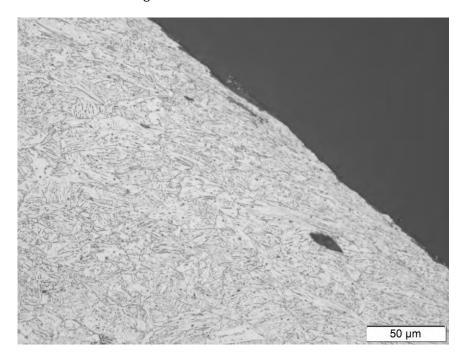
Figure 64. Light photomicrograph of Mount M4 near the OD surface (2% Nital Etchant); area indicated in Figure 63.

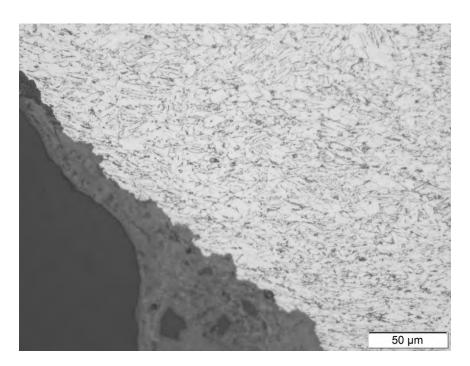
Figure 67. High magnification light photomicrograph of Mount M4 showing fissures (2% Nital Etchant); area indicated in Figure 66.

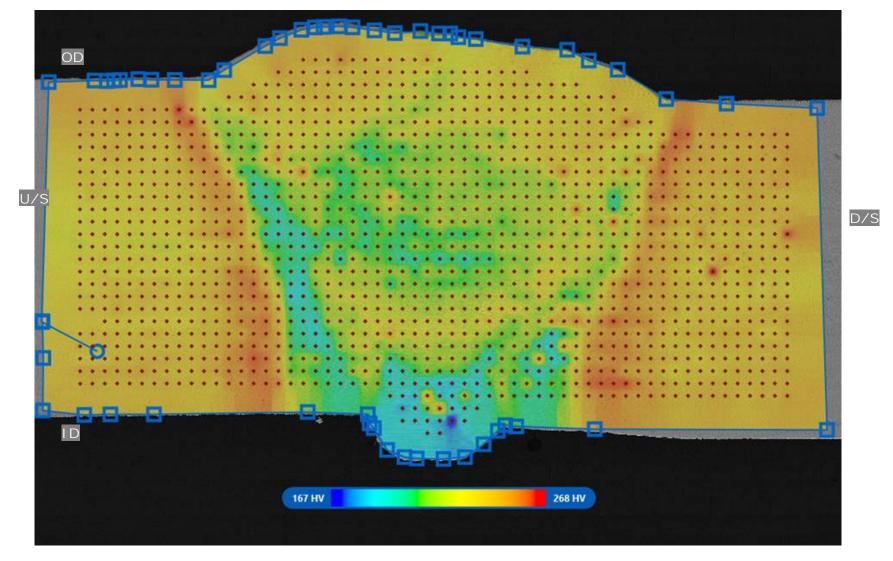
Figure 78. Hardness map overlay following hardness testing (Vickers 1 kg load) performed on Mount MU1.

The hardness montage for mount MU1 is provided in Figure 78 of the DNV Metallurgical Analysis Report (Appendix C).
