In the Matter of the Application of SCS Carbon Transport LLC for Certificate of Corridor Compatibility and Route Permit for the Midwest

Case No.: PU-22-391

# DIRECT TESTIMONY OF JACK WILLINGHAM

A. I am sponsoring Willingham Direct Exhibit 1, which is a copy of the May 26, 2022, PHMSA Failure Investigation Report related to the CO2 pipe rupture in Satartia, Mississippi, that occurred in February 2020. I am also sponsoring Willingham Direct Exhibit 2, which is a statement from the Shelby County Iowa Board of Health, as an exemplar of County concerns and issues that can confront any county, detailing its public health concerns related to pressurized CO2; Willingham Direct Exhibit 3 is a true and accurate copy of my live sworn testimony during the Iowa IUB hearing; Willingham Direct Exhibits 4 and 5 are true and accurate recordings of 911 emergency calls my department received during the Satartia CO2 pipeline rupture. Willingham Direct Exhibit 6 is testimony filed with the IUB from Debrae Burns, regarding his experience being exposed to CO2 during the 2020 pipe rupture.

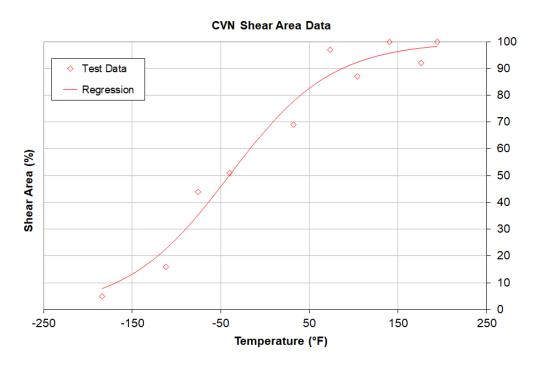
Table 6 shows the results of CVN testing for axial specimens removed from the intact girth weld (notch in the HAZ from PS C), while Figure 79 and Figure 80 show the Charpy percent shear and impact energy curves. An analysis of the data for the girth weld specimens indicates that the 85% FATT is 59.9°F and upper shelf Charpy energy is 114 ft lbs, as shown in Table 7. Both values are good for line pipe steel.

Figure 79. Percent shear from Charpy V-notch tests as a function of temperature for axial/cross-girth weld (HAZ notch) specimens removed from Pipe Section C.

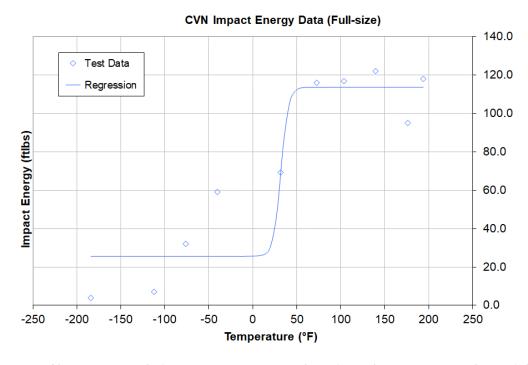
Figure 80. Charpy V-notch impact energy as a function of temperature for axial/cross-girth weld (HAZ notch) specimens removed from Pipe Section C.

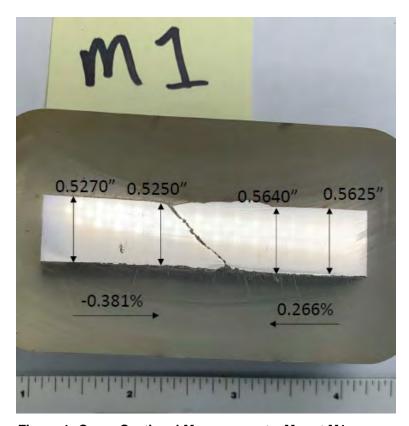
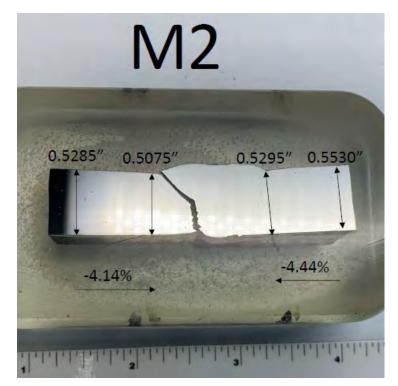
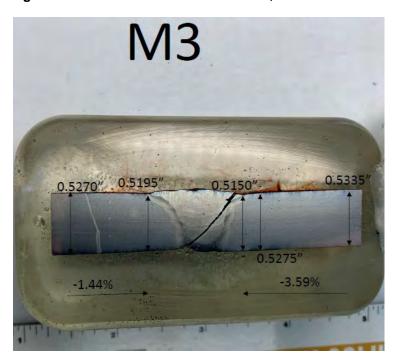
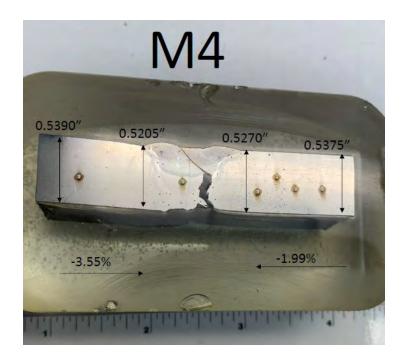
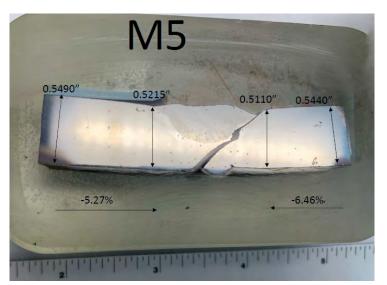
Evaluation of the metallurgical samples indicated slight reduction in wall thickness in each sample, ranging from 1.44% to 6.46%. Photos and measurements are provided in in figures 1 through 5 below:

These results are consistent with the characteristics of API X80M PSL 2 Line pipe.

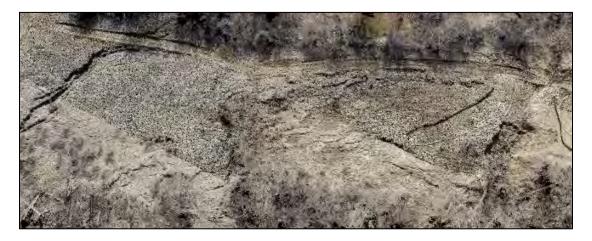
FIGURE 1: SOIL MOVEMENT PLAN VIEW

During the initial site visit, Mott MacDonald noticed evidence of soil movement along the ROW. The soil failure planes in the ROW extended approximately 900 ft at varying angles from 45° to 90°. Figure 1 and Figure 2 below show 3D photogrammetry scans taken of the ROW and displays the long linear failures.

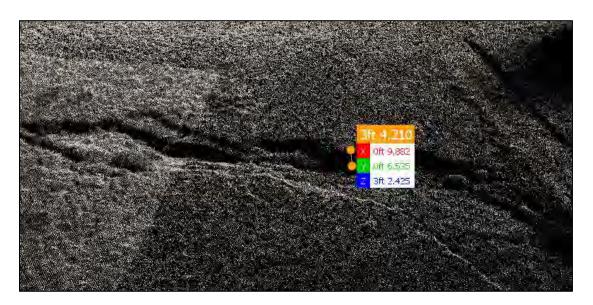
FIGURE 3: SOIL FAILURE DEPTH

The depth of the soil failures varied throughout the ROW, but as shown in Figure 3, the high level of detail captured with the 3D photogrammetry allowed for accurate measurements.

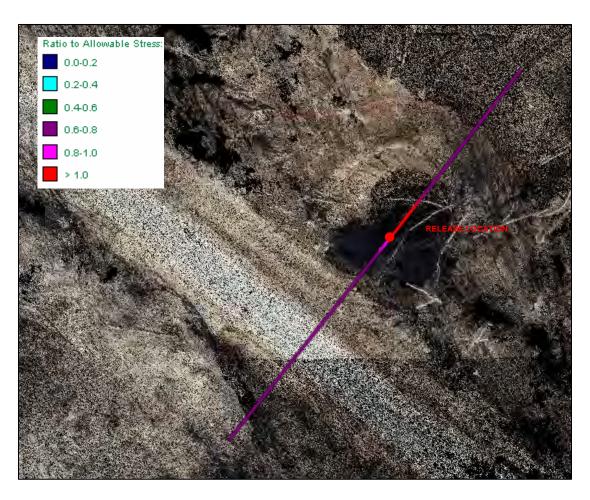
FIGURE 10: FAILURE LOCATION

As shown in Figure 10 below, the pipeline release location experienced excessive stress. The focal point of the stress at this location shows a maximum stress ratio of 1.43.

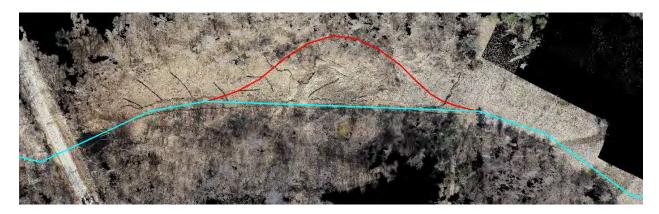
FIGURE 11: DEFLECTION CURVE

Figure 11 below shows an exaggerated deflection curve of the pipeline.

Mott MacDonald examined results as full design group to analyze the failure types and deflection curves. It was established that forces applied to the pipeline from the soil movement were significant enough to exceed the allowable stress limit of the Delhi Pipeline and likely was a contributing factor to the rupture.

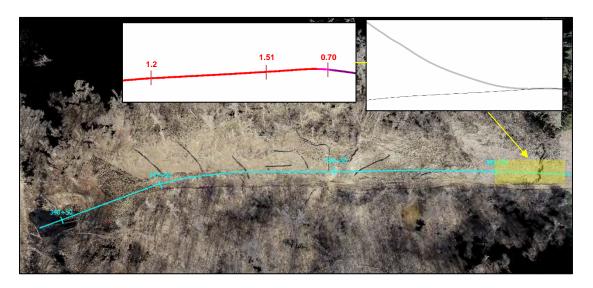
FIGURE 12: RECOMMENDED

The stress on the downstream side of 339+00 was caused by the restrained/unrestrained boundary condition created by the soil movement. This bending stress is the target of the relief exercise. The area shown in Figure 12 below, show a sharp rise in stress from a ratio of 0.70 to 1.51 in less than 50 ft. This boundary condition at the soil failure plane did not relieve after the pipeline failure and will have to be repaired.

Exposing at least 135 ft and removing and replacing as least a 10 ft section of pipe as recommended in the repair alleviates the overstressed boundary condition left by the soil movement and allows for safe transition between the two soil conditions. This recommendation is with the understanding that the remainder of the area of concern will be hydrotested as per ASME B31.4 to ensure the integrity of the pipe that experienced high tensile loads.
