Casey and Julie Voigt v. Coyote Creek Mining Company, LLC

Inspection Reports

INSPECTION REPORT

DATE OF INSPECTION: May 10, 2023
TYPE OF INSPECTION: Complete
PERMITTEE - MINE: Coyote Creek Mining Company, LLC - Coyote Creek Mine
PERMITS INSPECTED: NACC-1302
PERSONS ACCOMPANYING INSPECTORS: Jeremy Eckroth
INSPECTION CONDITIONS: The inspection was conducted between 9:00 a.m. and 12:30 p.m. CDT. Skies were initially overcast but cleared as the inspection proceeded. The temperature ranged from 60 to 75° F. Access was unrestricted.

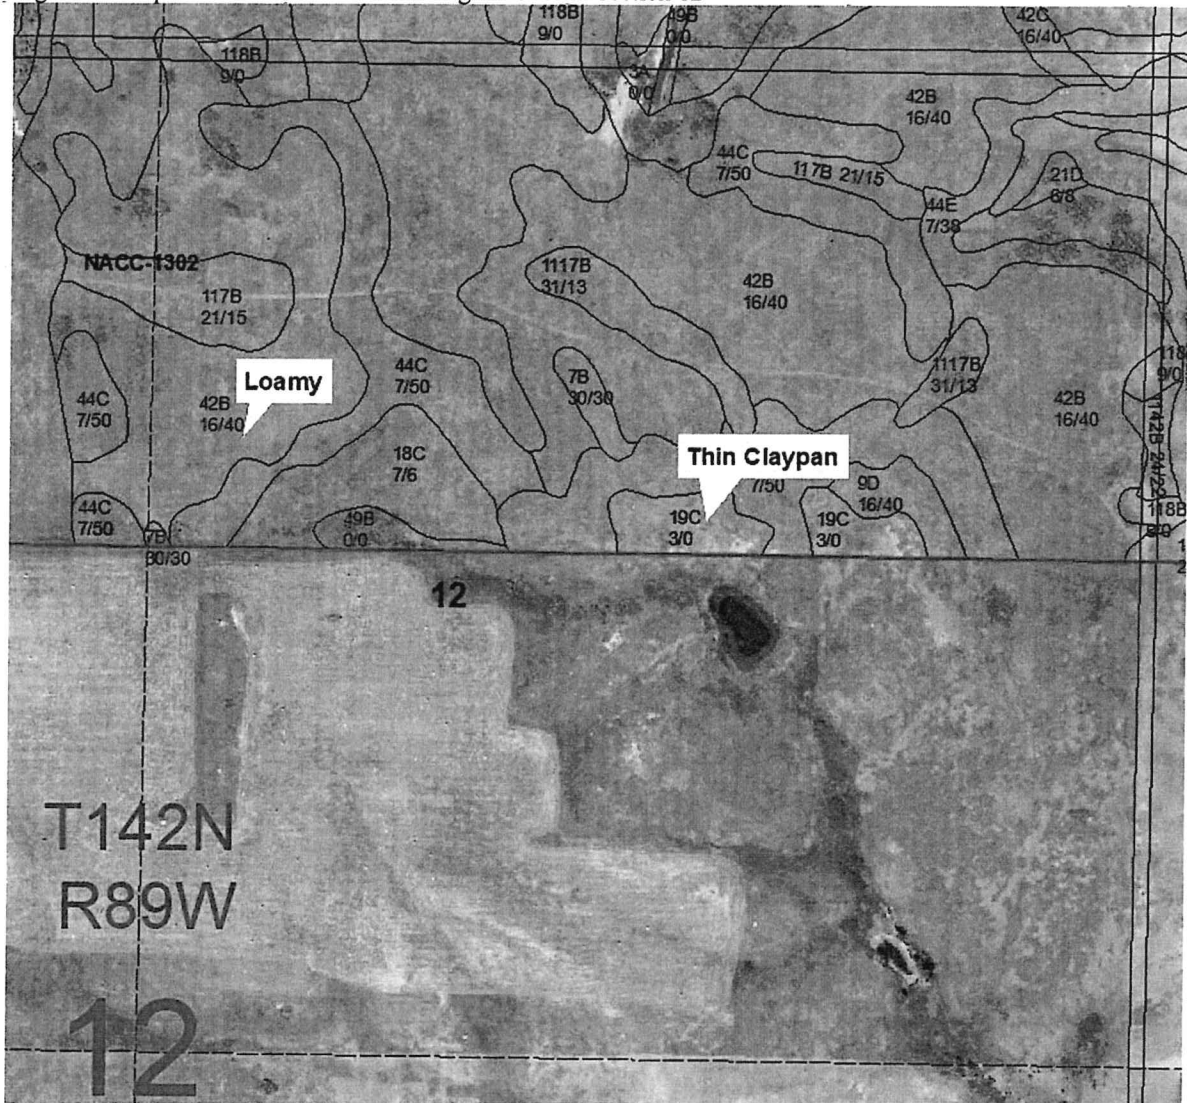
Figures 1 and 2, attached show the location of the proposed native grassland reference areas. Four of the proposed native grassland sites are in the NW¼ of Section 19. This includes a Sandy ecological site on soil mapping unit 47C (Livona fine sandy loam), a Shallow Loamy ecological site on soil mapping unit 132F (Cabba silt loam), a Sands ecological site on soil mapping unit 39B/D (Krem fine sandy loam), and a Claypan ecological site on soil mapping unit 21D (Janesburg silt loam). The two sites in Section 12 include a Thin Claypan ecological site on soil mapping unit 19C (Rhoades silt loam) and a Loamy ecological site on mapping unit 42B (Williams loam). There was a considerable amount of western snowberry on the Loamy ecological site in Section 12 so species composition on this site may vary considerably annually depending upon where yield sampling data are collected. Likewise, species composition differences were apparent within the Sands ecological site where sand and big bluestem species were more prominent on steeper sloping areas within the site. Photographs were taken at each of these sites to provide photo documentation of the vegetative communities. Mr. Krabbenofft had recommended that enclosures not be placed on these sites and the Reclamation Division concurs with that recommendation as cattle tend to concentrate and adversely affect areas around fenced enclosures.

Figure 2: Proposed Native Grassland Ecological Sites in Section 12
