**PU-24-351
Offer Tail Power Company
Abercrombie Solar
Topsoil Inspection Report**

File No. 227708967

May 28, 2026

North Dakota Public Service Commission
600 E. Boulevard Avenue
Bismarck, ND 58505-0480

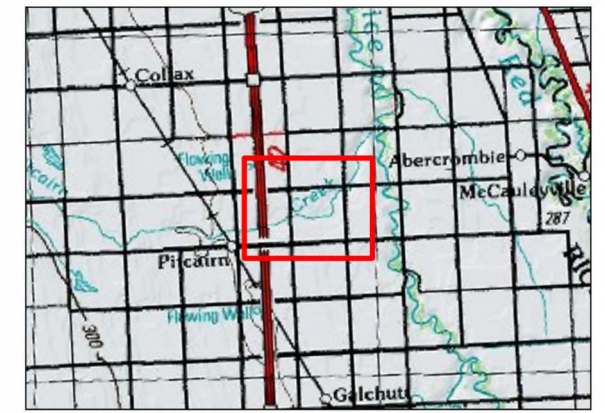
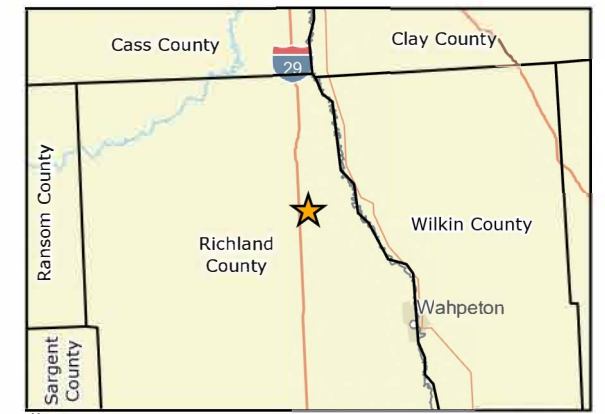
Figure 1 Topsoil Observation Locations

Stantec shared the PSC order provisions relating to topsoil stripping, segregation, and protection with individuals present during the inspection and provided opportunity for Otter Tail and its contractors to ask questions on expectations for topsoil stripping depths and segregation. Stantec then observed the contractor's topsoil stripping, segregation of stockpiling practices. Visual inspections were made by Stantec at various locations to confirm the proper depths of topsoil stripping were reached and mixing of the underlying subsoils were not being mixed with the topsoil being stripped. Additionally, two borings were observed within the project area crossing 172nd Ave SE. and 173rd Ave SE. These are marked at photo points 9 & 10 and 11 & 12 in Figure 1.
