**PU-25-83  
Hiland Crude, LLC  
Hiland Gullickson Reroute Pipeline  
As-Built Inspection Report**

July 2026

**North Dakota Public Service Commission**  
600 E. Boulevard Avenue  
Bismarck, ND 58505-0480

**Stantec Consulting Services Inc.**  
100 Collins Avenue, Suite 101  
Mandan, ND 58554

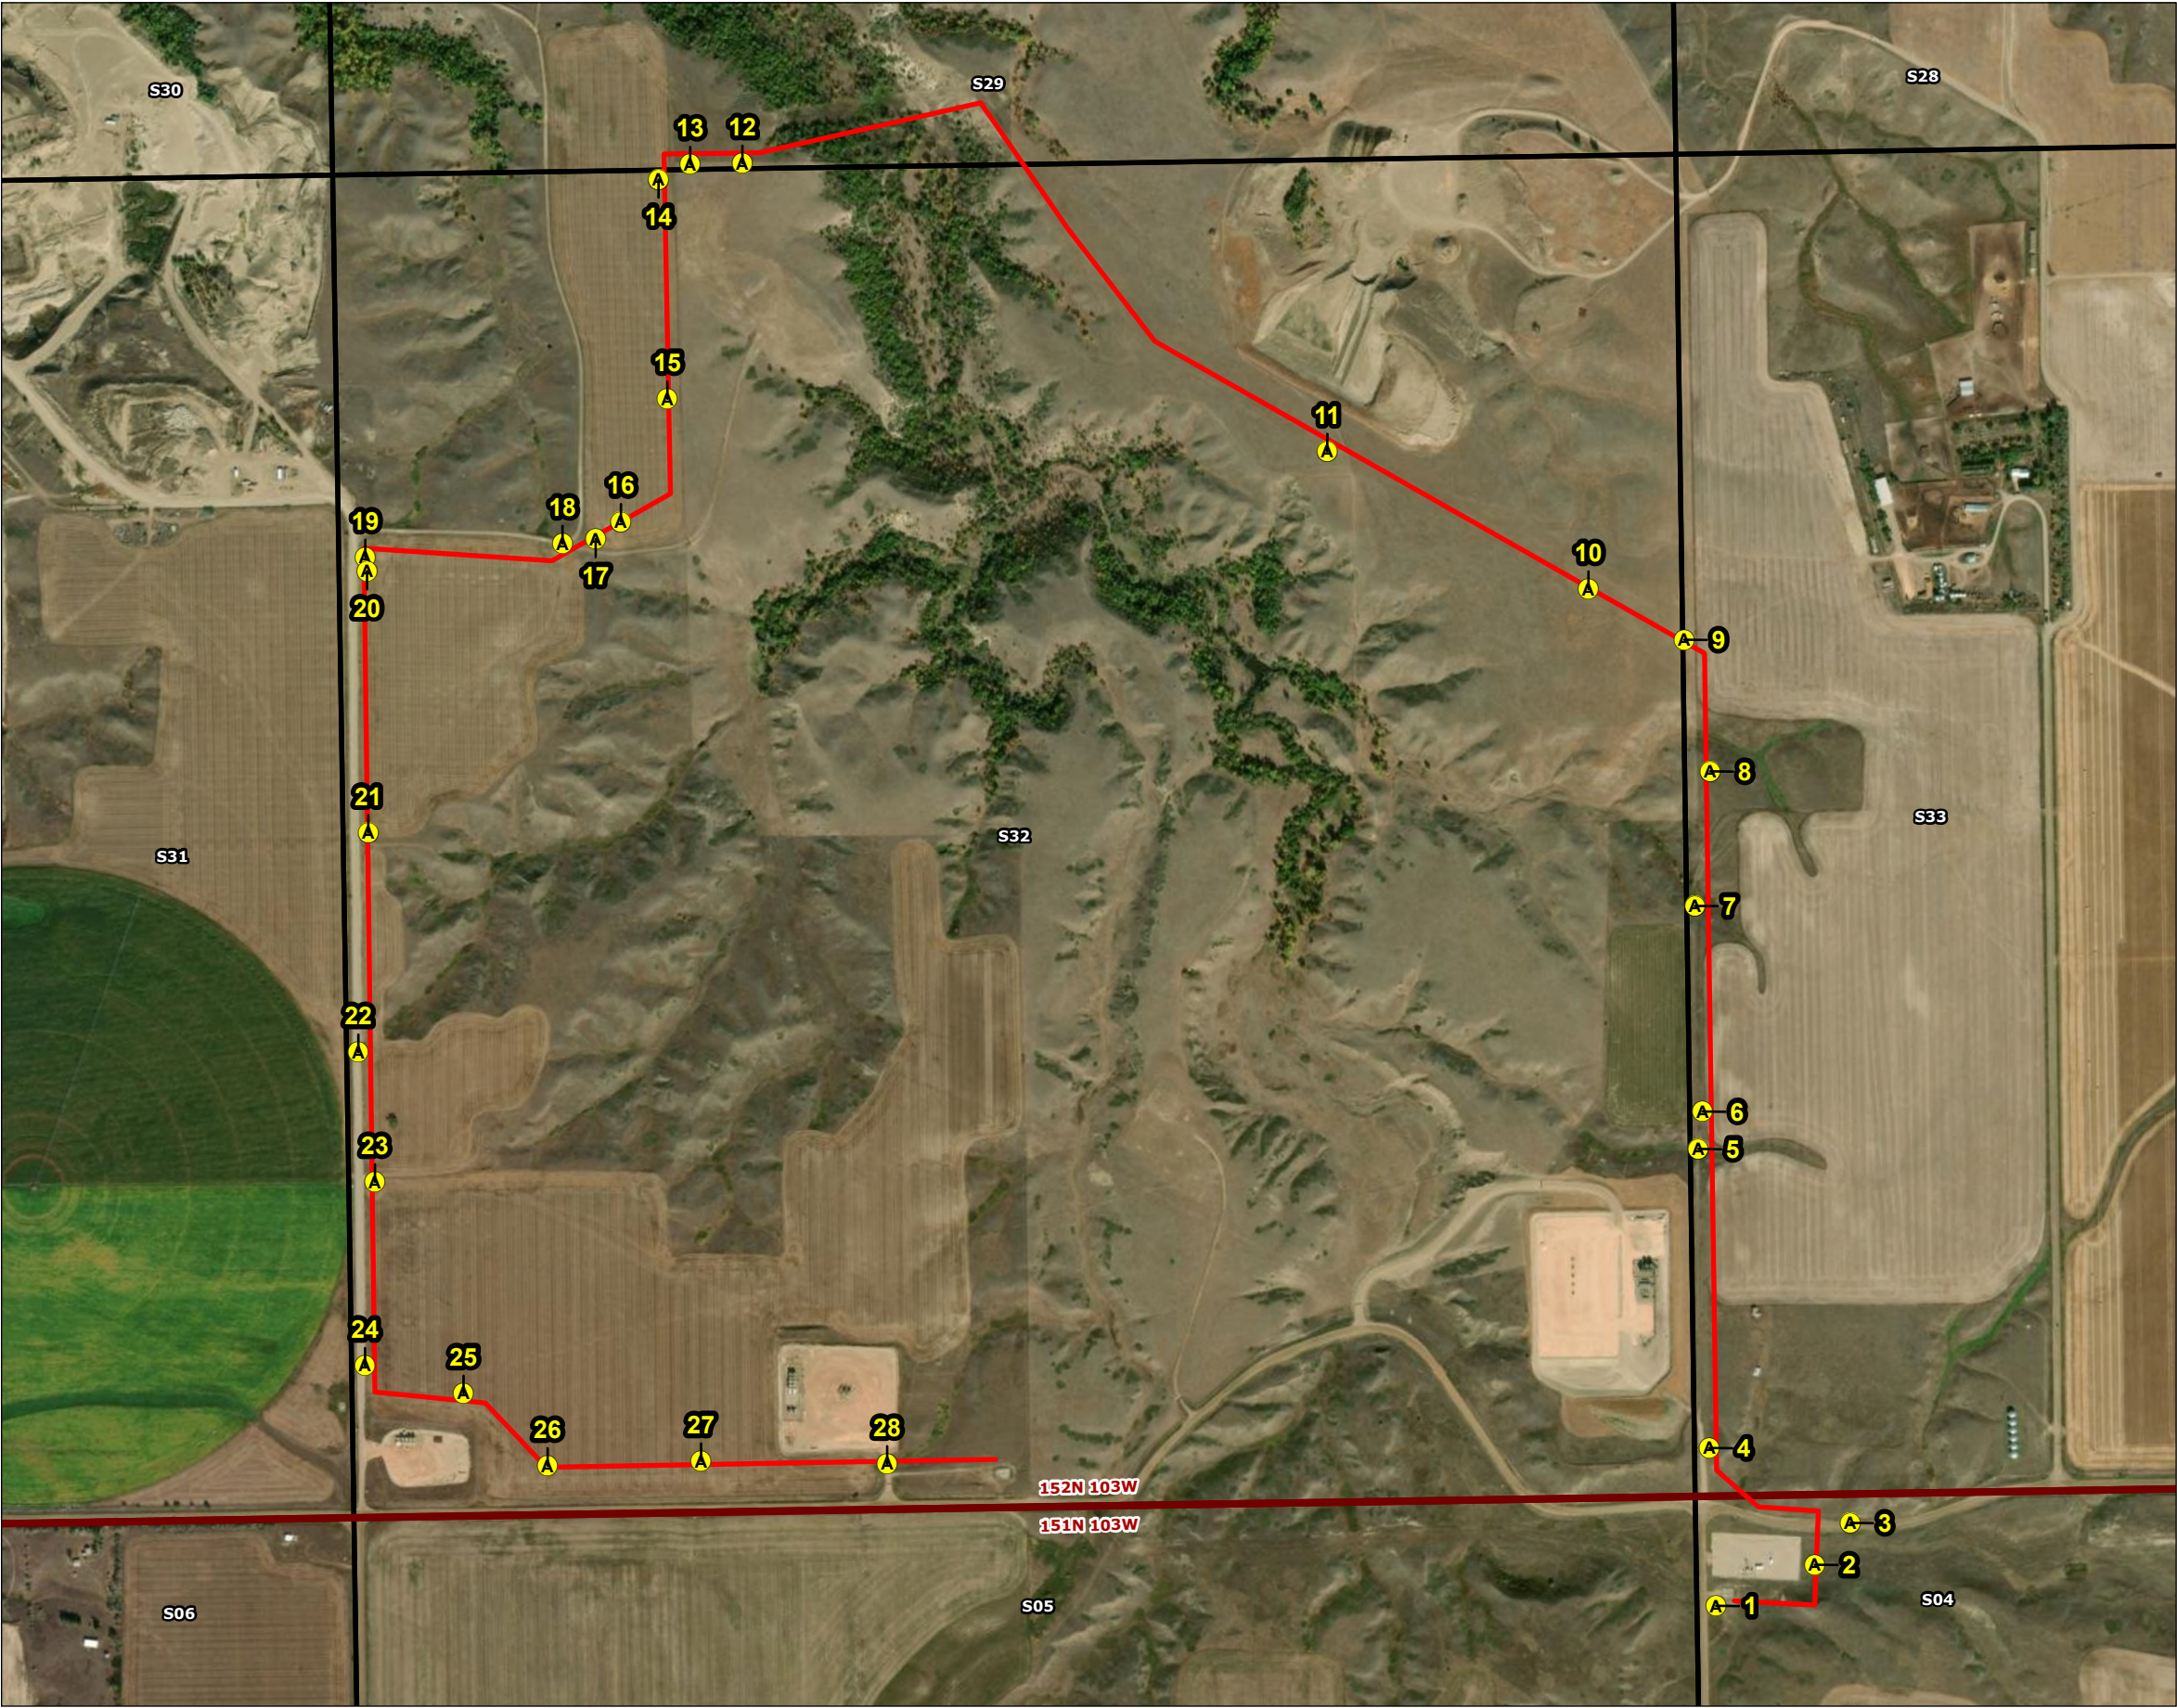
**Figure 1: Construction Observation Locations Map**

Multiple points along the as-built corridor of the pipeline were observed. The site inspection observations coincided well with the GIS shapefiles of the pipeline provided to Stantec (**Figure 1**). No points were observed to be differing with the route filed with the PSC (PSC Docket #1, 25 March 2023). Stantec staff reviewed the publicly-available documents and did not find any filed Route Adjustments on the PSC docket for this project. Additionally, there is no indication that an as-built alignment of the project has been filed with the PSC post construction completion. Construction of the pipeline was completed in January of 2026.
