**PU-25-84**  
**Hiland Crude, LLC**  
**Hiland Express Spine Pipeline**  
**As-Built Inspection Report**

File No. 193807520

July 2026

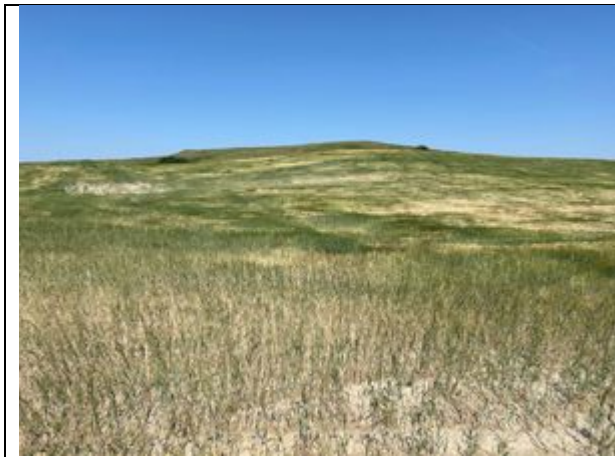
**Observation Point: 1**

Photo Description: Silt fence still in place near wetland

- Request company to remove any remaining silt fence once vegetation is fully established (**Appendix A, Observation Points 1, 20**).
- Request company to re-seed areas with inadequate vegetation cover, such as noted in Section 3.4.2 (**Appendix A, Observation Points 14, 33, 47, 54** [55 excluded as this is cropland]).
- Request company to seed roadway ditches, such as noted in Section 3.4.2 (**Appendix A, Observation Points 49, 51**).
- Request company to file Tree and Shrub Mitigation Plan and georeferenced as-built alignment file for the project.
- Request company to submit an as-built pipeline alignment as noted in Section 3.2.

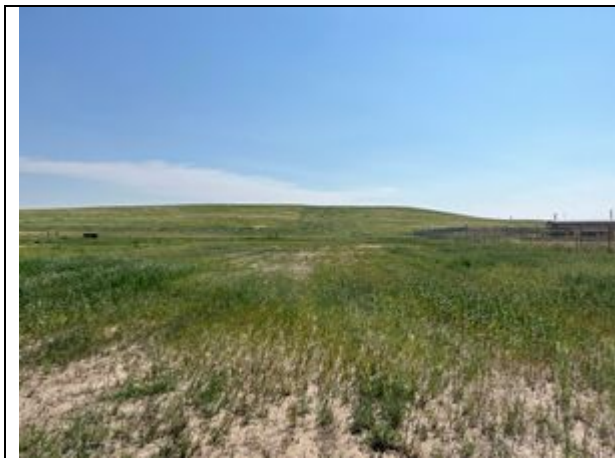
**Observation Point: 2**

Photo Description: Crop fields growing back well following pipeline restoration.

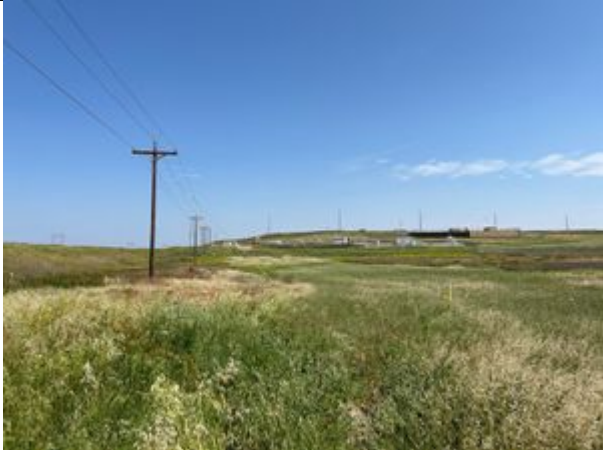
| | <p><b>Observation Point: 5</b><br/>Date Taken: July 20, 2026 11:41 AM<br/>Direction Photo is Taken:</p> <p>Photo Description: Good contouring, vegetation establishing well</p> <p>Latitude: 47.69948387166082<br/>Longitude: -103.28226324162716</p> |

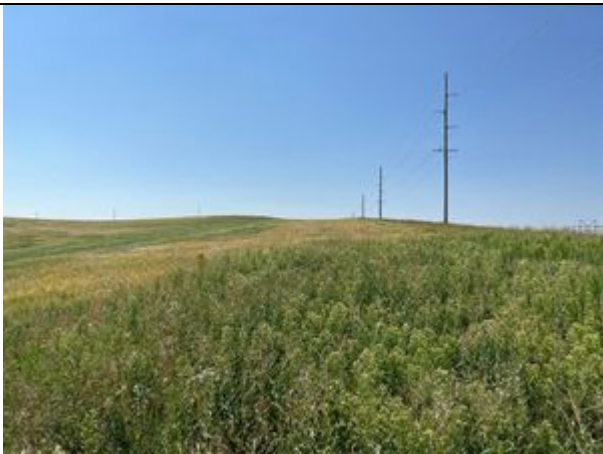
| | <p><b>Observation Point: 6</b><br/>Date Taken: July 20, 2026 11:50 AM<br/>Direction Photo is Taken: South</p> <p>Photo Description: Good contouring, vegetation establishing well</p> <p>Latitude: 47.70692150589852<br/>Longitude: -103.28286948900454</p> |

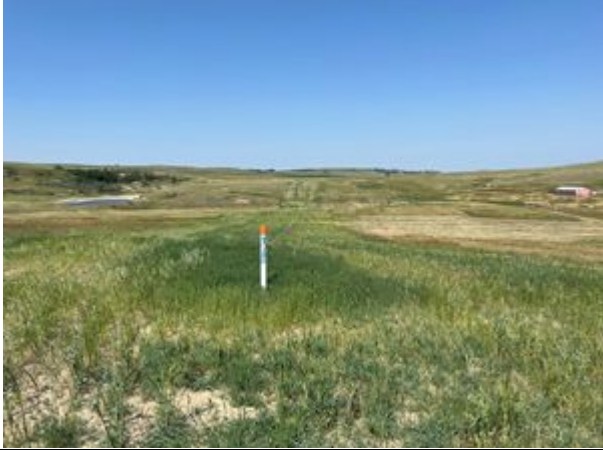
| | <p><b>Observation Point: 7</b><br/>Date Taken: July 20, 2026 11:52 AM<br/>Direction Photo is Taken: West</p> <p>Photo Description: Good contouring, vegetation establishing well</p> <p>Latitude: 47.70736857801723<br/>Longitude: -103.28473530844037</p> |

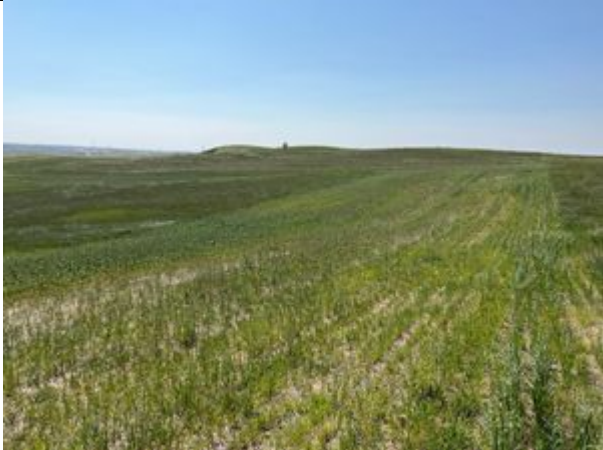
| | <p><b>Observation Point: 8</b><br/>Date Taken: July 20, 2026 11:57 AM<br/>Direction Photo is Taken: Southeast</p> <p>Photo Description: Good contouring, crops within ROW appear to be comparable to those adjacent</p> <p>Latitude: 47.71569550984361<br/>Longitude: -103.29296517069653</p> |

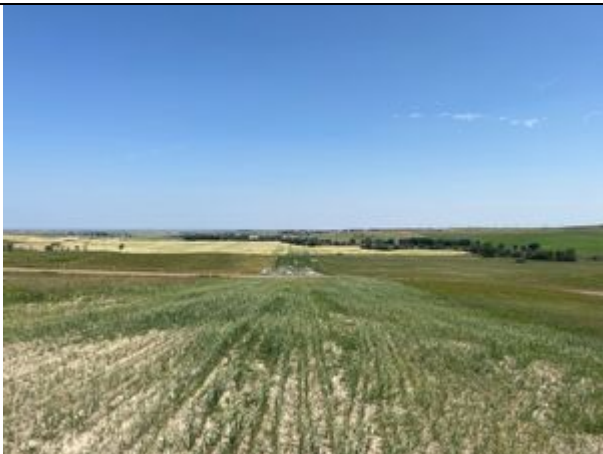
| | <p><b>Observation Point: 9</b><br/>Date Taken: July 20, 2026 11:59 AM<br/>Direction Photo is Taken: North</p> <p>Photo Description: Good contouring, vegetation establishing well</p> <p>Latitude: 47.71695145469533<br/>Longitude: -103.29284933447795</p> |

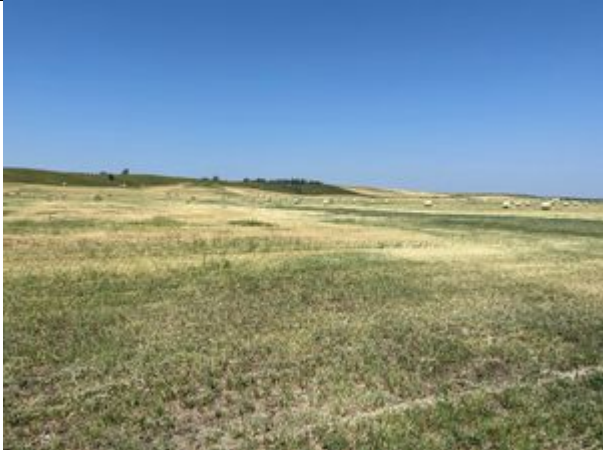
| | <p><b>Observation Point: 11</b><br/>Date Taken: July 20, 2026 12:05 PM<br/>Direction Photo is Taken: Northwest</p> <p>Photo Description: Good contouring, vegetation establishing well</p> <p>Latitude: 47.72203575312955<br/>Longitude: -103.29276109049572</p> |

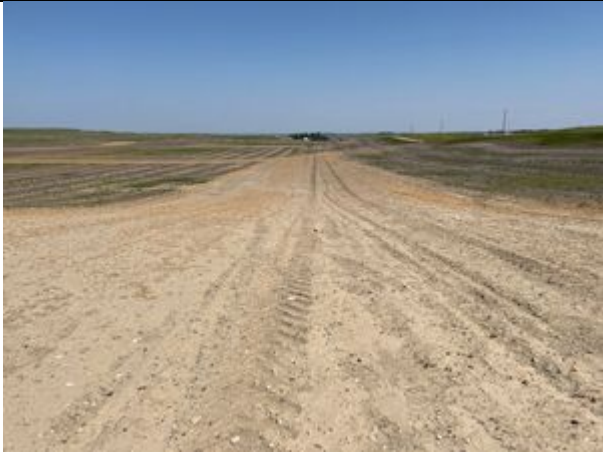
| | <p><b>Observation Point: 13</b><br/>Date Taken: July 20, 2026 12:20 PM<br/>Direction Photo is Taken: North</p> <p>Photo Description: Good contouring, topsoil contains rocks but consistent with surrounding soils in the area.</p> <p>Latitude: 47.72681591474224<br/>Longitude: -103.30539353332846</p> |

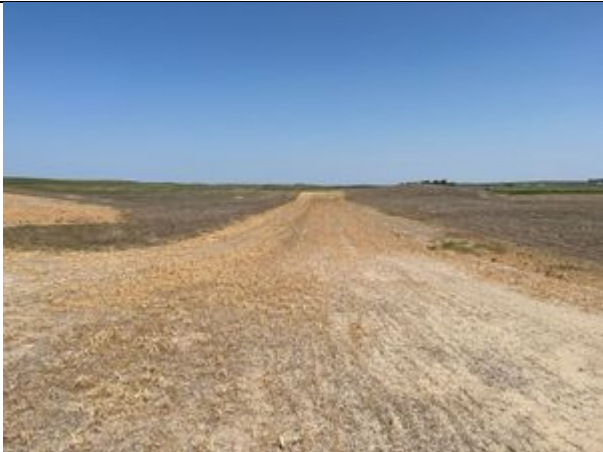
| | <p><b>Observation Point: 14</b><br/>Date Taken: July 20, 2026 12:24 PM<br/>Direction Photo is Taken: North</p> <p>Photo Description: Good contouring, vegetation appears to have died prior to being well established. Area may need to be re-seeded in the fall.</p> <p>Latitude: 47.72933630371812<br/>Longitude: -103.3081956701153</p> |

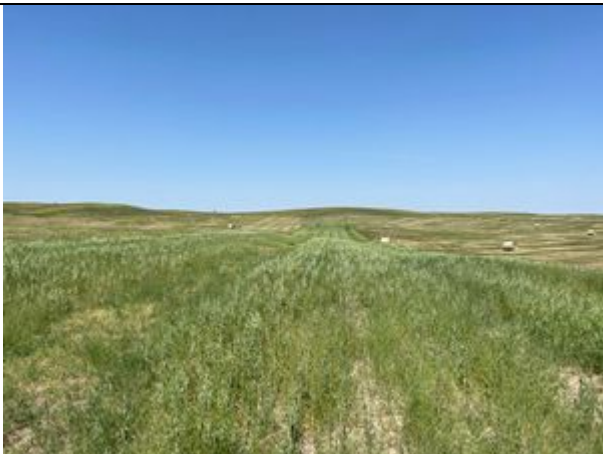
| | <p><b>Observation Point: 15</b><br/>Date Taken: July 20, 2026 12:27 PM<br/>Direction Photo is Taken: West</p> <p>Photo Description: Good contouring, vegetation establishing well</p> <p>Latitude: 47.73364183941925<br/>Longitude: -103.3101186687731</p> |

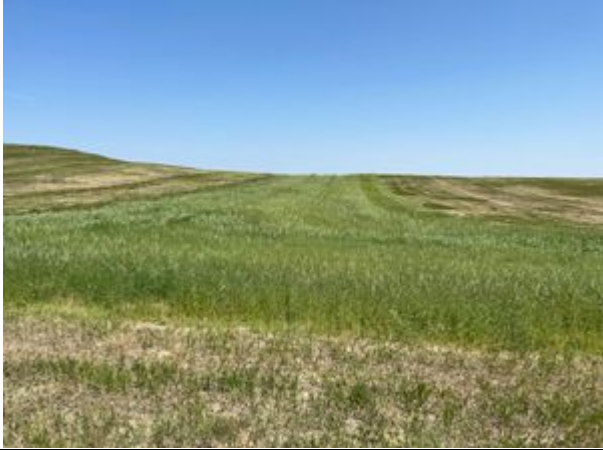
| | <p><b>Observation Point: 16</b><br/>Date Taken: July 20, 2026 12:30 PM<br/>Direction Photo is Taken: North</p> <p>Photo Description: Good contouring, vegetation establishing well</p> <p>Latitude: 47.7355373225831<br/>Longitude: -103.31424523734563</p> |

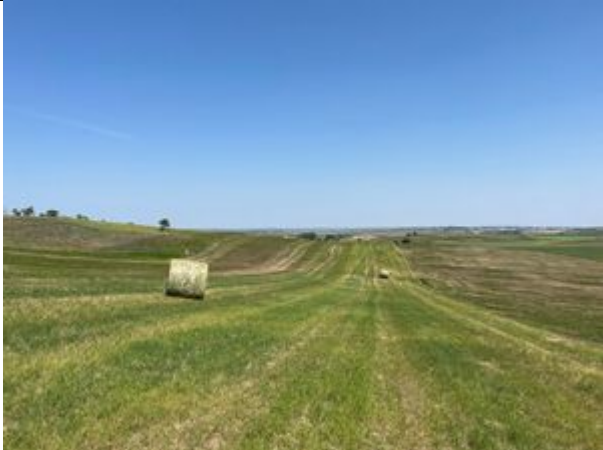
| | <p><b>Observation Point: 17</b><br/>Date Taken: July 20, 2026 12:33 PM<br/>Direction Photo is Taken: North</p> <p>Photo Description: Good contouring, vegetation establishing well</p> <p>Latitude: 47.74027242610663<br/>Longitude: -103.31471641128822</p> |

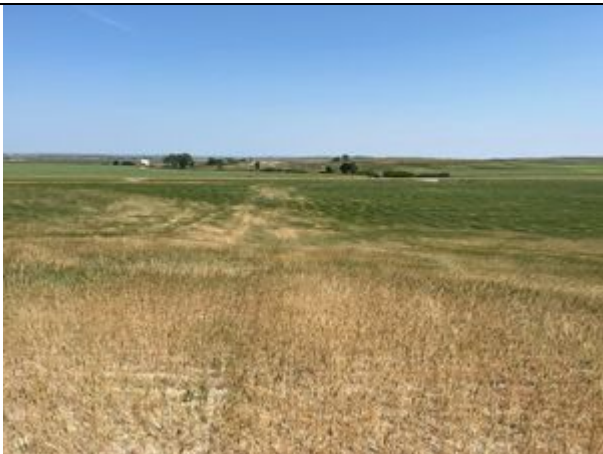
| | <p><b>Observation Point: 18</b><br/>Date Taken: July 20, 2026 12:37 PM<br/>Direction Photo is Taken: North</p> <p>Photo Description: Good contouring, crops within ROW appear to be comparably to those adjacent</p> <p>Latitude: 47.74430707066346<br/>Longitude: -103.31470435649253</p> |

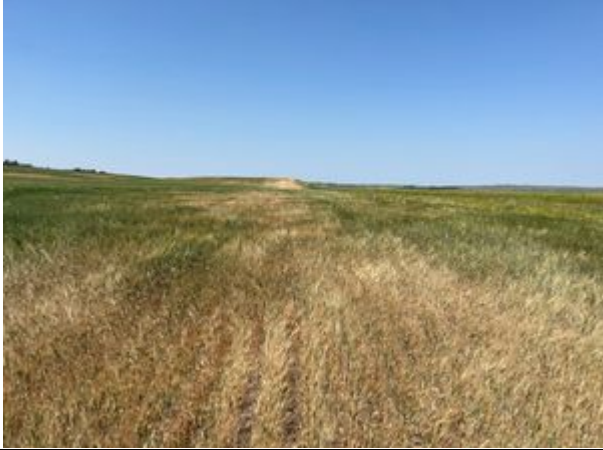
| | <p><b>Observation Point: 19</b><br/>Date Taken: July 20, 2026 12:39 PM<br/>Direction Photo is Taken: West</p> <p>Photo Description: Good contouring, crops within ROW appear to be stressed as compared to those adjacent.</p> <p>Latitude: 47.7464830935204<br/>Longitude: -103.3157626127917</p> |

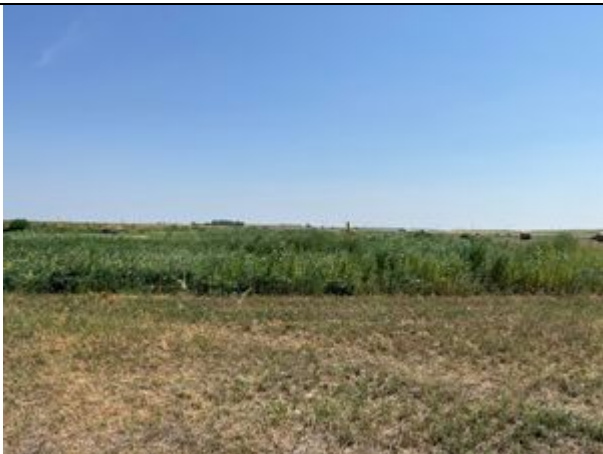
| | <p><b>Observation Point: 21</b><br/>Date Taken: July 20, 2026 12:47 PM<br/>Direction Photo is Taken: East</p> <p>Photo Description: Vegetation well established adjacent to stream.</p> <p>Latitude: 47.74576438205464<br/>Longitude: -103.3319179678139</p> |

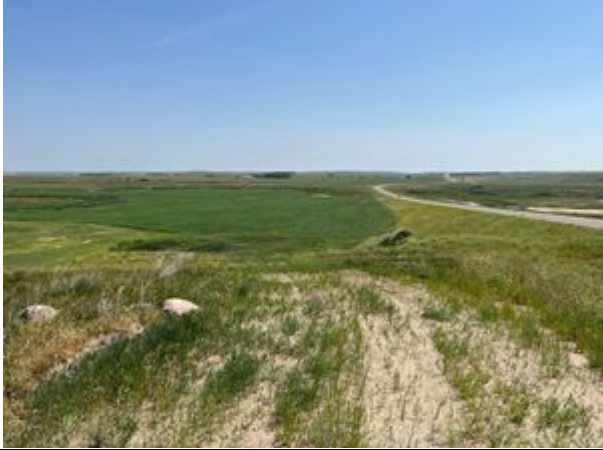
| | <p><b>Observation Point: 22</b><br/>Date Taken: July 20, 2026 12:51 PM<br/>Direction Photo is Taken: East</p> <p>Photo Description: Good contouring, crops within ROW appear to be comparable to those adjacent</p> <p>Latitude: 47.74713677944172<br/>Longitude: -103.33788091202148</p> |

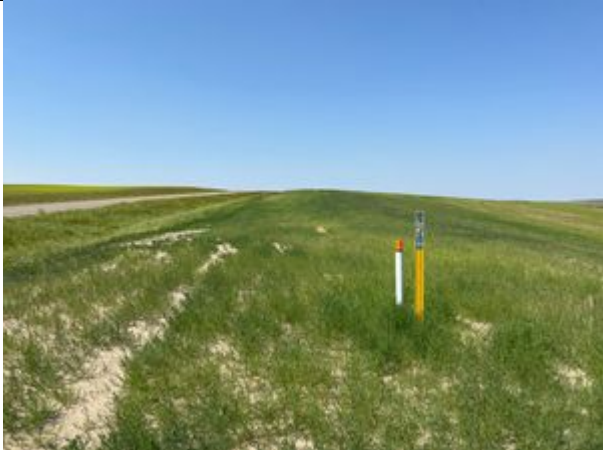
| | <p><b>Observation Point: 23</b><br/>Date Taken: July 20, 2026 12:52 PM<br/>Direction Photo is Taken: West</p> <p>Photo Description: Good contouring, vegetation well established. Pipeline marker indicates pipeline is constructed per the plans submitted to the PSC.</p> <p>Latitude: 47.74716317644689<br/>Longitude: -103.3379703819935</p> |

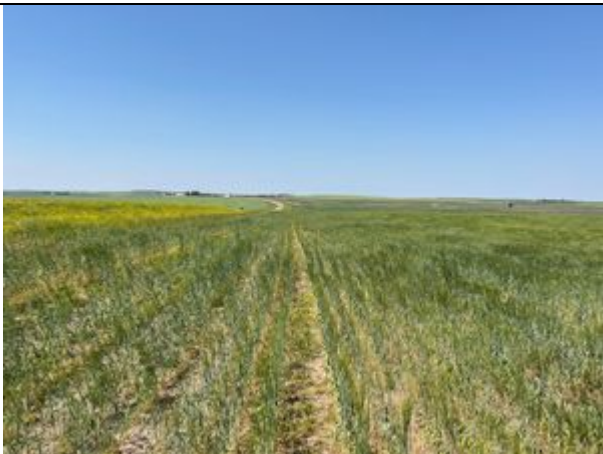
| | <p><b>Observation Point: 24</b><br/>Date Taken: July 20, 2026 12:55 PM<br/>Direction Photo is Taken: West</p> <p>Photo Description: Good contouring, crops within ROW appear to be comparable to those adjacent</p> <p>Latitude: 47.74711254960801<br/>Longitude: -103.3507920957346</p> |

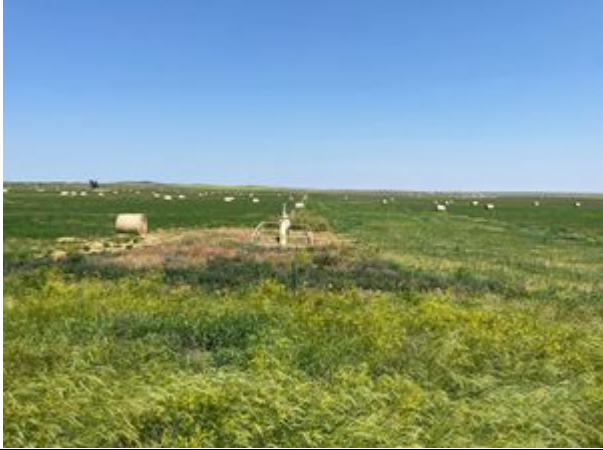
| | <p><b>Observation Point: 25</b><br/>Date Taken: July 20, 2026 12:59 PM<br/>Direction Photo is Taken: North</p> <p>Photo Description: Good contouring and crop through ROW. (above ground facility in photo not part of this project)</p> <p>Latitude: 47.74698000671482<br/>Longitude: -103.36290967867214</p> |

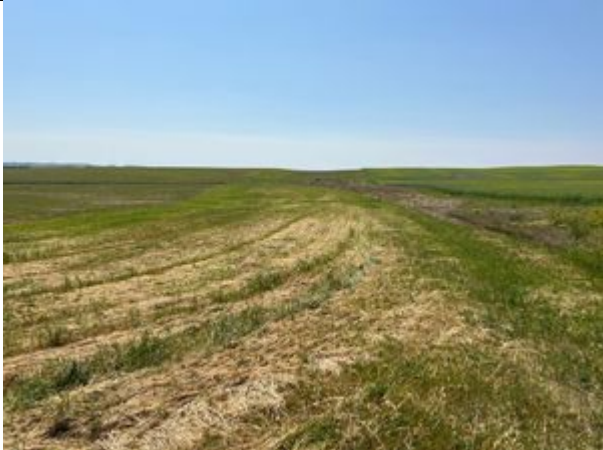
| | <p><b>Observation Point: 26</b><br/>Date Taken: July 20, 2026 1:04 PM<br/>Direction Photo is Taken: South</p> <p>Photo Description: Good contouring, crops within ROW appear to be comparable to those adjacent</p> <p>Latitude: 47.76124129021151<br/>Longitude: -103.36353892368405</p> |

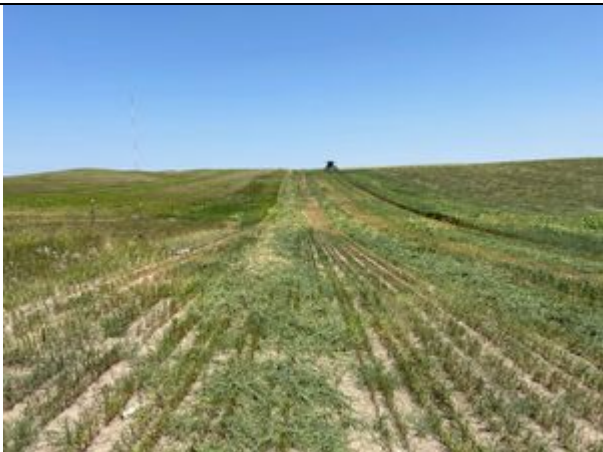
| | <p><b>Observation Point: 27</b><br/>Date Taken: July 20, 2026 1:23 PM<br/>Direction Photo is Taken: North</p> <p>Photo Description: Good contouring, crops within ROW appear to be comparable to those adjacent. As of taking this photo, this crop was being harvested and thus may appear misleading as the ROW area was freshly cut.</p> <p>Latitude: 47.76361419695735<br/>Longitude: -103.36359807519824</p> |

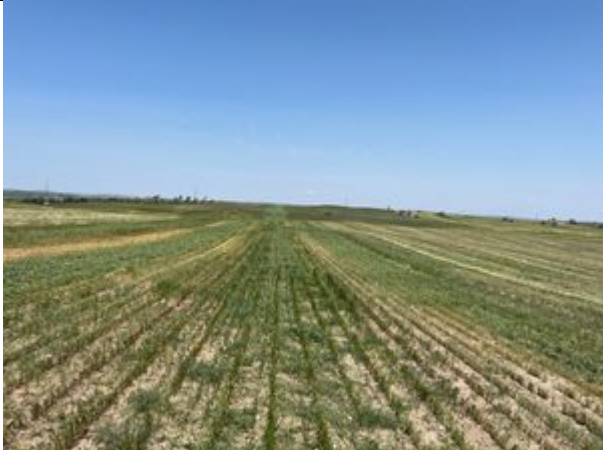
| | <p><b>Observation Point: 29</b><br/>Date Taken: July 20, 2026 1:27 PM<br/>Direction Photo is Taken: North</p> <p>Photo Description: Good contouring, crops within ROW appear to be comparable to those adjacent</p> <p>Latitude: 47.77963375564457<br/>Longitude: -103.36845713377927</p> |

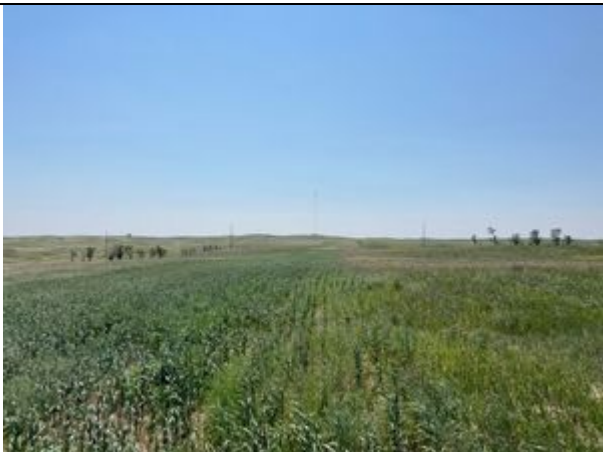
| | <p><b>Observation Point: 30</b><br/>Date Taken: July 20, 2026 1:35 PM<br/>Direction Photo is Taken: South</p> <p>Photo Description: Good contouring, crops within ROW appear to be comparable to those adjacent</p> <p>Latitude: 47.78574220099122<br/>Longitude: -103.36861225952616</p> |

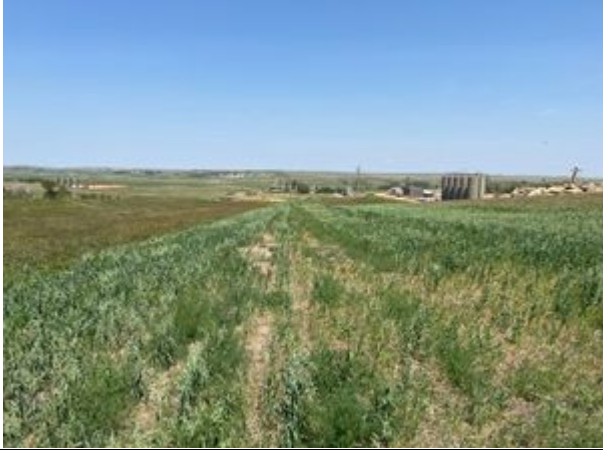
| | <p><b>Observation Point: 31</b><br/>Date Taken: July 20, 2026 1:39 PM<br/>Direction Photo is Taken: North</p> <p>Photo Description: Adequate vegetation establishment across ROW.</p> <p>Latitude: 47.78719063182784<br/>Longitude: -103.3685557192527</p> |

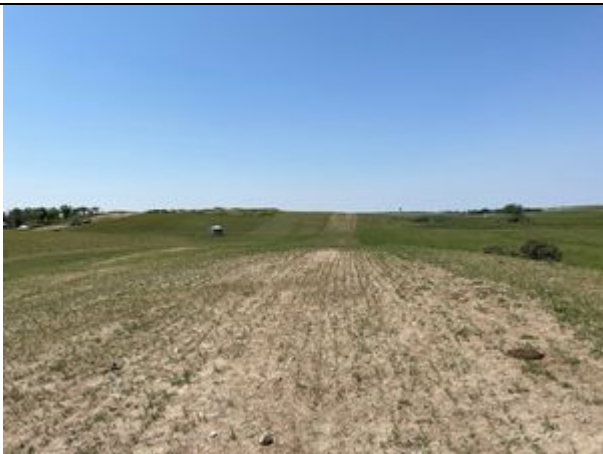
| | <p><b>Observation Point: 33</b><br/>Date Taken: July 20, 2026 1:44 PM<br/>Direction Photo is Taken: West</p> <p>Photo Description: Good contouring, sparse vegetation may require re-seeding in the fall.</p> <p>Latitude: 47.79608220699721<br/>Longitude: -103.3701117890883</p> |

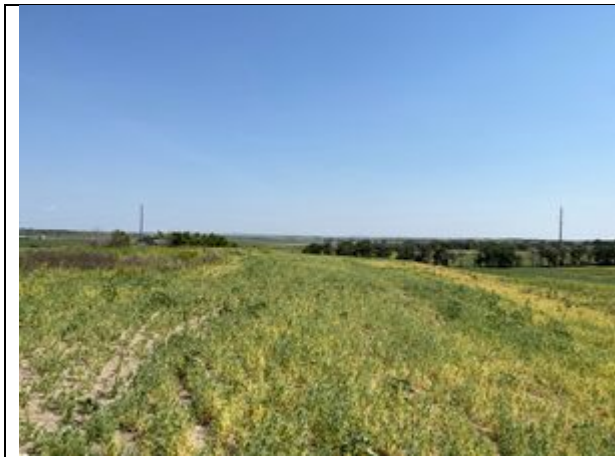
**Observation Point: 35**

Photo Description: Good contouring and vegetation establishment across ROW.

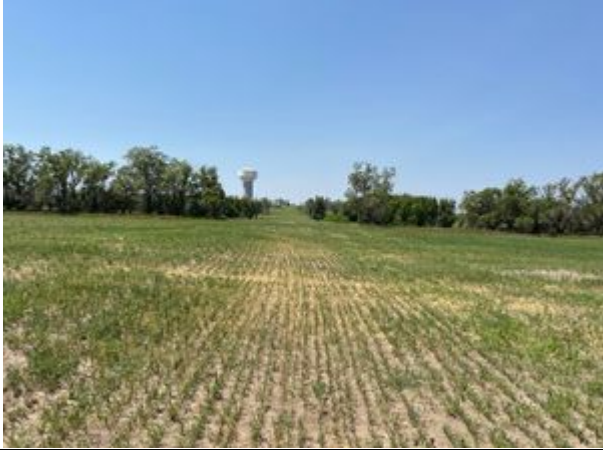
| | <p><b>Observation Point: 37</b><br/>Date Taken: July 20, 2026 2:12 PM<br/>Direction Photo is Taken: West</p> <p>Photo Description: Crop appear adequate across pipeline ROW.</p> <p>Latitude: 47.80254507018225<br/>Longitude: -103.41318200982386</p> |

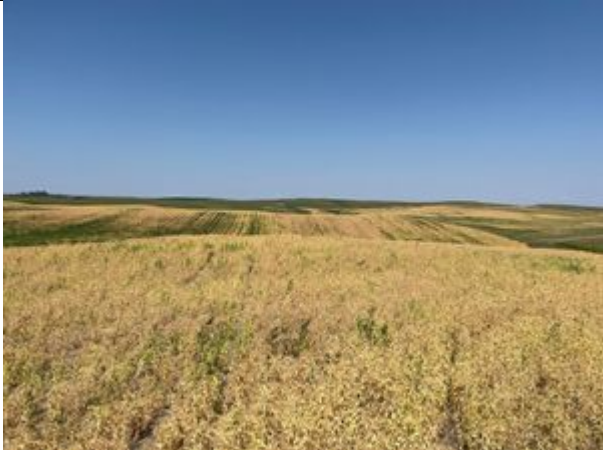
| | <p><b>Observation Point: 38</b><br/>Date Taken: July 20, 2026 2:21 PM<br/>Direction Photo is Taken: North</p> <p>Photo Description: Crops well established through pipeline ROW</p> <p>Latitude: 47.82152566503673<br/>Longitude: -103.4233977774394</p> |

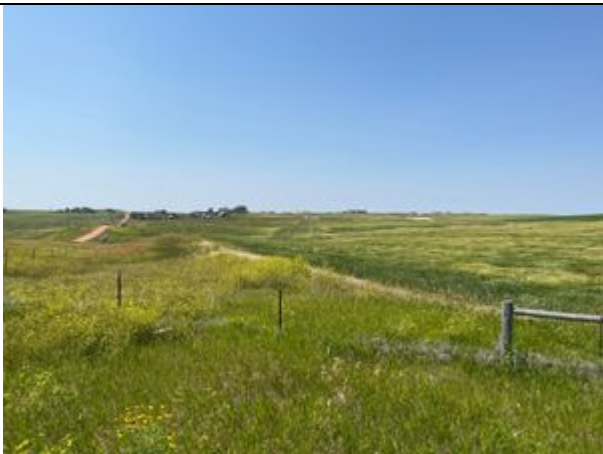
| | <p><b>Observation Point: 39</b><br/>Date Taken: July 20, 2026 2:28 PM<br/>Direction Photo is Taken: Northwest</p> <p>Photo Description: Vegetation well established across ROW. Confirmed pipeline was bored underneath roadway at this location.</p> <p>Latitude: 47.83390941861345<br/>Longitude: -103.42257578917913</p> |

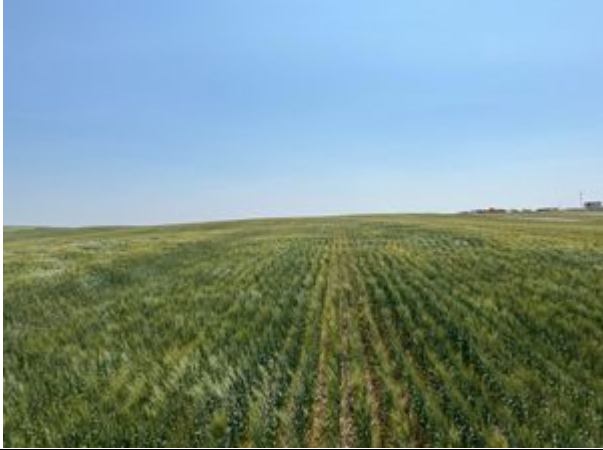
| | <p><b>Observation Point: 40</b><br/>Date Taken: July 20, 2026 2:36 PM<br/>Direction Photo is Taken: South</p> <p>Photo Description: Crops well established through pipeline ROW.</p> <p>Latitude: 47.84322389749182<br/>Longitude: -103.43243907880615</p> |

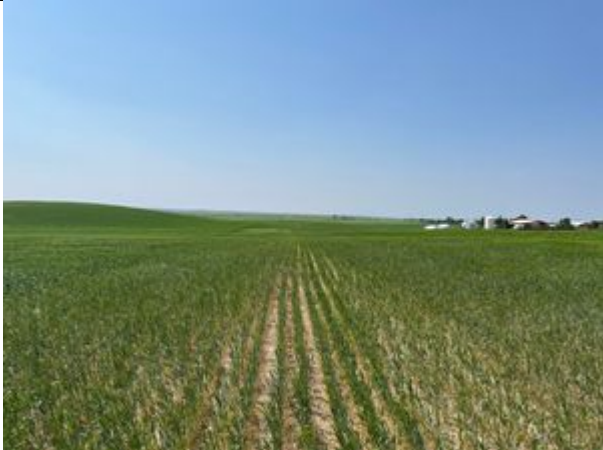
| | <p><b>Observation Point: 41</b><br/>Date Taken: July 20, 2026 2:46 PM<br/>Direction Photo is Taken: West</p> <p>Photo Description: Crops well established through pipeline ROW.</p> <p>Latitude: 47.84566511830102<br/>Longitude: -103.44431495029237</p> |

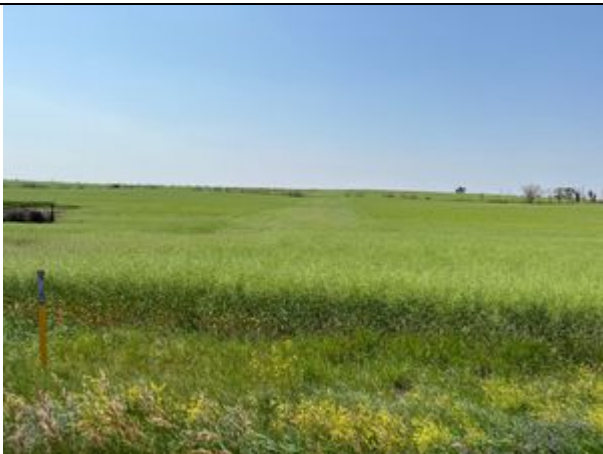
| | <p><b>Observation Point: 42</b><br/>Date Taken: July 20, 2026 2:53 PM<br/>Direction Photo is Taken: West</p> <p>Photo Description: Crops well established across pipeline ROW.</p> <p>Latitude: 47.84564743126528<br/>Longitude: -103.45494604158716</p> |

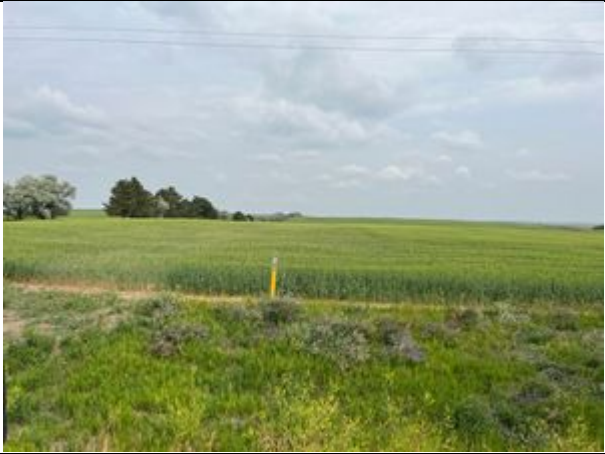
| | <p><b>Observation Point: 43</b><br/>Date Taken: July 21, 2026 11:39 AM<br/>Direction Photo is Taken: North</p> <p>Photo Description: Crops well established across pipeline ROW.</p> <p>Latitude: 47.84828713059272<br/>Longitude: -103.4617336493306</p> |

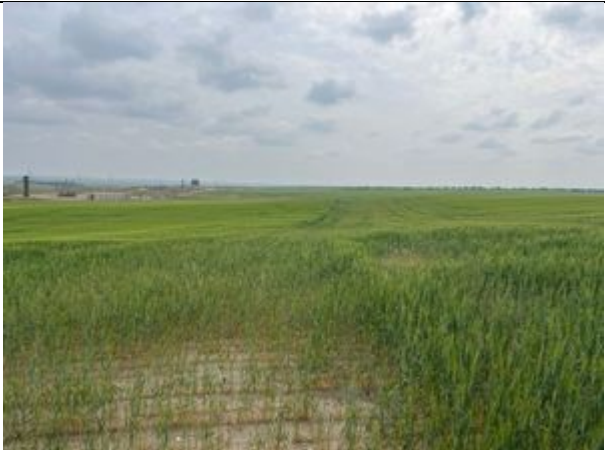
| | <p><b>Observation Point: 44</b><br/>Date Taken: July 21, 2026 11:43 AM<br/>Direction Photo is Taken: East</p> <p>Photo Description: Crops well established across pipeline ROW.</p> <p>Latitude: 47.85976060661663<br/>Longitude: -103.475767259462</p> |

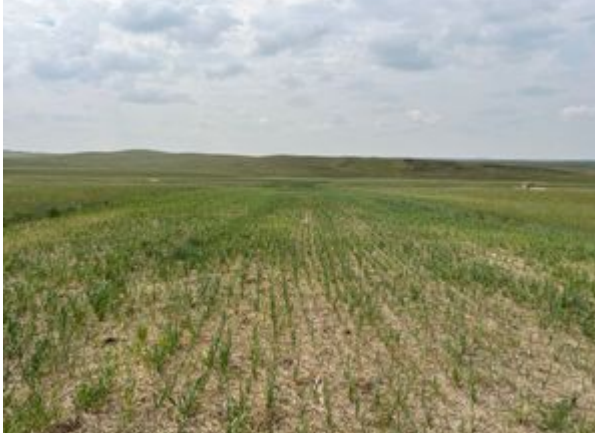
| | <p><b>Observation Point: 46</b><br/>Date Taken: July 21, 2026 11:54 AM<br/>Direction Photo is Taken: South</p> <p>Photo Description: Crop yields are relatively sparse across ROW in this area, will need to revisit following year to re-check vegetation.</p> <p>Latitude: 47.86242502327243<br/>Longitude: -103.4972347794617</p> |

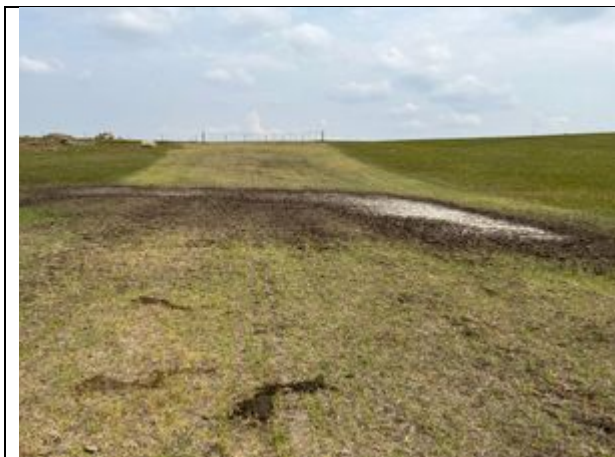
**Observation Point: 48**

Photo Description: Low area appearing to contain high salinity soils preventing vegetation growth. It appears that this area was in a similar condition pre-construction.

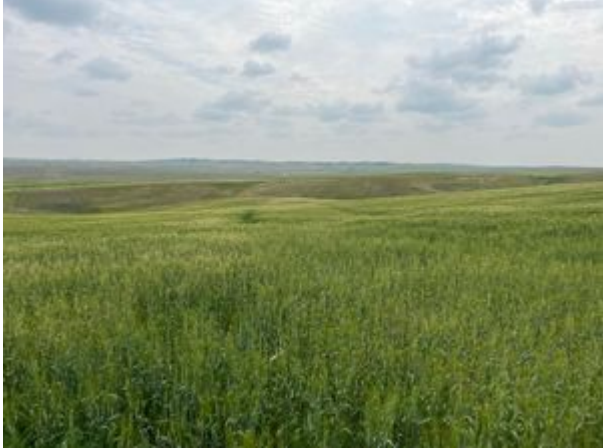
| | <p><b>Observation Point: 50</b><br/>Date Taken: July 21, 2026 12:21 PM<br/>Direction Photo is Taken: Southeast</p> <p>Photo Description: Crops well established across pipeline ROW.</p> <p>Latitude: 47.90428217469263<br/>Longitude: -103.51884821056814</p> |
