Public Service Commission

State of North Dakota

May 10, 2010

The Reclamation Division has reviewed DWC's response to our September 16, 2009, technical review of Revision 25 to KRSB-8802. The following issues must be addressed prior to this office recommending Commission action. Considering the renewal and associated revision that needs to be submitted for this permit and the need to begin grading work in the final pit area, please respond to this letter no later than June 1, 2010.

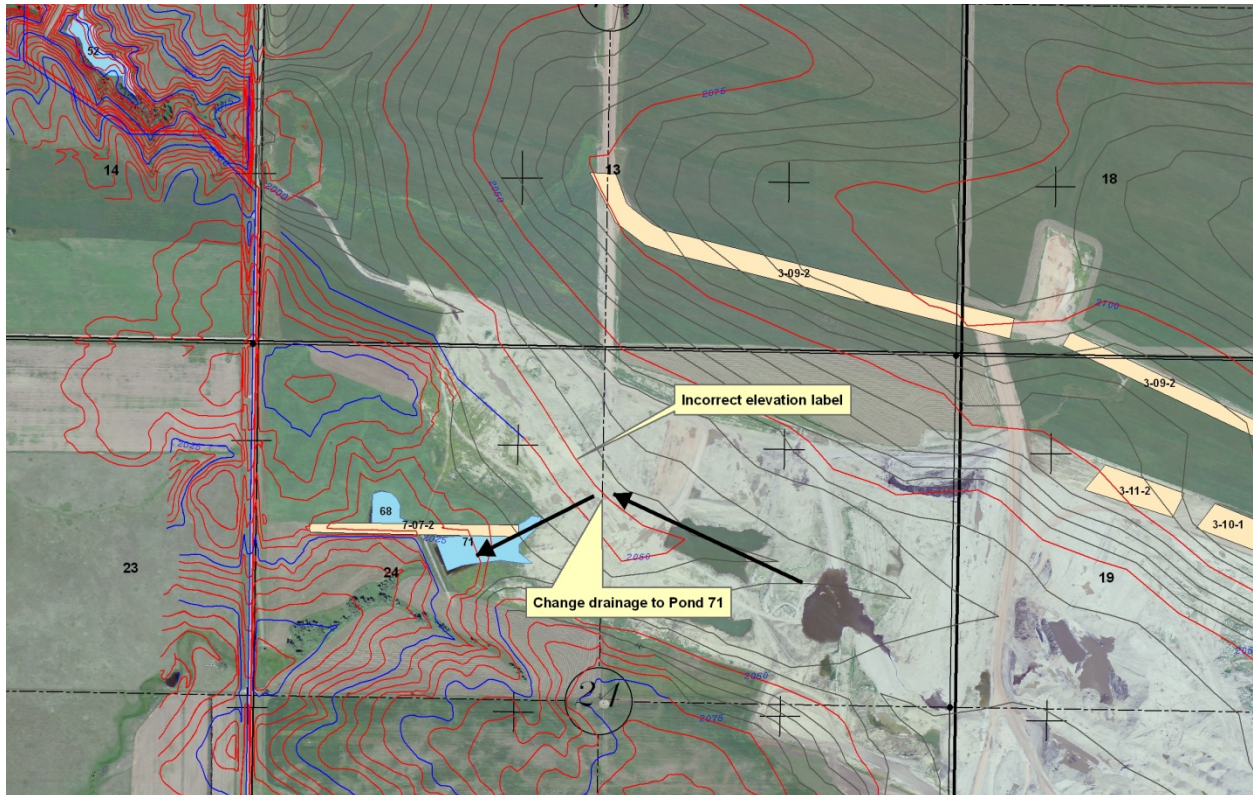
8. Follow-up to Item No. 10: The contour elevation line near the drainageway in the N½ of Section 24 is mislabeled on the Contour Map of Post-Mining Topography, Exhibit 3.5.3, as 2050 when in fact it is 2025. The Reclamation Division believes that runoff from the NE¼ of Section 24 should be directed to Pond 71 rather than towards Pond 52. This will create a watershed break where the long flat channel is proposed and the pre-mine watershed for the undisturbed drainageway in the NW¼ of Section 24 will be more similar to the pre-mining conditions. Please revise Exhibit 3.5.3 and all associated exhibits accordingly. See image below. The surface water PHC may also have to be updated as well. (GAW)
