Installation Guide

Permasert® Mechanical Repair Couplings

RESOLUTION CITY OF GRANVILLE, NORTH DAKOTA

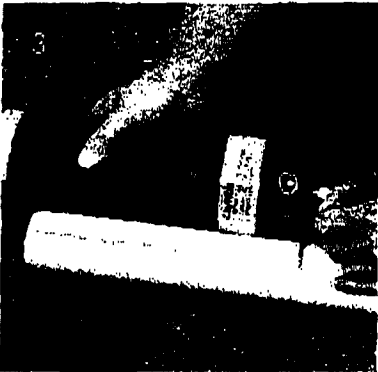
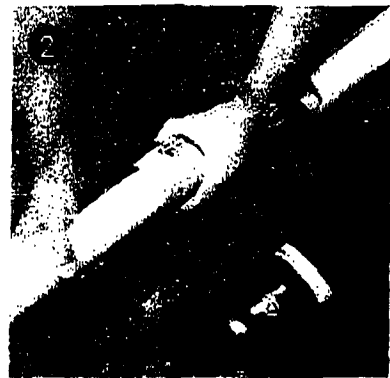
To complete the second stab, the Permasert's telescoping stiffener allows the coupling to slide toward the other pipe end and stab the coupling. The stab depth mark on this side will look just like all other Permasert couplings, just visible. Notice how the stab depth mark is several inches away from the coupling on the "CAUTION" labeled end due to the telescoping stiffener.

Pressure test the finished joint according to your standard operating procedure.

On July 15, 2010 Zerr, assisted by Drader repaired the damaged service line. The damaged pipe was removed and repairs were made with a short length of PE pipe and two Permasert® couplings. The repair was checked with an air pressure test (85 p.s.i.) and the fittings were soap tested prior to re-establishing service. No additional repairs to the line have been required.

6. The damaged service line was repaired using a short length of PE pipe and two Permasert couplings. The repaired line was then checked with an air pressure test (85 PSI) and the fittings were soap tested prior to re-establishing service. A Pressure Test Report, showing the amount of pressure applied to the damaged service line should have been placed in the City's records. Although the use of Permasert mechanical couplings to repair the damaged service line is now permitted under the City's Operation and Maintenance Plan, at the time, it was not a qualified procedure. Therefore, the damaged service line should have been prepared using a fusion procedure that was qualified.
