**RE: Meadowlark Wind I LLC
New Frontier Wind Energy Project
Case No. PU-11-69**

**RESPONSES TO DATA REQUESTS
MEADOWLARK WIND I LLC (Case No. PU-11-69)**

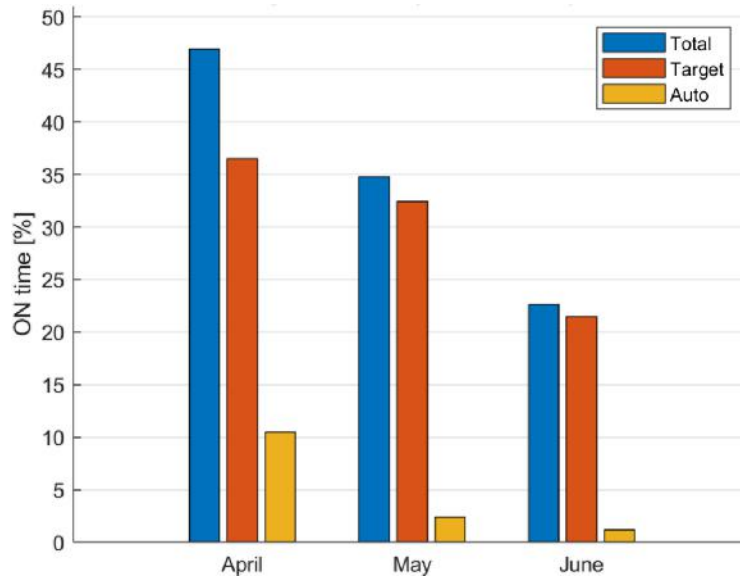
RESPONSE: Vestas is currently analyzing the New Frontier log data from the past quarter of 2020. The data is depicted in the graph below, which shows the amount the lights were on during the night due to either target detection (Target) or due to a fail-safe mode (Auto), as well as the sum of both (Total).
