Minnesota Power 2018 Wildlife Impact Report **For the Bison 1, 2, 3 & 4 Wind Facilities**

Bison 1 (PU-09-151), Bison 2 (PU-11-57), Bison 3 (PU-11-162), Bison 4 (PU-13-127)

A WIND ENERGY INITIATIVE OF MINNESOTA POWER IN NORTH DAKOTA

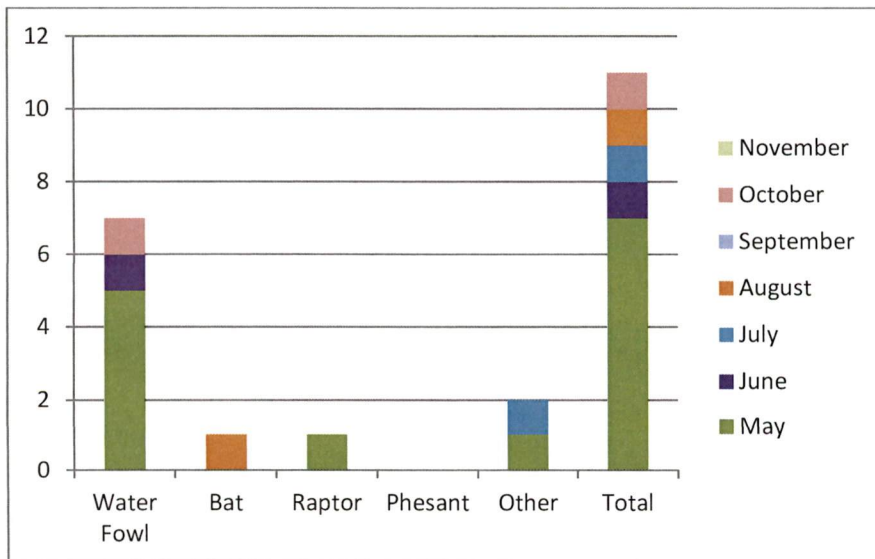
Table 1-1:
2018 Avian Carcasses Found at Minnesota Power’s Bison Facility

After reviewing the inspection/fatalities records, no turbine, structure or location showed an elevated risk for avian or bat mortality when compared to surrounding Bison Facility structures. Mortality appears to be dispersed throughout the Bison Facility. One bat carcasses was found in August 2018 which coincides with fall migratory activity. Duck carcasses were more prevalent during spring migration, however an increase was not observed during fall migration when avian species are typically most vulnerable to collision. The 2018 results are as shown in Table 1-1 below.

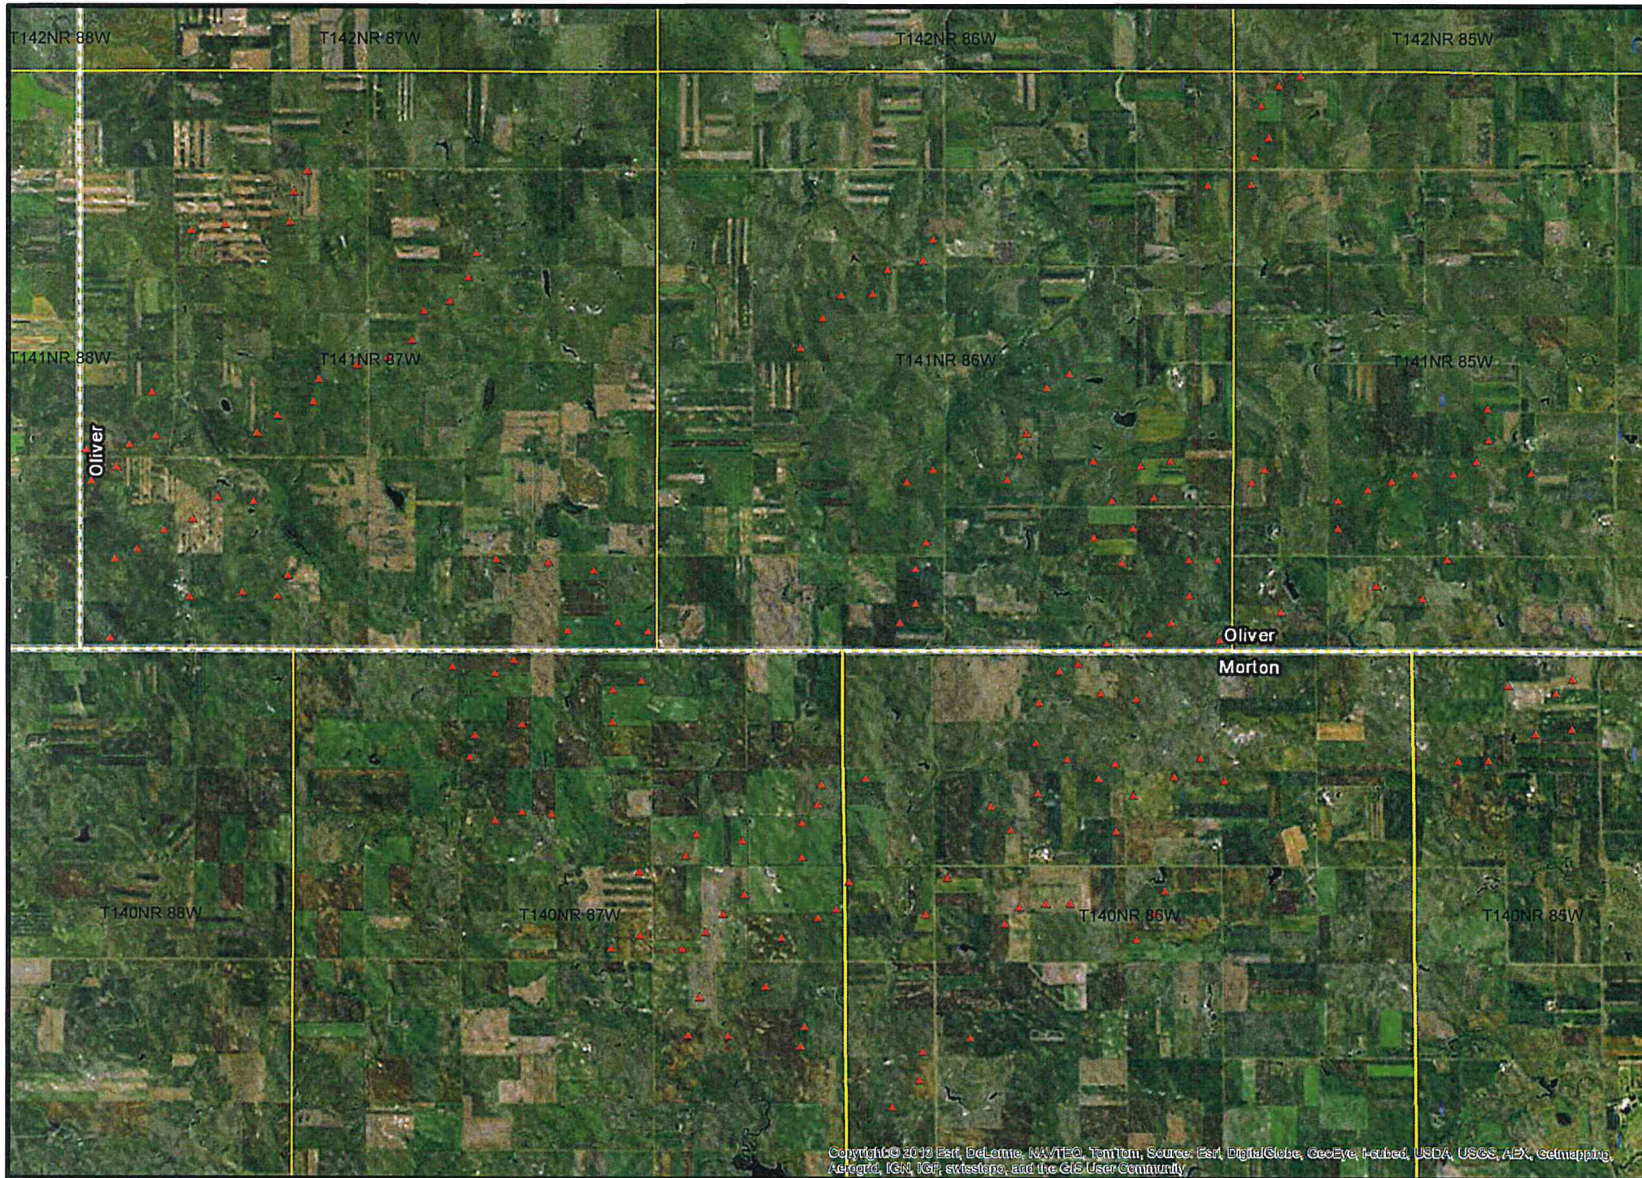
Figure 1

Minnesota Power Bison 1, 2, 3 & 4 Project Area

Figure 1- Bison 1, 2, 3 & 4 Project Area
