# Geotechnical Evaluation Report

Global Stampede Pipeline  
2100 McKinney Avenue  
Dallas, TX 75201

**Re:** Geotechnical Evaluation  
Global Stampede Pipeline Mined Land Evaluation  
NENE, Sec 16, T162N, R94W  
Burke County, North Dakota

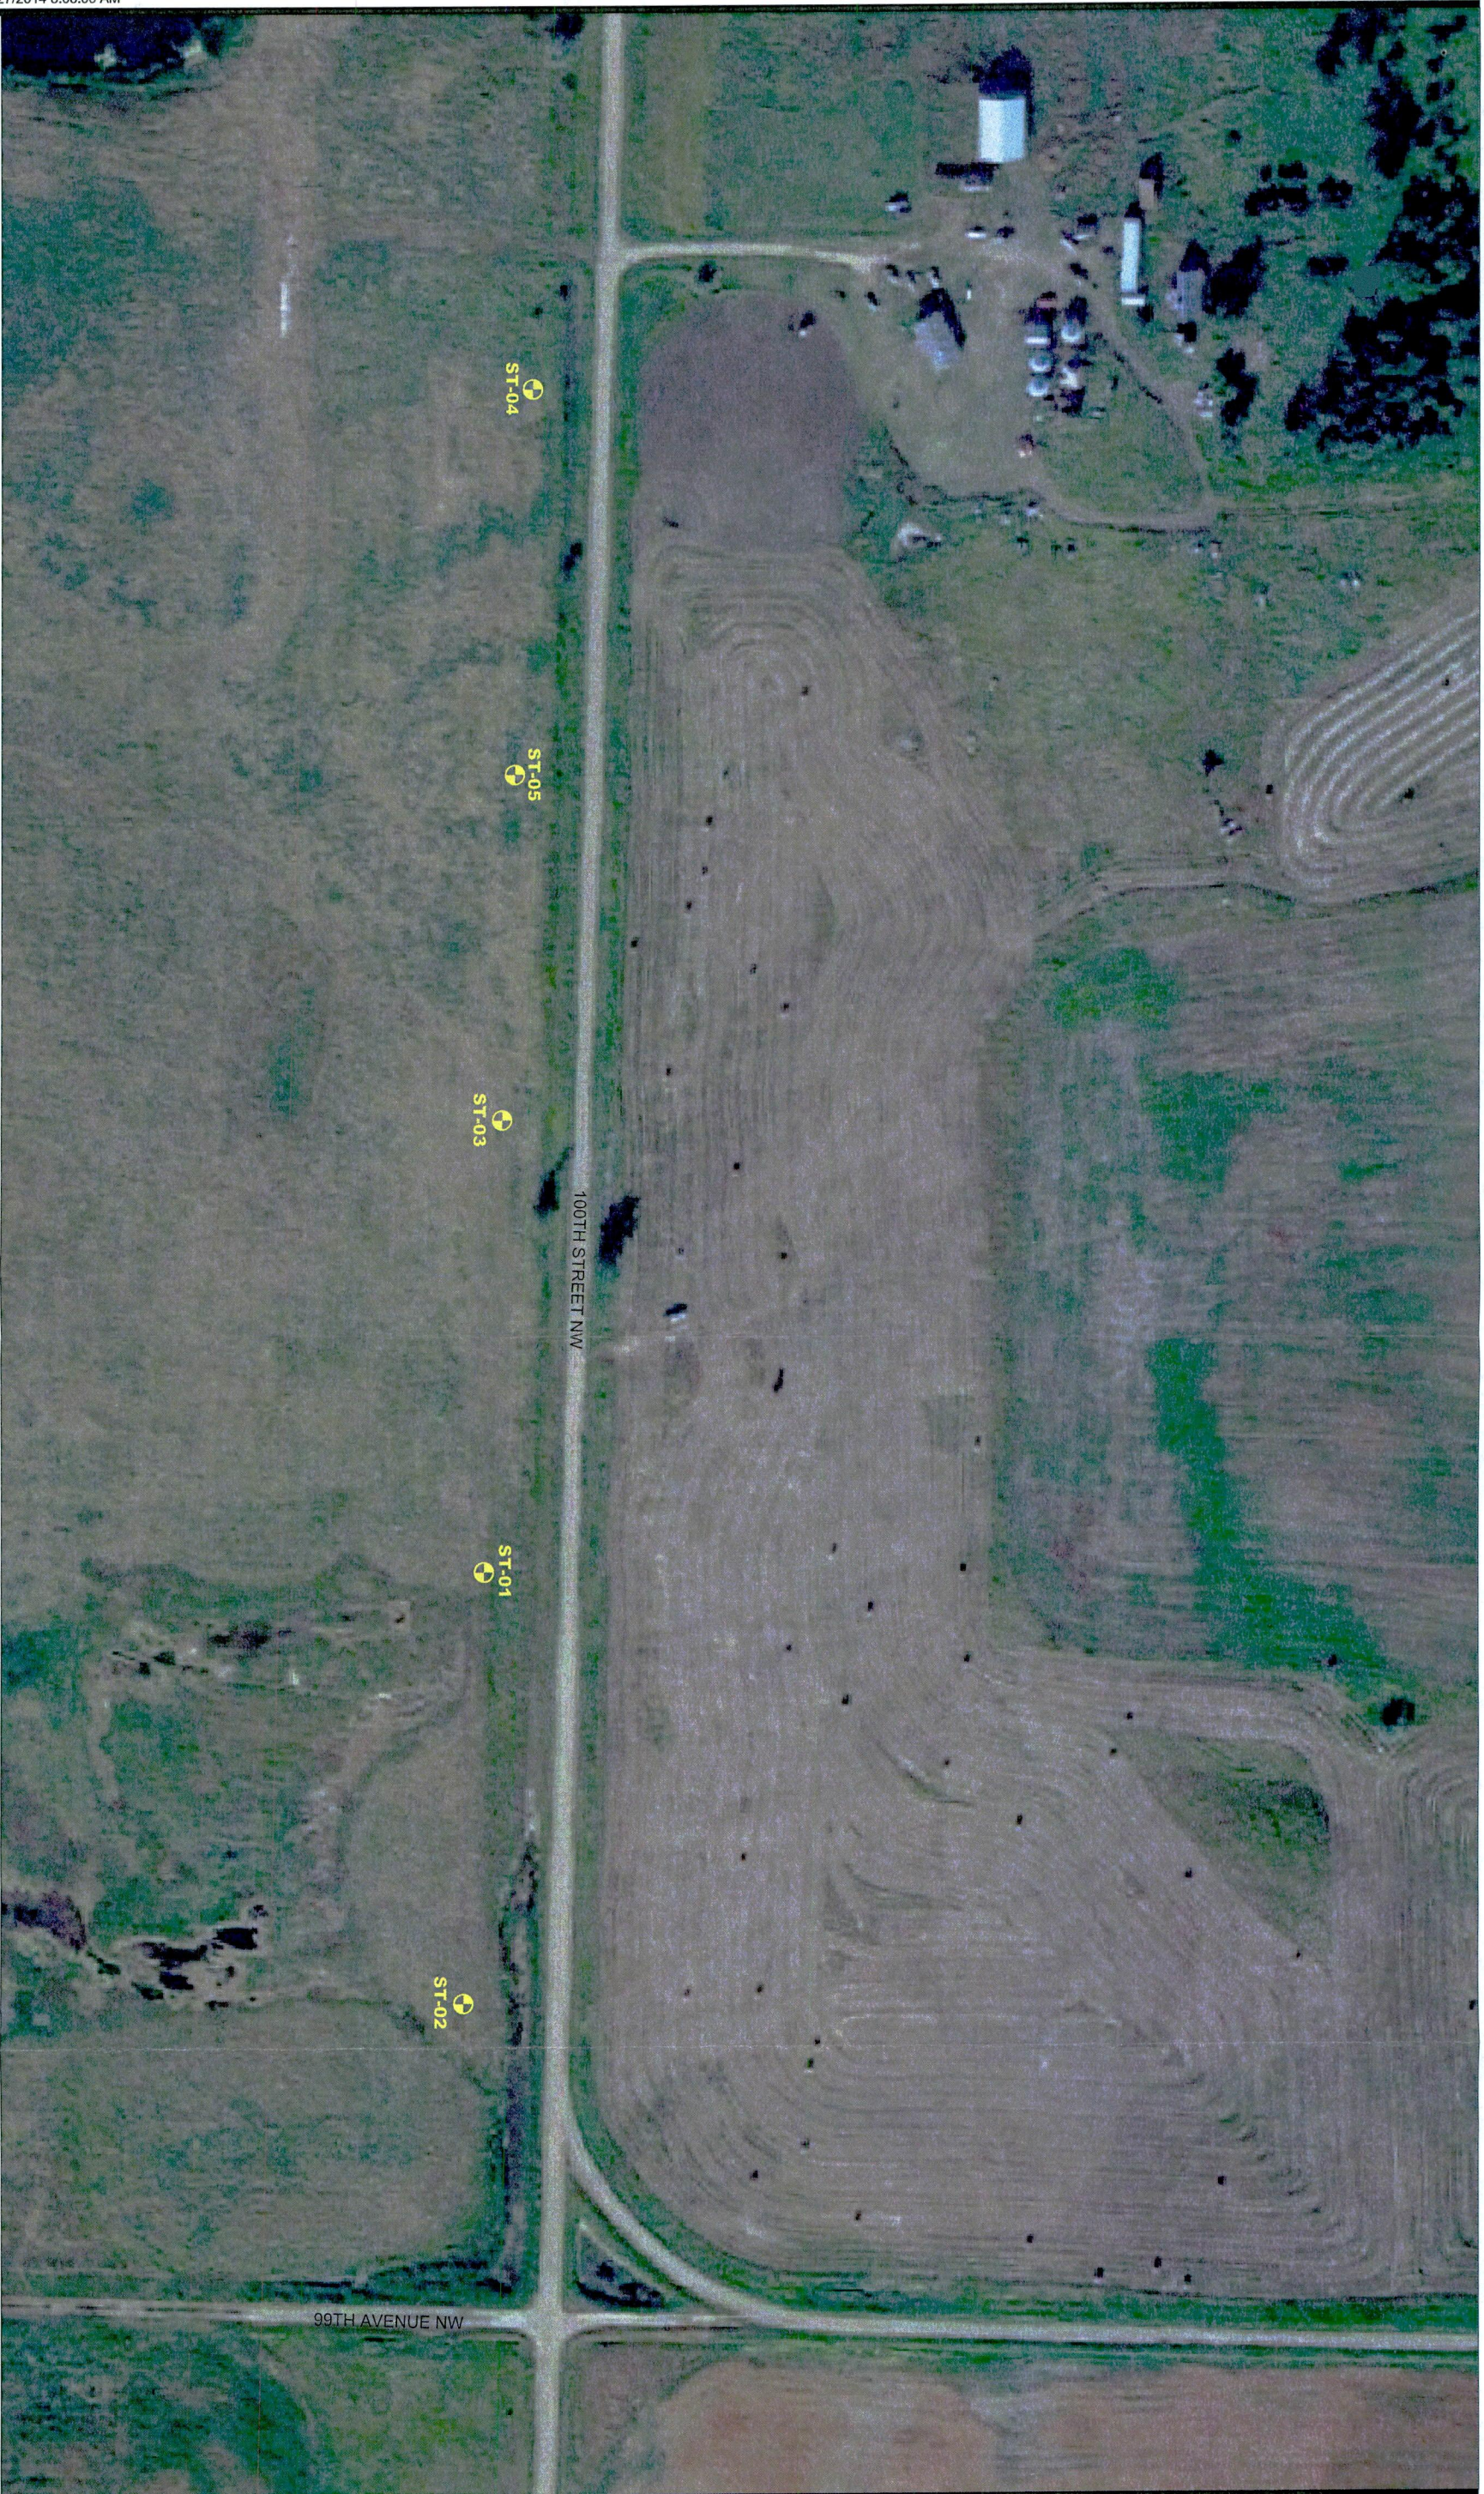
DENOTES APPROXIMATE LOCATION OF  
 STANDARD PENETRATION TEST BORING
