Xcel Energy Data Request No. 1-1
 Case No.: PU-15-174
 Response To: North Dakota Public Service Commission
 Requestor: Victor Schock
 Date Received: May 10, 2022

Case No	Name
PU-15-174	Courtenay Wind

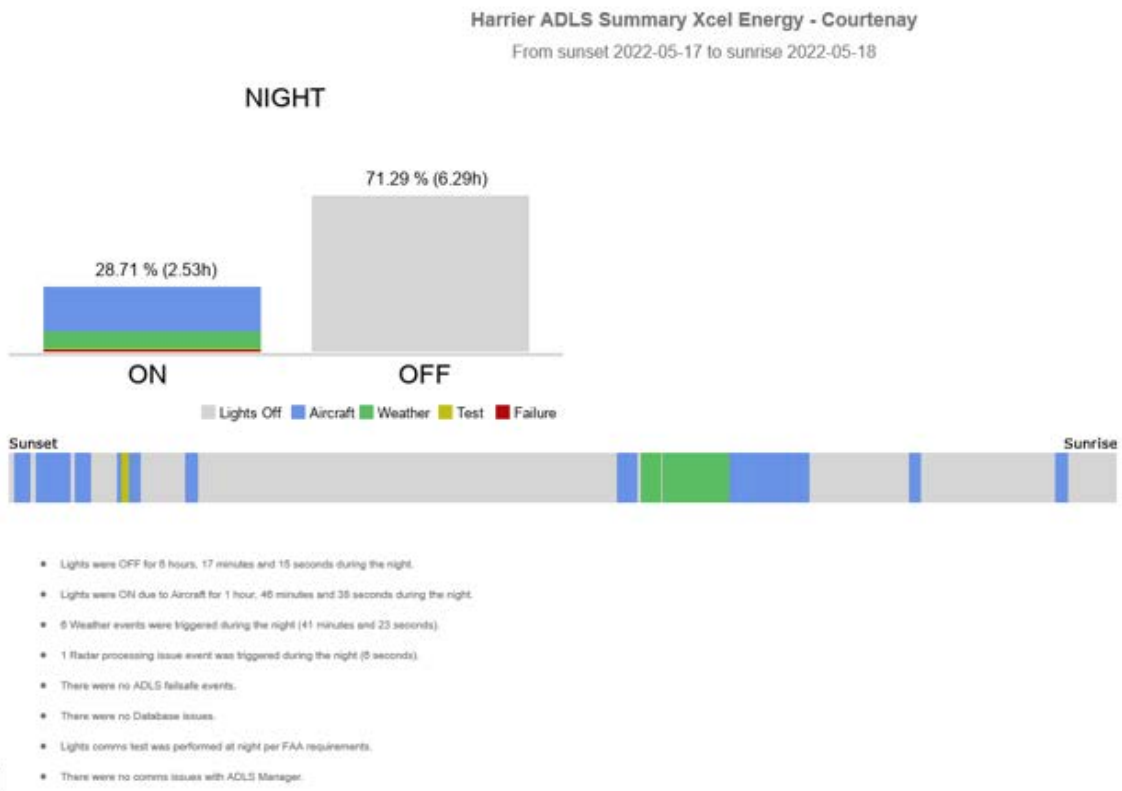
4. Xcel Energy is currently working with DeTect to expand their reporting to weekly and monthly summary reports to provide this and other information. Currently, DeTect is providing daily performance that provides a breakdown of the reasons that the ADLS illuminated the turbine lights during each night (due to aircraft, testing, failure, weather). Below is an example of the reporting available at this time:

As shown above, on this night (5/17/22) weather was a factor in activating the lights. Dense fog, heavy snow fall, or even a low elevation thunderstorm can result in a default activation. The detection system is using radar (it does not work off of aircraft transmitters) so if there is any possibility of the radar not

being able to sufficiently detect aircraft due to weather conditions it will default to lights on.
