# Visual Impacts Assessment for the Dickinson Renewable Diesel Facility Wind Turbine Project, Stark County, North Dakota

**VISUAL IMPACTS ASSESSMENT FOR THE DICKINSON  
RENEWABLE DIESEL FACILITY WIND TURBINE PROJECT,  
STARK COUNTY, NORTH DAKOTA**

SWCA Project No. 67406

SWCA Cultural Resources Report No. 21-431

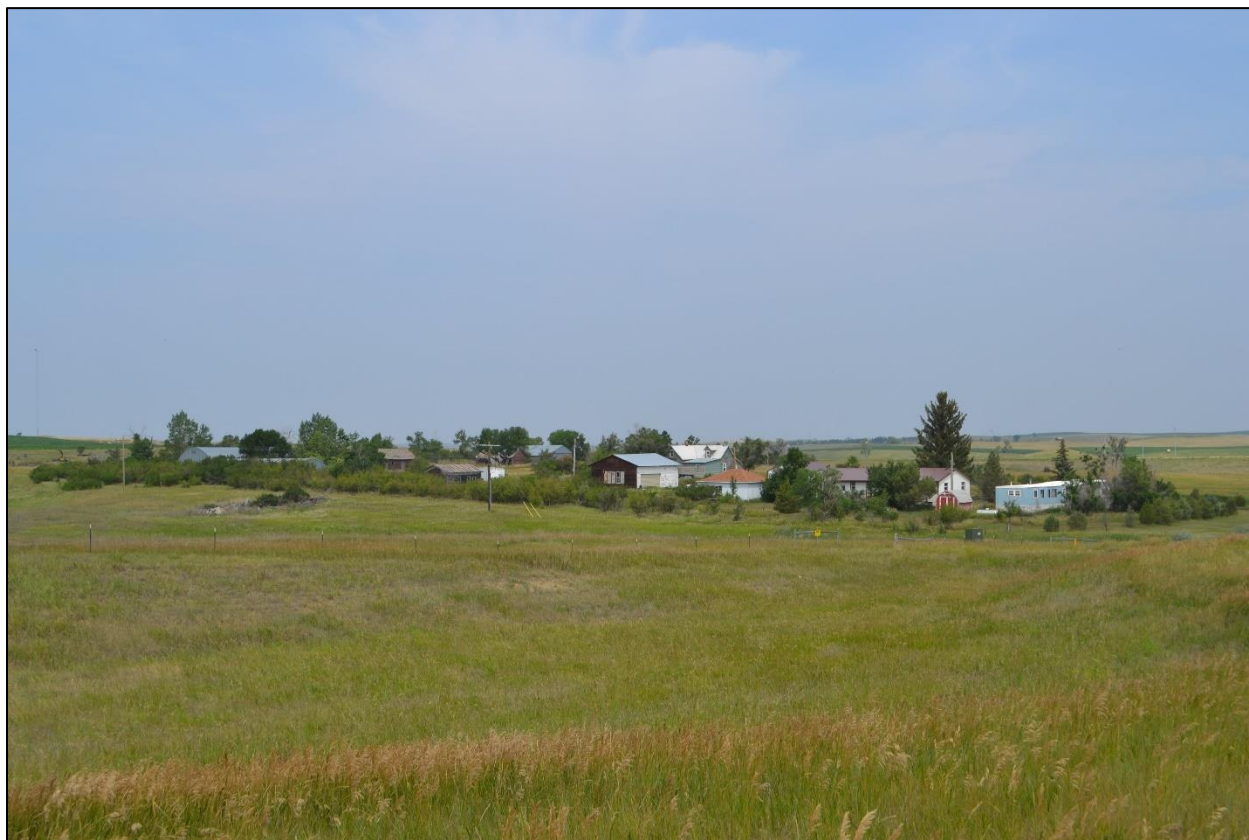
**Figure 3. From left, Resources 1m, 1l, 1c, 1b, 1d, 1e, 1b, 1a, 1f, 1g, 1i, 1j, and 1k, facing northwest. Resource 1h is obscured by trees in this photograph.** Photographed by SWCA (H. Curry), July 21, 2021; image has not been altered.

Resource 1a is a two-story farmhouse with a metal gable roof and a dormer on the south. The dwelling has two chimneys, horizontal wood siding, and six 1/1 wood hung sash windows visible from the ROW. There is evidence that the dwelling was originally an L-shaped plan with a porch that was enclosed at a later date. No doors are visible from the ROW to determine their style or Resource 1a's orientation on the site. The metal roof, enclosed porches, and additional resources on site constructed in different decades demonstrate that Resource 1a has diminished integrity of materials, design, workmanship, and setting. As a result, SWCA recommends that Resource 1a is NOT ELIGIBLE for the NRHP as an individual resource.

Resource 1c is a two-story wood-frame barn with an asphalt shingle gable roof and horizontal wood siding. There is one single-light fixed window on the east elevation, and no entry points are visible from the ROW. Resource 1c does not rise to the level of significance required for individual listing in the NRHP; therefore, SWCA recommends that it is NOT ELIGIBLE for the NRHP.

Resource 1d is a wood-frame barn that suffered structural failure and collapsed. The barn had a corrugated sheet metal gable roof and horizontal plank siding; however, no other details are discernible. Resource 1c has no integrity of design or workmanship due to its collapse; therefore, SWCA recommends that it is NOT ELIGIBLE for the NRHP as an individual resource.

Resource 1e is a prefabricated metal-frame barn with a gable roof. The barn uses the same sheet metal for both roofing and cladding, and there are two sliding doors located on the east elevation; however, the number of leaves in each door cannot be determined from the ROW. Resource 1e does not rise to the level of significance required for individual listing in the NRHP; therefore, SWCA recommends that it is NOT ELIGIBLE for the NRHP.

Resource 1 is located at 3625 116th Avenue SW, and the property contains 13 resources visible from the ROW (Figure 3). There is a private gravel driveway on the west side of 116th Avenue SW, and the property abuts Interstate 94 on its northern boundary. Resource 1a is the historic-age dwelling, 1b is a workshop, 1c is a barn, 1d is a barn, 1e is barn, 1f is a garage, 1g is a shed, 1h is a garage, 1i is a secondary dwelling, 1j is a shed, 1k is a secondary dwelling, 1l is a shed, and 1m is a garage. SWCA estimates that Resource 1a was constructed in approximately 1925.

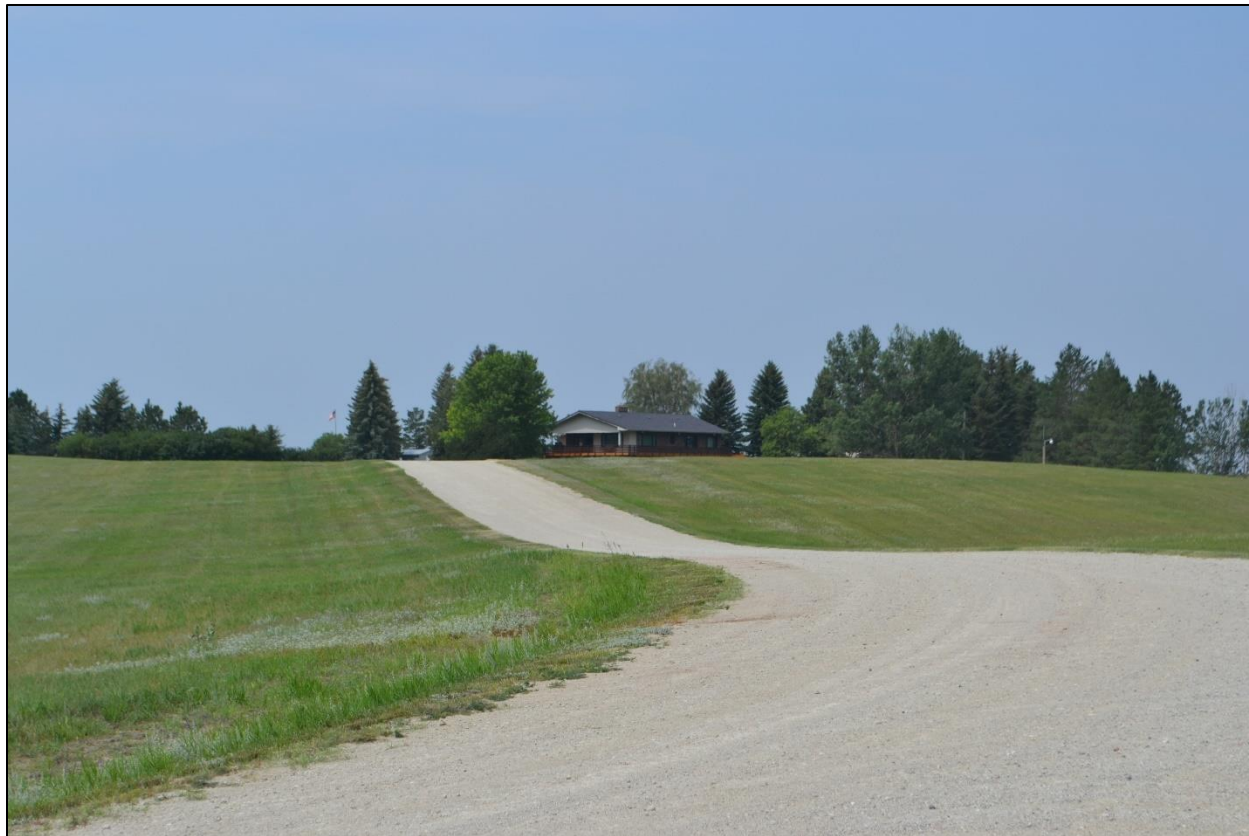
**Figure 4. From left, the flagpole object, Resource 2b, and Resource 2a, facing west.** Photographed by SWCA (H. Curry), July 21, 2021; image has not been altered.

Resource 2a is a one-story dwelling facing southeast on its site. The gable roof uses asphalt shingles and a central chimney, and the cladding is a mixture of horizontal plank siding on the southeast (primary) elevation and brick cladding on the northeast elevation, the only other elevation visible from the ROW. There is a wraparound deck on the visible elevations with round columns on the southeast (primary) elevation supporting the roofline above. Typical windows are fixed picture windows with flanking shutters, and no details about the primary entry were visible from the ROW. Resource 2a does not have any unique or precedent-setting architectural details, and it does not rise to the level of significance required for individual listing in the NRHP; therefore SWCA recommends that it is NOT ELIGIBLE for the NRHP.

Resource 2b is a detached, prefabricated metal garage with a gable roof, and vehicular access appears to be on the southeast elevation. No other details were visible from the ROW. As a prefabricated building, Resource 2b does not rise to the level of significance required for individual listing in the NRHP; therefore, SWCA recommends that it is NOT ELIGIBLE for the NRHP.

Resource 2 is located at 3651 117th Avenue SW, and the property contains two buildings visible from the public ROW as well as one object, a flagpole (Figure 4). The property is accessible from a private gravel driveway on the west side of 117th Avenue SW, and the terrain limits visibility for the property. Resource 2a is the primary dwelling, and Resource 2b is a detached garage. SCA records state that Resource 2a was constructed in 1975, and SWCA concurs with that date (SCA 2021).

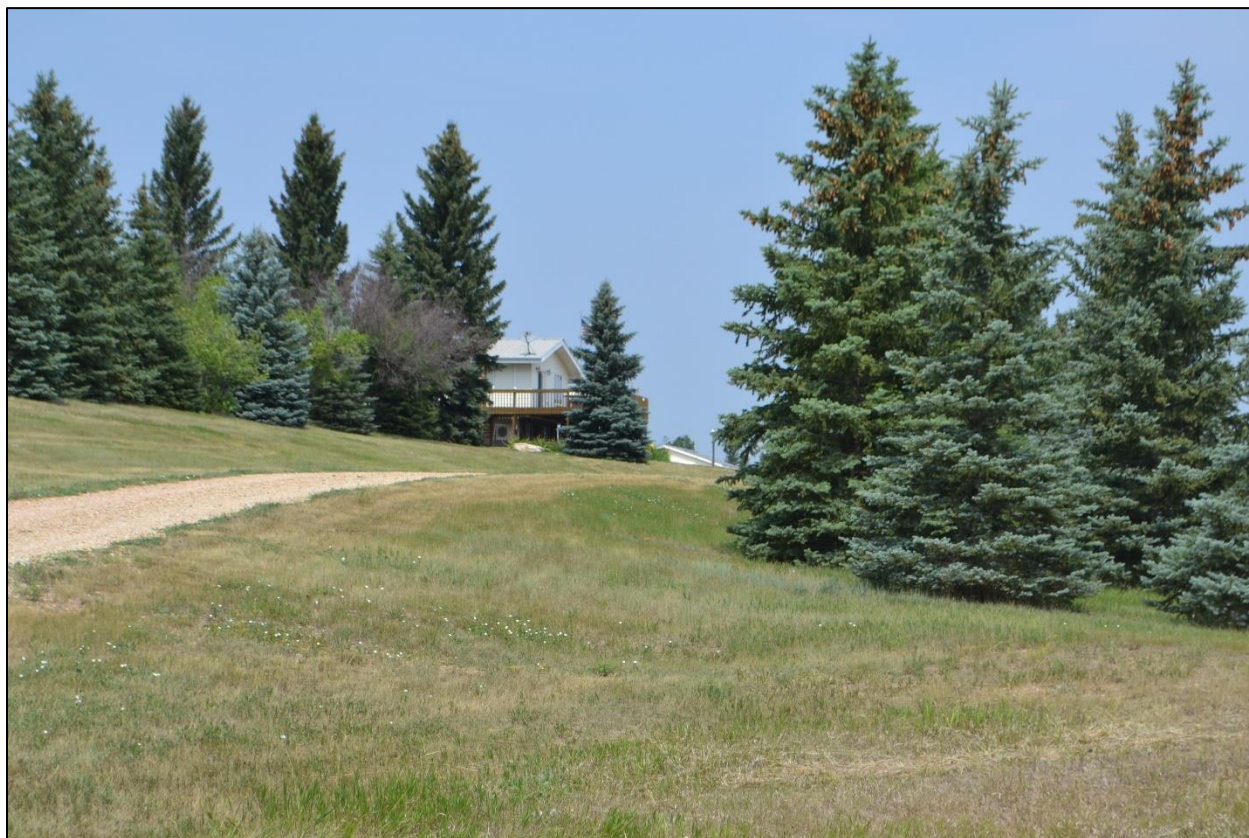
**Figure 5. From left, Resources 3a and 3b, facing north.** Photographed by SWCA (H. Curry), July 21, 2021; image has not been altered.

Resource 3a is a one-story dwelling facing east on its site with a raised basement foundation. The gable roof uses asphalt shingles, and there is a chimney located on the south elevation. The siding is horizontal plank siding, and there is a wood deck on the south and east elevations. Visible windows on the east (primary) elevation are triple-grouped single-light windows, and there is a single door on the east elevation. Resource 3a does not rise to the level of significance required for the individual listing in the NRHP; therefore, SWCA recommends that it is NOT ELIGIBLE for the NRHP.

Resource 3 is located at 11741 Highway 10, and the property contains two buildings visible from the ROW as well as one object, a flagpole (Figure 5). The property is accessible from a private gravel driveway on the north side of Highway 10, and the terrain limits visibility of the property from the ROW. Resource 3a is the primary dwelling, and Resource 3b is a secondary building described as a shop by SCA. SCA reports that Resource 3a was constructed in 1976, and SWCA concurs with that construction date (SCA 2021).

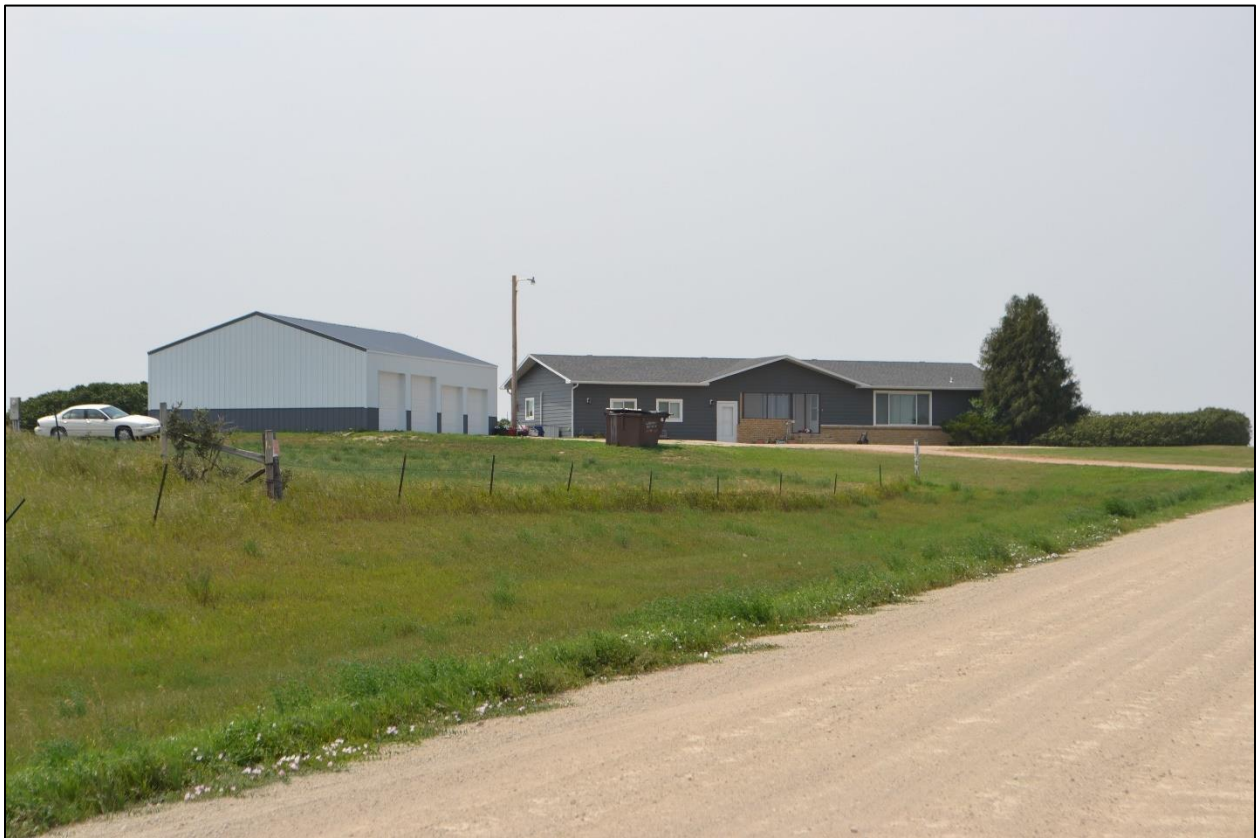
**Figure 6. From left, Resources 4b and 4a, facing west.** Photographed by SWCA (H. Curry), July 21, 2021; image has not been altered.

Resource 4a is a one-story house on a basement foundation with horizontal plank siding and thin stone wainscot facing northeast on its site. Typical windows are 1/1 sliding vinyl sash windows, and the gable roof uses asphalt shingles with a cross-gabled section over the primary entry. The northeast (primary) elevation is arranged in an AABCD pattern. Bays A are typical windows. Bay B is a single door with one large light, and Bay C is the primary entry. The entry is located under a raised portico with stone steps located under the roofline. The primary entry faces southeast and has a storm door obscuring additional details about the door unit. Bay D is a picture window with flanking side lights. Resource 4a does not rise to the level of significance required for individual listing in the NRHP; therefore, SWCA recommends that it is NOT ELIGIBLE for the NRHP.

Resource 4 is located at 11660 40th Avenue SW, and the property is accessible from a gravel driveway on the south side of the ROW (Figure 6). The property includes two buildings: Resource 4a is the primary dwelling and Resource 4b is a detached garage. SCA records report that Resource 4a was constructed in 1976, and SWCA concurs with that construction date (SCA 2021).

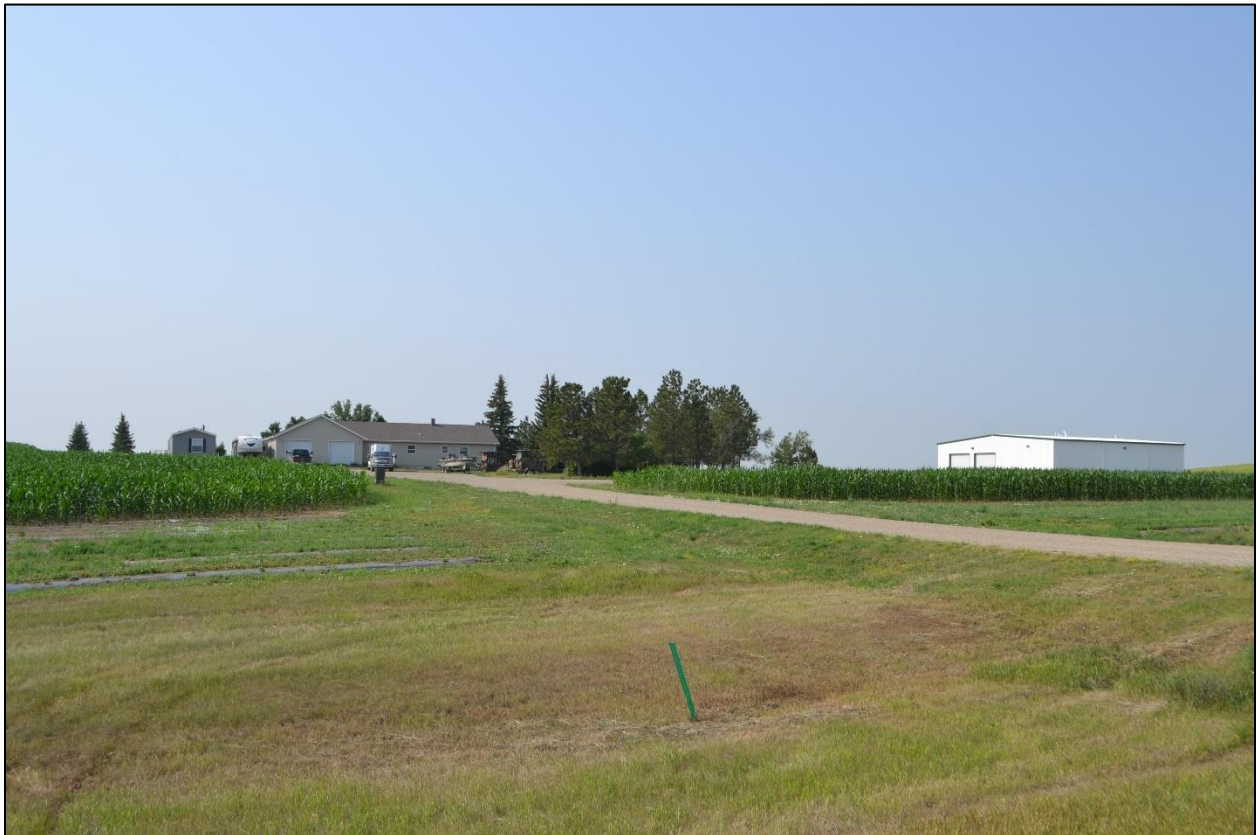
**Figure 7. From left, Resources 5b, 5a, and 5c, facing south.** Photographed by SWCA (H. Curry), July 21, 2021; image has not been altered.

Resource 5a is a Ranch-style residential building used for commercial purposes, and it faces north on its site. The L-plan building sits on a basement foundation, uses cementitious plank siding, and has a gabled asphalt shingle roof with a cross gable over the attached garage. There is a chimney on the ridgeline, and typical windows are 1/1 hung vinyl sash. The attached garage contains two personal vehicle bays, each

Resource 5 is located at 11660 Highway 10, and access comes from a gravel drive on the south side of the ROW (Figure 7). There are three buildings located at this resource, which functions as a commercial veterinarian clinic. Resource 5a is the primary building, 5b is a dwelling, and 5c is a detached garage. SCA dates Resource 5a to 1960; however, SWCA estimates the date is ca. 2000 (SCA 2021).

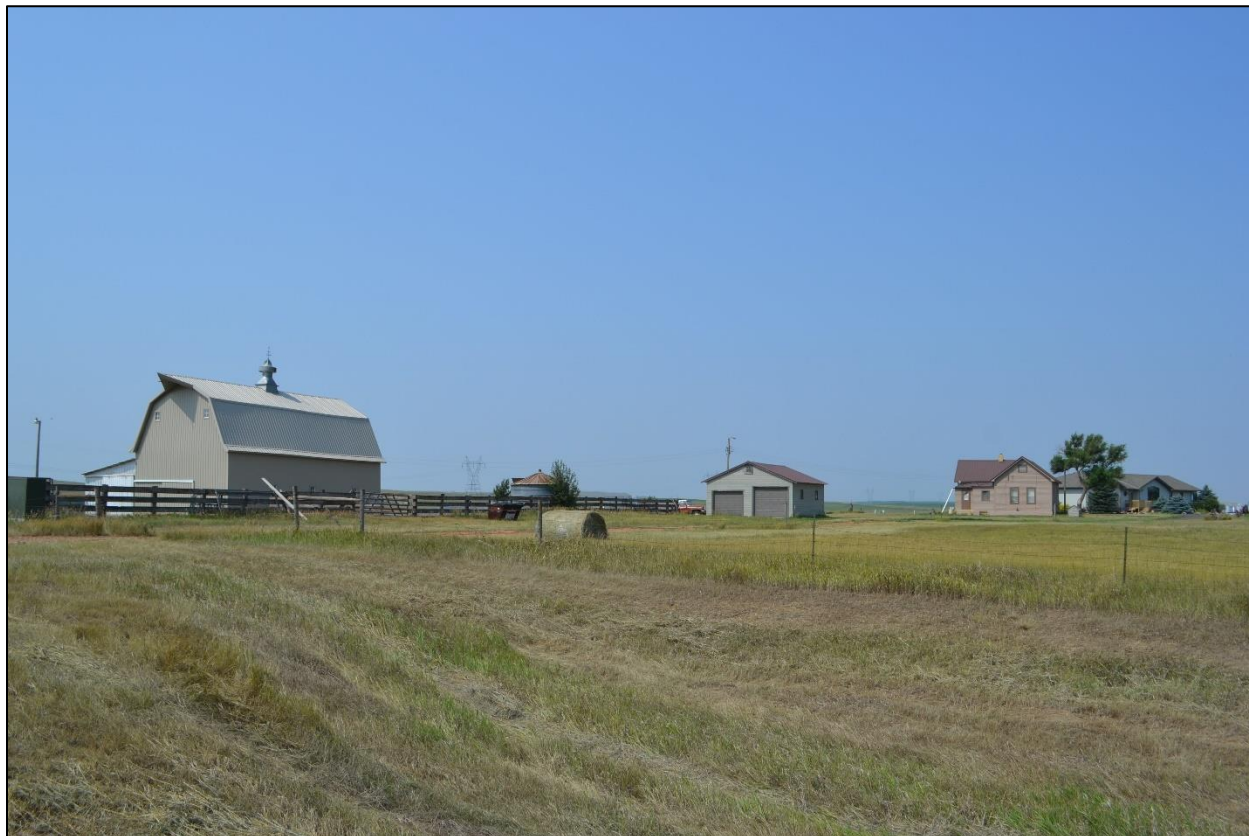
**Figure 8. From left, Resources 6f, 6h, 6e, 6a, and 6b, facing southwest.** Photographed by SWCA (H. Curry), July 22, 2021; image has not been altered.

Resource 6f is a two-story beef barn facing east on its site, and SWCA's analysis estimates that it was originally constructed in approximately 1925 as a contemporary of Resource 6a. The barn has a standing seam sheet metal gambrel roof with the original metal weathervane centered on the ridgeline, and the exterior uses standing seam metal cladding. There are 2/2 vinyl windows placed regularly on the north and east elevations. The east elevation also contains a one-leaf sliding door. A shed roof addition was constructed on the south elevation at an unknown date. The addition uses ribbed sheet metal for both the roofing and cladding, and it has a separate single-leaf sliding door on the east elevation. There are no other openings on the addition. Resource 6f has diminished integrity of materials and workmanship through the new sheet metal exterior and vinyl windows; therefore, SWCA recommends that it is NOT ELIGIBLE for the NRHP as an individual resource.

Resource 6 is located at 3911 116th Avenue SW, and the property contains 10 resources (Figures 8 and 9). Located at the southwest corner at the intersection of 116th Avenue SW and 39th Avenue SW, access to the property stems from a gravel and asphalt driveway on the property's east side. Resource 6a is the historic-age dwelling, 6b is the occupied dwelling, 6c is a garage, 6d is a shed, 6e is a garage, 6f is a barn, 6g is a doghouse, 6h is a cistern, 6i is a shed, and 6j is a stable. SWCA estimates that Resource 6a was constructed in approximately 1925 and that Resource 6b was constructed in approximately 1960. SCA does not provide construction dates for any resource on this property (SCA 2021).

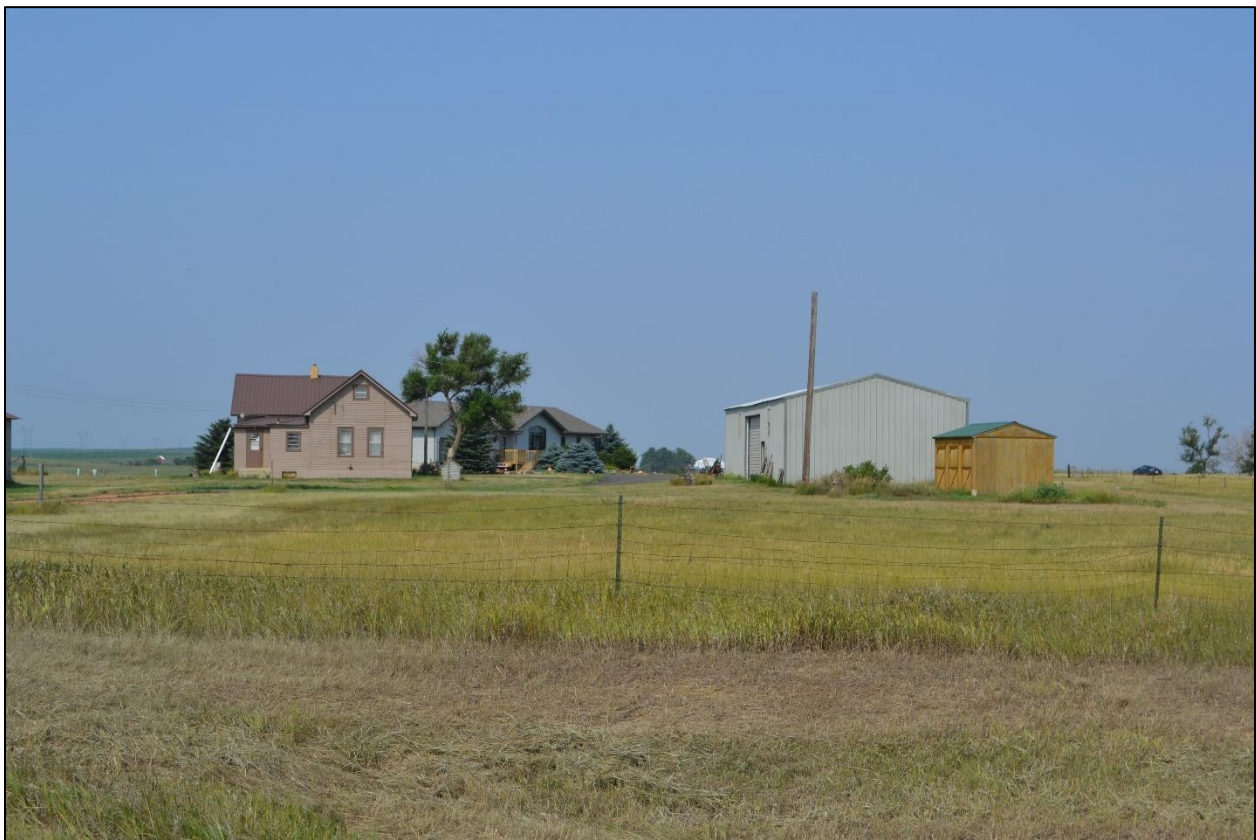
Resource 6c is a prefabricated metal-frame garage facing south on its site. The garage has a corrugated sheet metal gable roof and standing seam sheet metal cladding. There is a single rolling overhead door located on the south (primary) elevation, and there is a solid, sheet metal pedestrian door east of the overhead door. The collective entries are flanked by window openings that use translucent sheet metal panels to allow in some light. There are no other visible openings on this building. Resource 6b does not rise to the level of significance required for individual listing in the NRHP as a prefabricated building; therefore, SWCA recommends that it is NOT ELIGIBLE for the NRHP.

Resource 6d is a prefabricated wood-frame shed facing south on its site. The building has a gable roof with standing seam sheet metal and vertical wood plank siding. There are three regularly spaced Dutch doors located on the south elevation, and there are no other visible openings on this building. As a prefabricated building, Resource 6d lacks significance as an individual resource; therefore, SWCA recommends that it is NOT ELIGIBLE for the NRHP.

**Figure 9. From left, Resources 6a, 6g, 6b, 6c, and 6d, facing west.** Photographed by SWCA (H. Curry), July 22, 2021; image has not been altered.

Resource 6g is a wood-frame doghouse with a wood shingle gable roof. There are no visible openings on this object. Resource 6g does not rise to the level of significance required for individual listing in the NRHP; therefore, SWCA recommends that it is NOT ELIGIBLE for the NRHP.

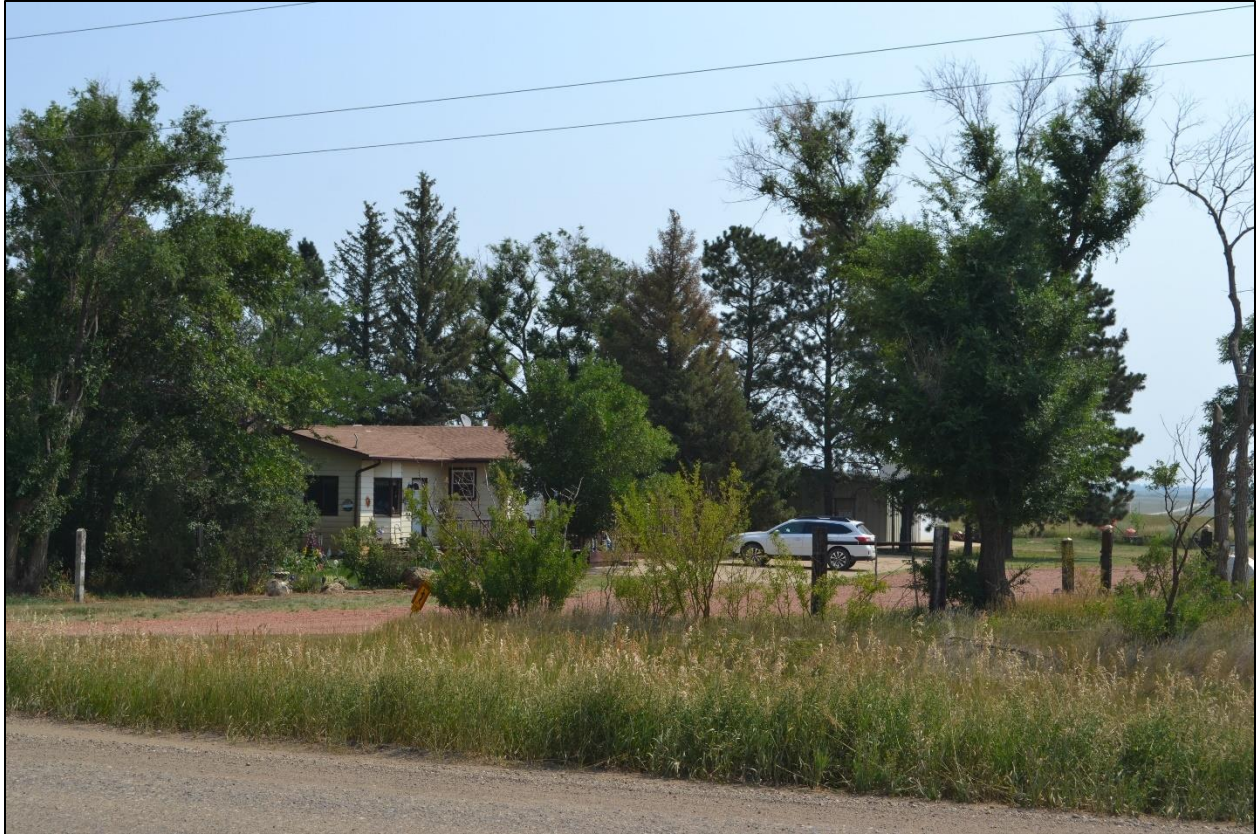
**Figure 10. From left, Resources 7a and 7b, facing northeast.** Photographed by SWCA (H. Curry), July 22, 2021; image has not been altered.

Resource 7a is a one-story house facing south on its site. The house has a gable roof with asphalt shingles and vinyl siding, and it sits on a basement foundation. There is a wood deck on the south elevation, and there is a chimney visible on the east elevation. Typical windows are 1/1 hung vinyl sash windows or single-light casement windows, and the entry contains a single wood-paneled door with a radial light in the upper quarter. Resource 7a does not exhibit any unique or precedent-setting architectural elements; therefore, SWCA recommends that it is NOT ELIGIBLE for the NRHP as an individual resource.

Resource 7 is located at 3910 116th Avenue SW at the southeast corner of 116th Avenue SW and 39th Avenue SW, and access to the property is from a gravel driveway on the east side of 116th Avenue SW (Figure 10). The property contains five buildings: Resource 7a is the primary dwelling, Resource 7b is a detached garage, Resource 7c is a shed, Resource 7d is a shed, and Resource 7e is a barn. SCA states that Resource 7a was constructed in 1962, and SWCA concurs with that date of construction (SCA 2021).

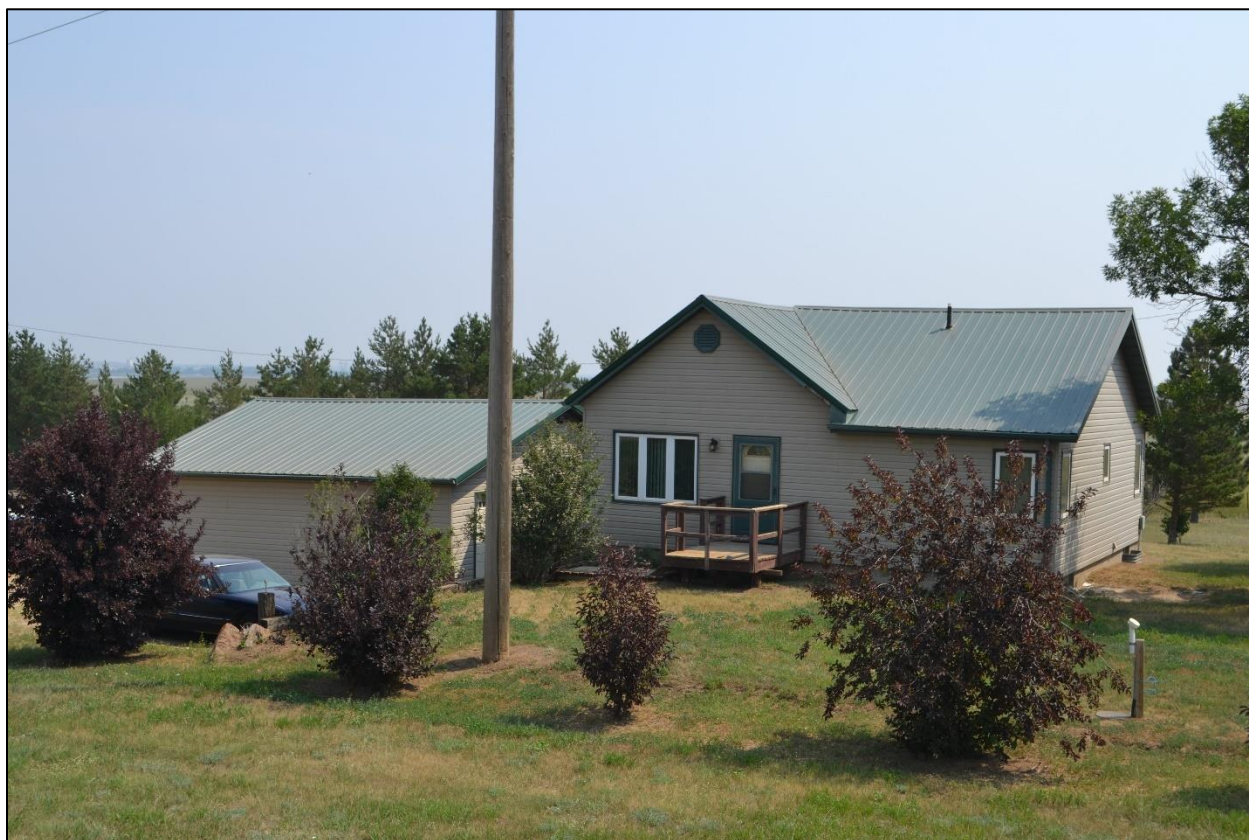
**Figure 11. From left, Resources 8c and 8a, facing east.** Photographed by SWCA (H. Curry), July 22, 2021; image has not been altered.

Resource 8a is a one-story house facing west on its site. The house has a standing seam sheet metal gable roof with a cross gable over the entries and vinyl siding, and it sits on a basement foundation constructed from concrete masonry units. Typical windows on this resource are single-light vinyl casement windows.

Resource 8 is located at 3990 116th Avenue SW, and access comes from a gravel driveway on the east side of 116th Avenue SW. The property contains four buildings. Resource 8a is the primary dwelling, 8b is a shed, 8c is the detached garage, and 8d is a wellhouse (Figure 11). SCA dates Resource 8a to 1960, and SWCA concurs with that date (SCA 2021).

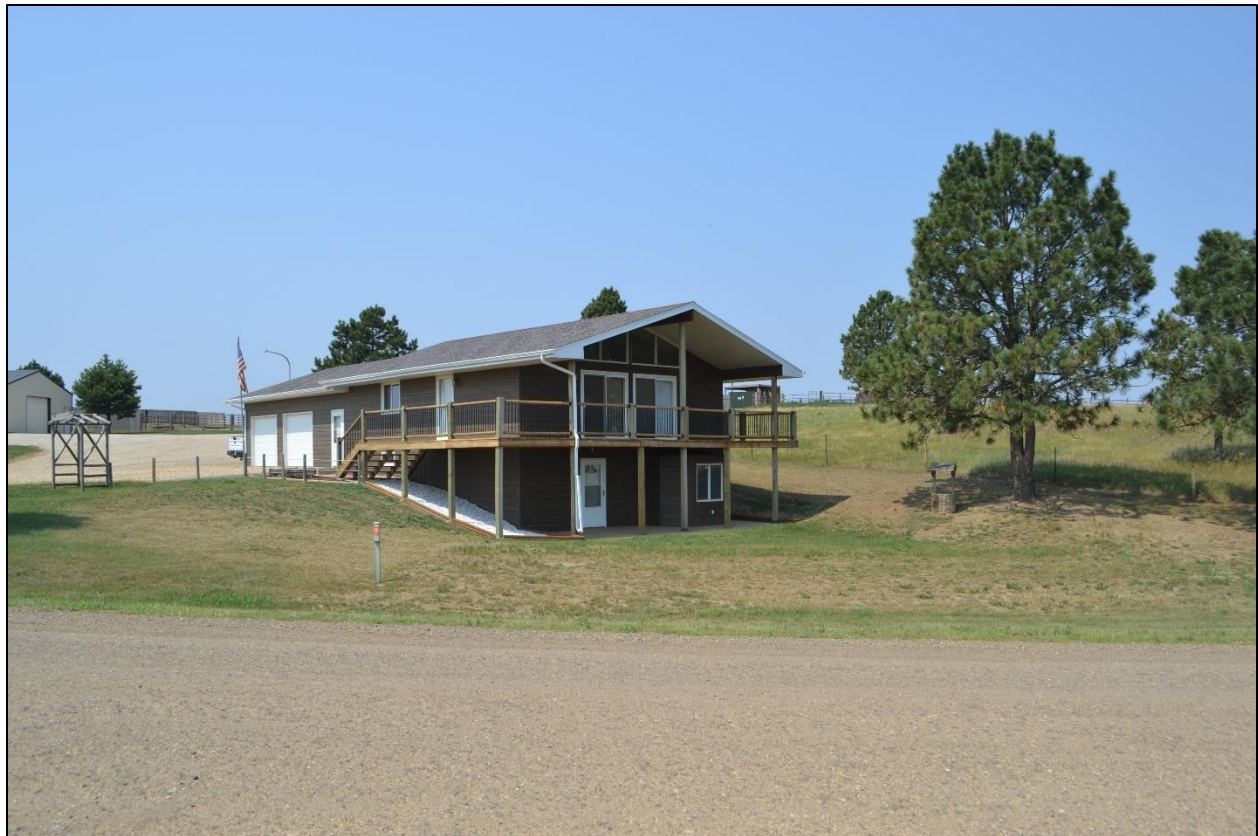
**Figure 12. From left, Resources 9c, 9a, 9g (rear), and 9b, facing west.** Photographed by SWCA (H. Curry), July 22, 2021; image has not been altered.

Resource 9a is a two-story house with Modernist influences facing northeast on its site. The building has a asphalt shingle gable roof, vinyl siding, and a basement foundation. Typical windows are 1/1 sliding vinyl sash. The southeast (primary) elevation is arranged in an AABCB pattern. Bays A are paneled overhead doors to the attached garage, each large enough for a single personal vehicle. Bays B are single entry doors, each with one light in the upper half; the first provides access to the attached garage, and the second is the primary entrance to the house. Bay C is typical window. The first floor has a tertiary entrance containing a paneled door with a radial light in the upper quarter and a storm door as well as a typical window. The second floor has two sets of paired sliding doors with triangular transoms in the gable above to provide the Modernist detailing. There is a two-story wood-frame porch spanning the northeast elevation and wrapping around to the southeast to meet the terrain. The second-floor porch is accessible on the exterior from a double-width flight of stairs, and it is protected with a wood-frame railing with simple metal balusters. Resource 9a does not exhibit any unique or precedent-setting architectural elements, and the vinyl windows indicate that alterations to the building exterior have occurred since its construction in 1974. Resource 9a does not rise to the level of significance required for individual listing in the NRHP; therefore, SWCA recommends that it is NOT ELIGIBLE for the NRHP.

Resource 9b is a well. This structure has a conical wall made from thin brick units, and the ends of each brick were left exposed to create a woven coursework pattern. There is also a wood-frame gable roof above the opening to protect the well from falling debris, and the roof uses asphalt shingles. Resource 9b does not exhibit any unique or precedent-setting architectural elements, and it does not rise to the level of significance required for individual listing in the NRHP; therefore, SWCA recommends that it is NOT ELIGIBLE for the NRHP.

Resource 9 is located at 4011 116th Avenue SW, and access comes from a gravel driveway located on the west side of the ROW. The property consists of seven buildings and structures, and there is one additional object, a flagpole. Resource 9a is the primary dwelling, Resource 9b is a well, Resource 9c is a garage, Resource 9d is a barn, Resource 9e is a stable, Resource 9f is a stable, and Resource 9g is an animal shelter (Figures 12 and 13). SCA dates Resource 9a to 1974, and SWCA concurs with that date (SCA 2021).

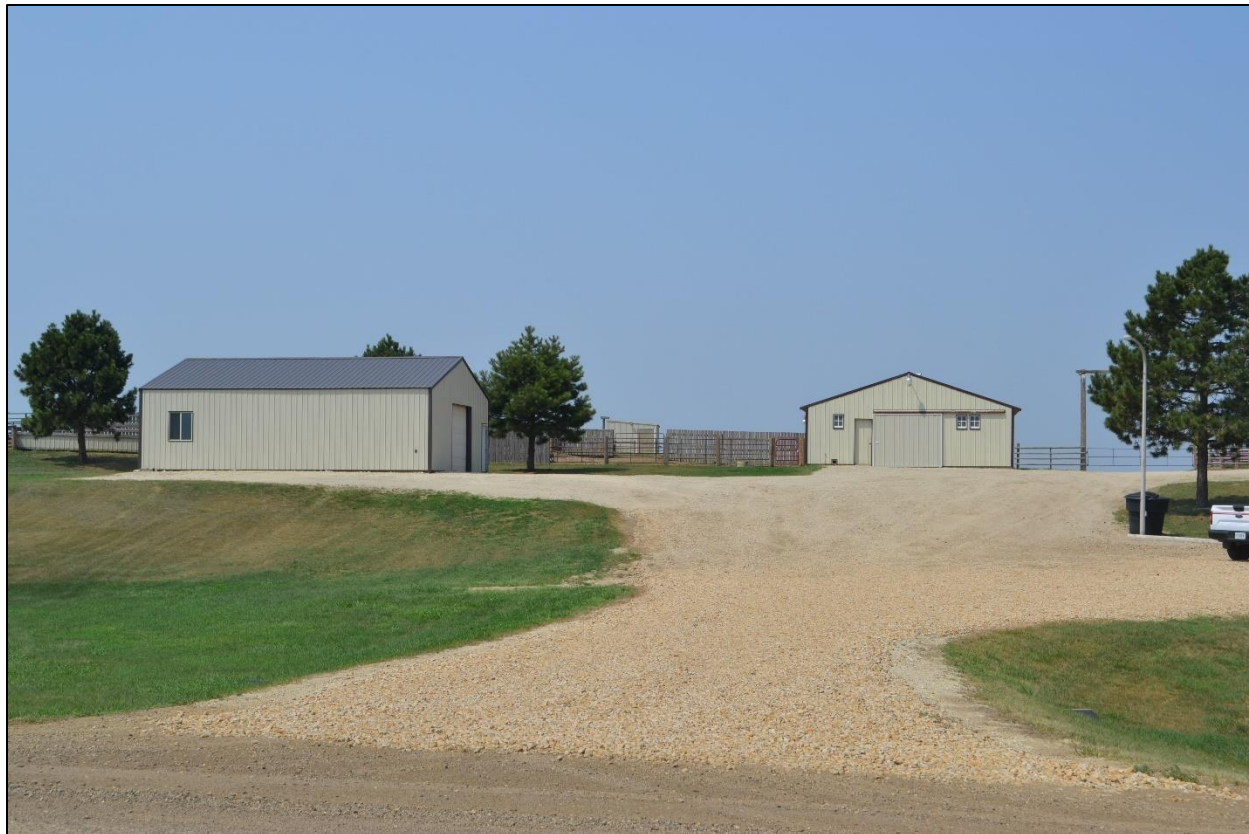
**Figure 13. From left, Resources 9c, 9f, and 9d, facing west.** Photographed by SWCA (H. Curry), July 22, 2021; image has not been altered.

Resource 9c is a one-story prefabricated metal-frame detached garage facing north on its site. The building has a gable roof, and it uses contrasting colors of standing seam sheet metal for both the roof and exterior cladding. There is a single 1/1 sliding sash window on the east elevation, and the north (primary) elevation has one rolling overhead door for a single commercial vehicle and a single pedestrian door with no lights. There are no other openings visible on Resource 9c. As a prefabricated building, it does not rise to the level of significance required for individual listing in the NRHP; therefore, SWCA recommends that it is NOT ELIGIBLE for the NRHP.

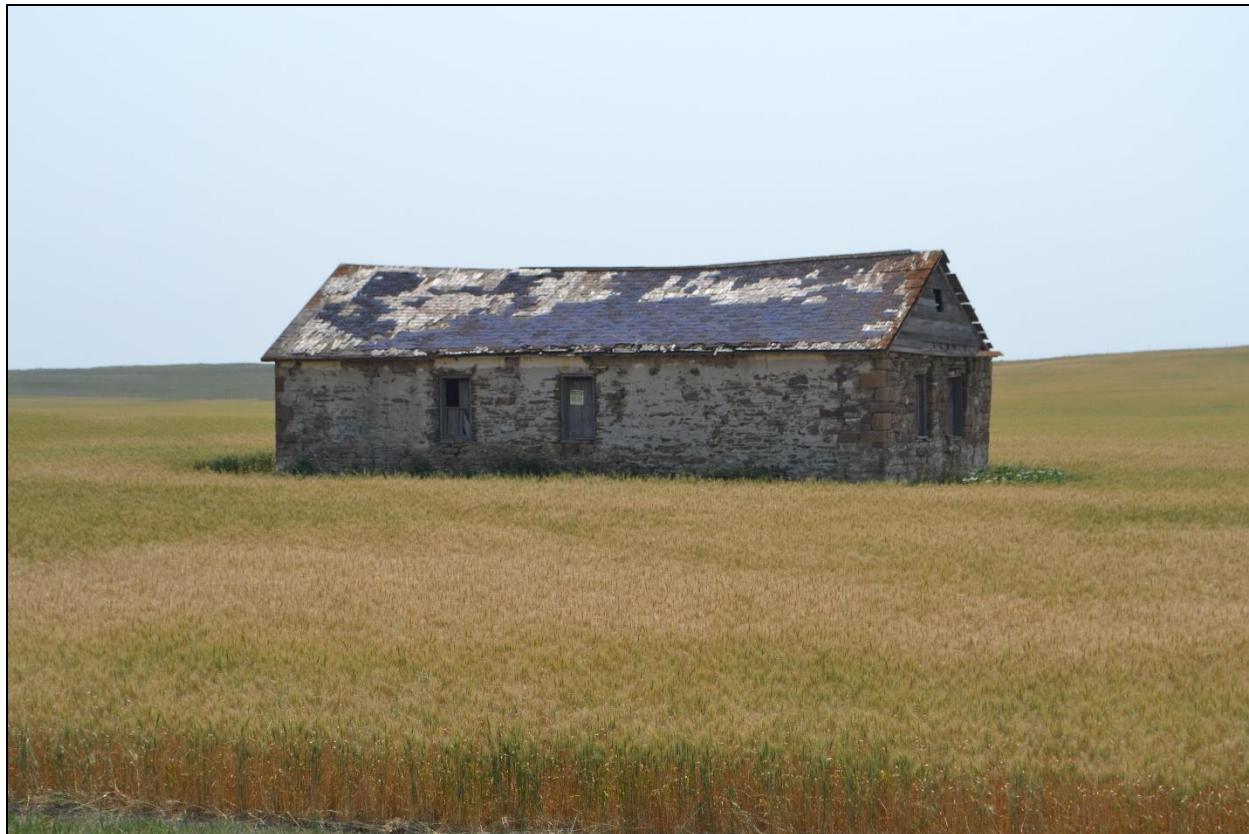
**Figure 15. Resource 10a, facing southwest.** Photographed by SWCA (H. Curry), July 22, 2021; image has not been altered.

Resource 10a is a one-story random rubble structural masonry house facing north on its site. The building has a gable roof with wood singles exposed under deteriorating tar paper, and there is evidence the masonry originally was covered in plaster or stucco. Openings include wood hung sash windows on the east and west elevations, and two no-light wood doors on the north elevation. Although its condition is poor, Resource 10a retains integrity of materials, design, workmanship, location, setting, and feeling. SWCA recommends that Resource 10a is ELIGIBLE for the NRHP under Criterion A at the local level of significance in the areas of agriculture and settlement and under Criterion C at the local level of significance in the area of architecture as a surviving example of nineteenth-century settlement housing.

Figure 15. Resource 10a, facing southwest. Photographed by SWCA (H. Curry), July 22, 2021; image has not been altered. .... 25

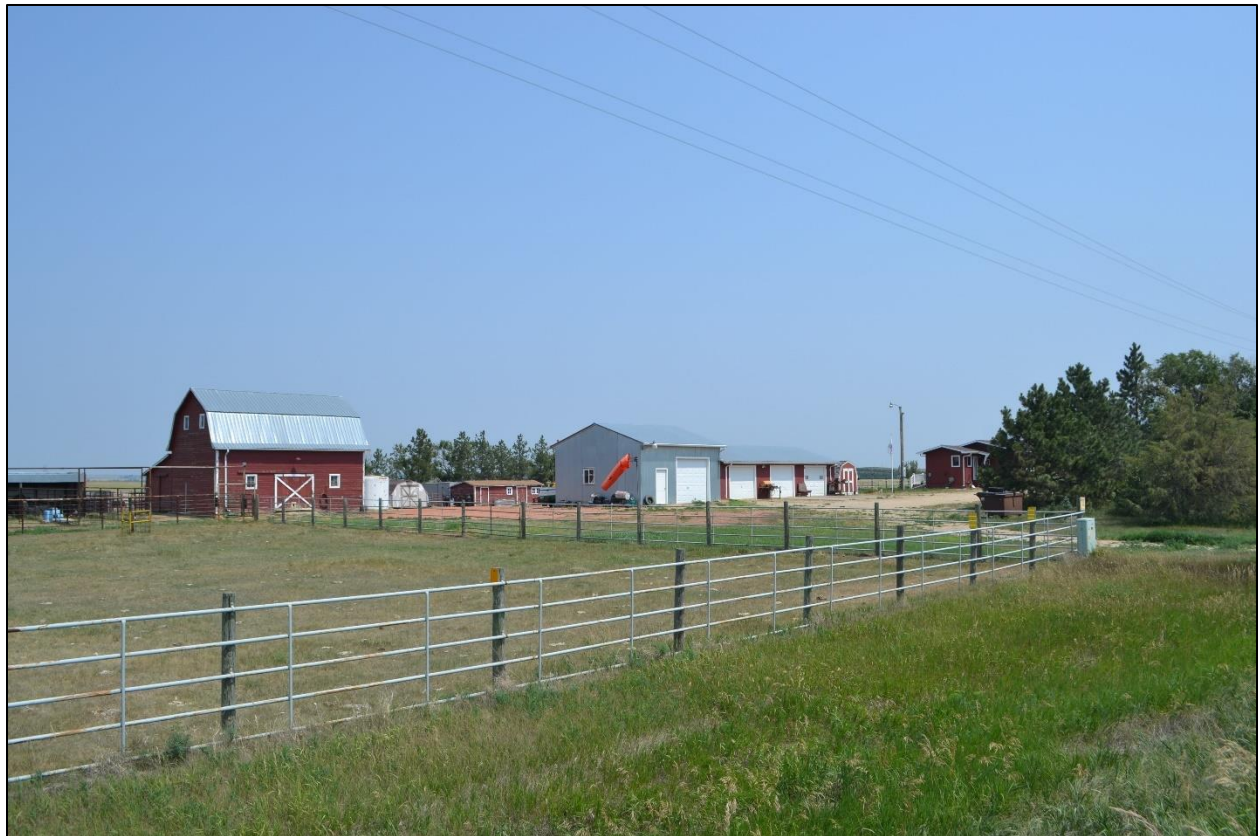
**Figure 16. From left, Resources 10f, 10e, 10g, 10h, 10i, 10j, 10d, 10c, and 10b, facing northeast.** Photographed by SWCA (H. Curry), July 22, 2021; image has not been altered.

Resource 10d is a detached garage facing south on its site. The building has a two-level corrugated sheet metal gable roof and two colors of vertical corrugated sheet metal siding and sits at grade. The garage has four overhead panel doors on the south (primary) elevation, one large enough for a single commercial vehicle and the others for individual personal vehicles. There is also a solid pedestrian door on the south elevation and a 1/1 sliding vinyl sash window on the west elevation; however, there are no other visible openings. Resource 10d does not rise to the level of significance required for individual listing in the NRHP; therefore, SWCA recommends that it is NOT ELIGIBLE for the NRHP.

Figure 16. From left, Resources 10f, 10e, 10g, 10h, 10i, 10j, 10d, 10c, and 10b, facing northeast. Photographed by SWCA (H. Curry), July 22, 2021; image has not been altered..... 26

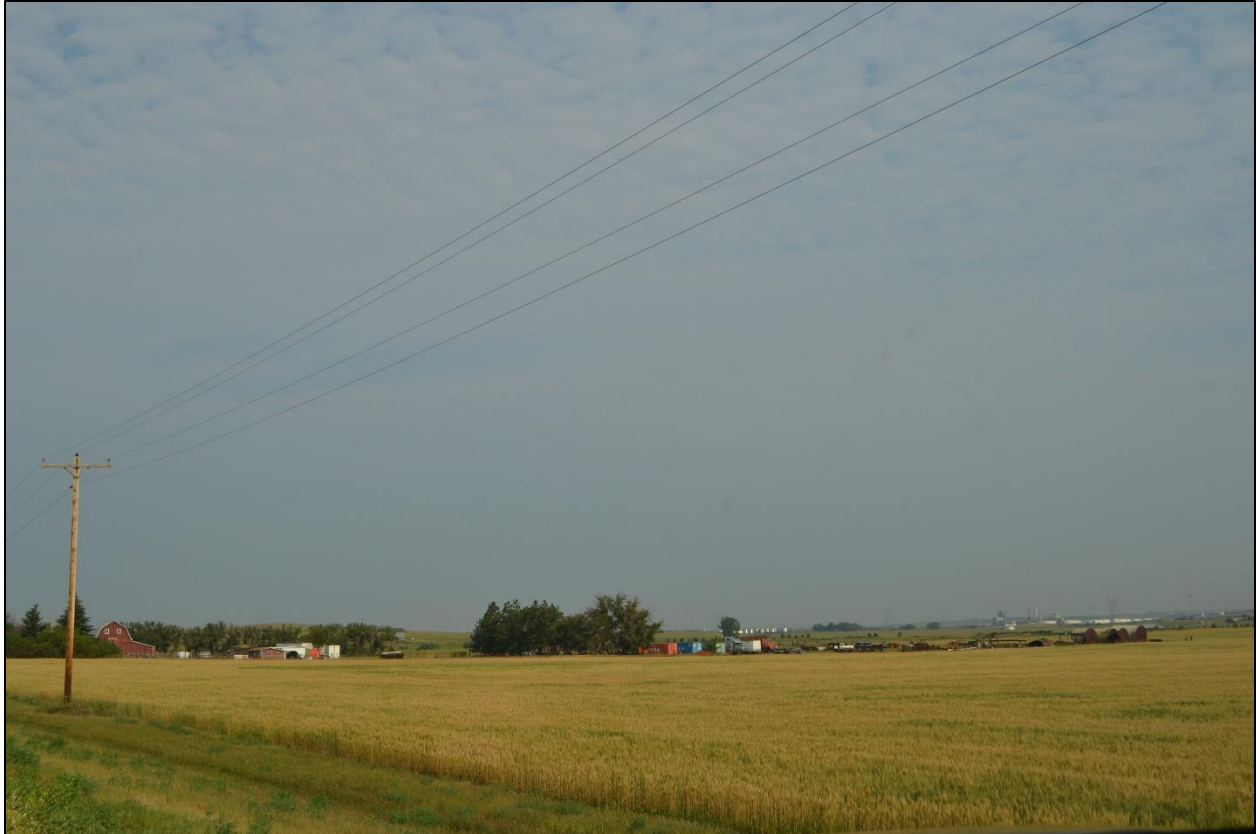
**Figure 17. The proposed project from Resource 10, facing northwest. Industrial components are already visible from the right-of-way, and new wind turbines will not adversely affect integrity of setting. Resource 10e is visible at left.** Photographed by SWCA (H. Curry), July 23, 2021; image has not been altered.

Figure 17. The proposed project from Resource 10, facing northwest. Industrial components are already visible from the right-of-way, and new wind turbines will not adversely affect integrity of setting. Resource 10e is visible at left. Photographed by SWCA (H. Curry), July 23, 2021; image has not been altered. .... 28

Although SWCA recommends that Resource 10 is ELIGIBLE, SWCA also recommends that the proposed project will have NO ADVERSE EFFECT. SWCA took pictures from the ROW in front of Resource 10 toward the project. Industrial components associated with the railyard and the Marathon Refinery are already visible from the ROW, and new wind turbines will not further diminish integrity of setting (Figure 17). Additionally, a windbreak along the west obscures the industrial components from the viewshed of the contributing resources, which are clustered at the west side of the resource (Figure 18).

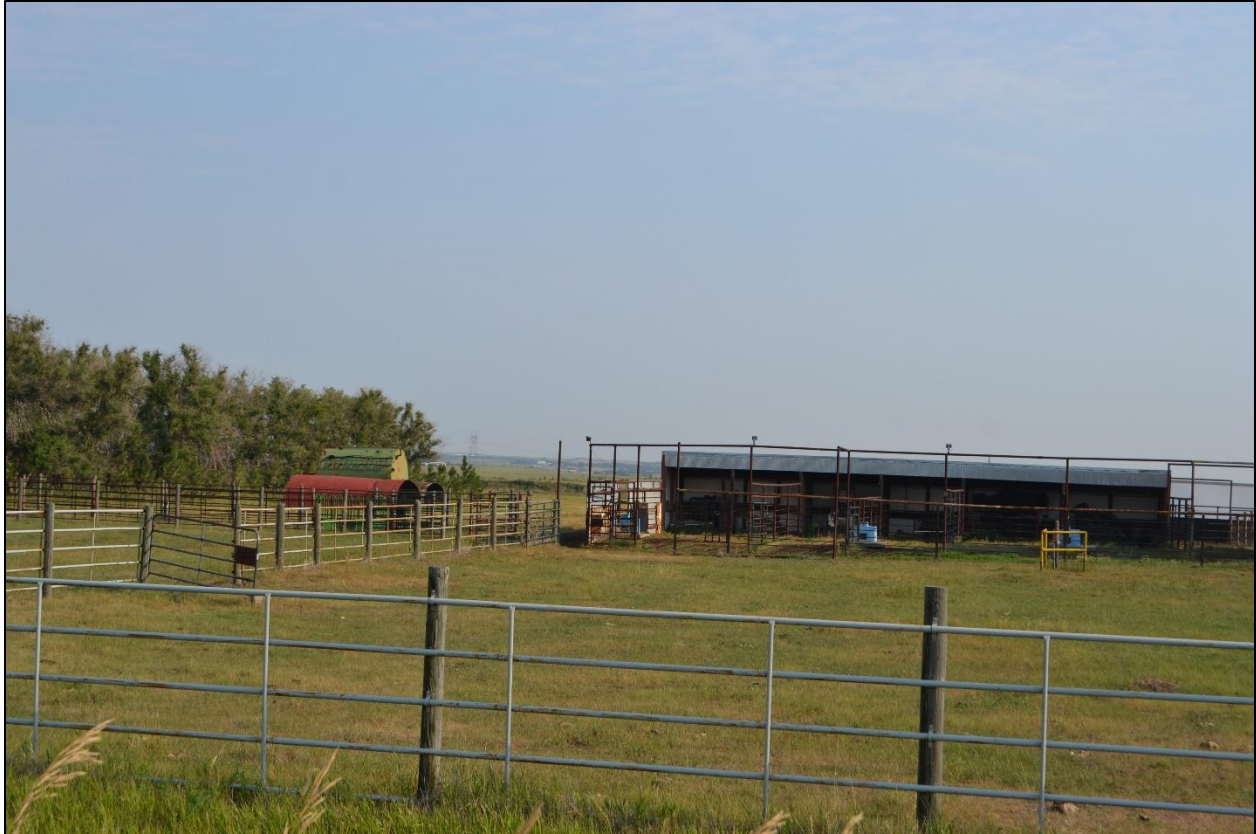
**Figure 18. Windbreak and Resource 10f, facing northwest. The windbreak along the west side of Resource 10 further obscures the view of industrial structures and will ensure that there is no adverse effect on the contributing resources.** Photographed by SWCA (H. Curry), July 23, 2021; image has not been altered.

Figure 18. Windbreak and Resource 10f, facing northwest. The windbreak along the west side of Resource 10 further obscures the view of industrial structures and will ensure that there is no adverse effect on the contributing resources. Photographed by SWCA (H. Curry), July 23, 2021; image has not been altered. .... 29
