# Visual Impacts Assessment for the Dickinson Renewable Diesel Facility Wind Turbine Project, Stark County, North Dakota

**VISUAL IMPACTS ASSESSMENT FOR THE DICKINSON  
RENEWABLE DIESEL FACILITY WIND TURBINE PROJECT,  
STARK COUNTY, NORTH DAKOTA**

SWCA Project No. 67406

SWCA Cultural Resources Report No. 21-431

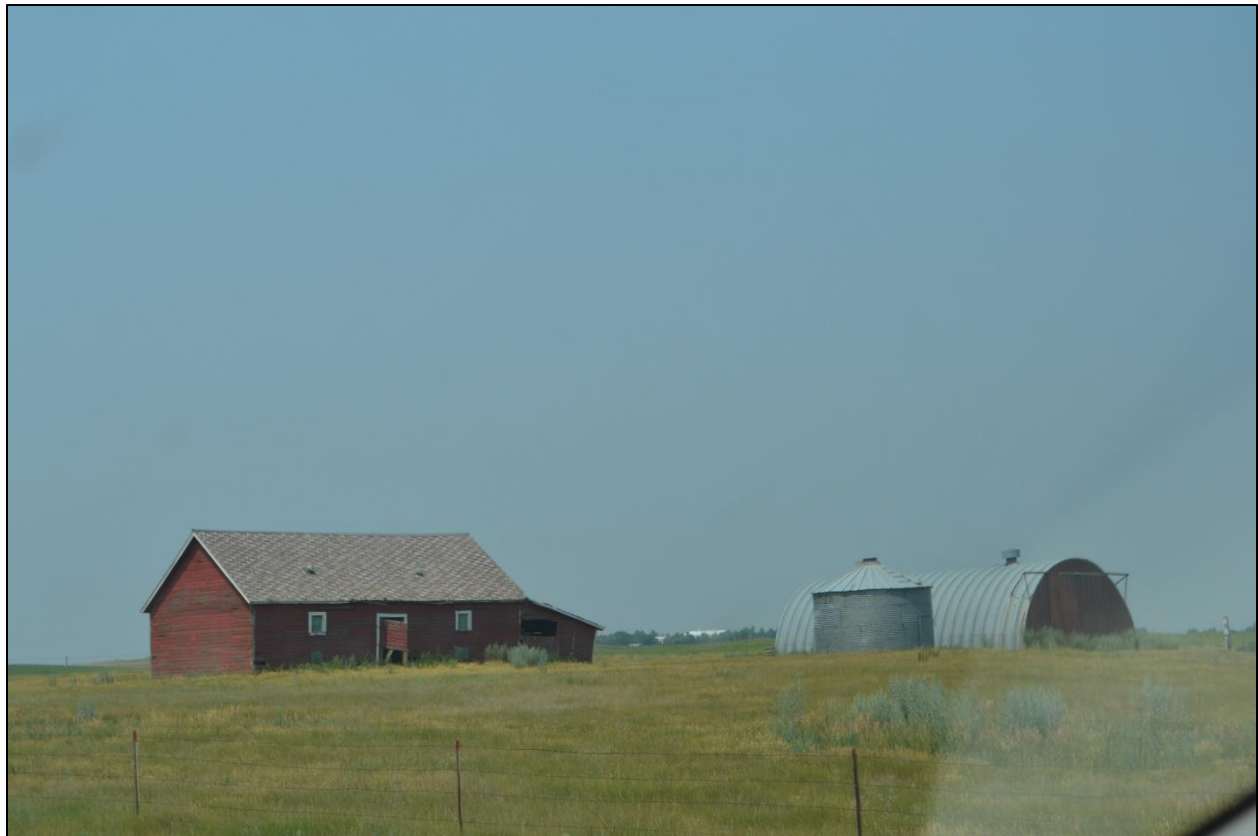
**Figure 19. From left, Resources 11a, 11b, and 11c, facing northwest.** Photographed by SWCA (H. Curry), July 22, 2021; image has not been altered.

Resource 11a is a one-story building facing east on its site. The original design includes an asphalt-shingle gable roof and horizontal wood siding, and it sits at grade. The east (primary) elevation has two wood-frame window openings enclosed at an unknown date, and they flank a single board and batten door with no lights. There are also three wood-frame window openings on the west (rear) elevation; however, there is no information about the style of window used. There is also a shed roof addition on the north elevation that has no visible openings. Based on the addition, SWCA's analysis concludes that Resource 11a was constructed as a barn or animal shelter that now lacks the primary residential structure, diminishing its integrity of setting and association. Resource 11a additionally does not display any unique or precedent-setting architectural elements and does not rise to the level of significance required for individual listing in the NRHP. As a result, SWCA recommends that Resource 11a is NOT ELIGIBLE for the NRHP as an individual resource.

Resource 11b is a prefabricated metal cistern. The cylindrical structure uses horizontal corrugated sheet metal cladding and a standing seam sheet metal conical roof. As a prefabricated structure, it does not rise to the level of significance required for individual listing in the NRHP; therefore, SWCA recommends that it is NOT ELIGIBLE for the NRHP.

Resource 11c is a metal-frame Quonset hut-style garage. The entire building is clad in ribbed sheet metal panels, and the only opening is on the east elevation. The opening contains paired single-leaf sliding doors made from the same ribbed sheet metal. Resource 11c does not exhibit any unique or precedent-setting architectural elements, and it does not rise to the level of significance required for individual listing in the NRHP. As a result, SWCA recommends that it is NOT ELIGIBLE for the NRHP as an individual resource.

Figure 19. From left, Resources 11a, 11b, and 11c, facing northwest. Photographed by SWCA (H. Curry), July 22, 2021; image has not been altered..... 30
