Document Details	
Lead Document	CR Exhibit 57 - Informal Conference Exhibit 220908 Amended Inspection Report.pdf
Lead Document Page Count	5
File Copy	View Document
This link is active for 30 days. If the link above is not accessible, copy this URL into your browser's address bar to view the document:

Public Service Commission

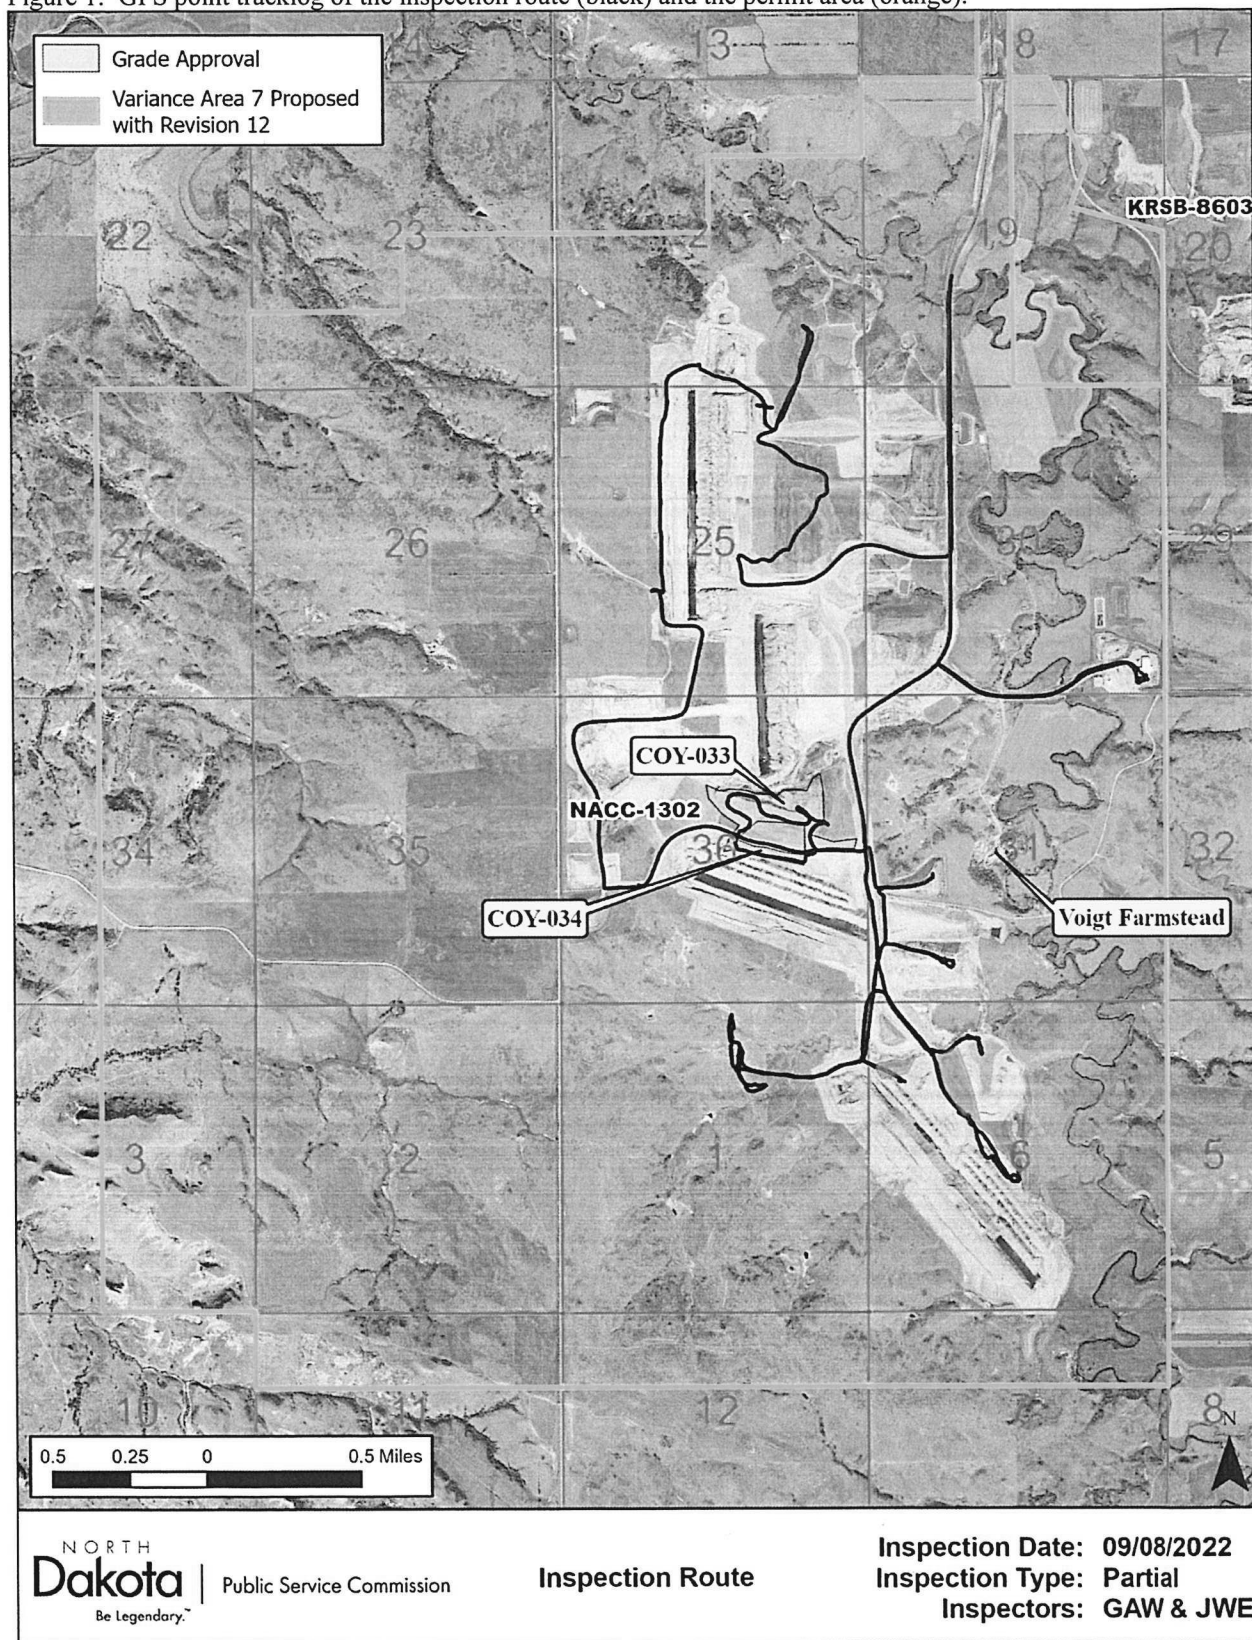
Figure 1: GPS point tracklog of the inspection route (black) and the permit area (orange).

A GPS tracklog of the route traveled is on file with the Reclamation Division as are photographs taken. A map showing the main body of Permit NACC-1302 and the route traveled is depicted in Figure 1. Figure 1 depicts the location of proposed Variance Area No. 7 and grade approval requests — COY-033 and COY-034.
