INSPECTION REPORT

PERMITTEE - MINE: Coyote Creek Mining Company, LLC - Coyote Creek Mine

PERMITS INSPECTED: NACC-1302

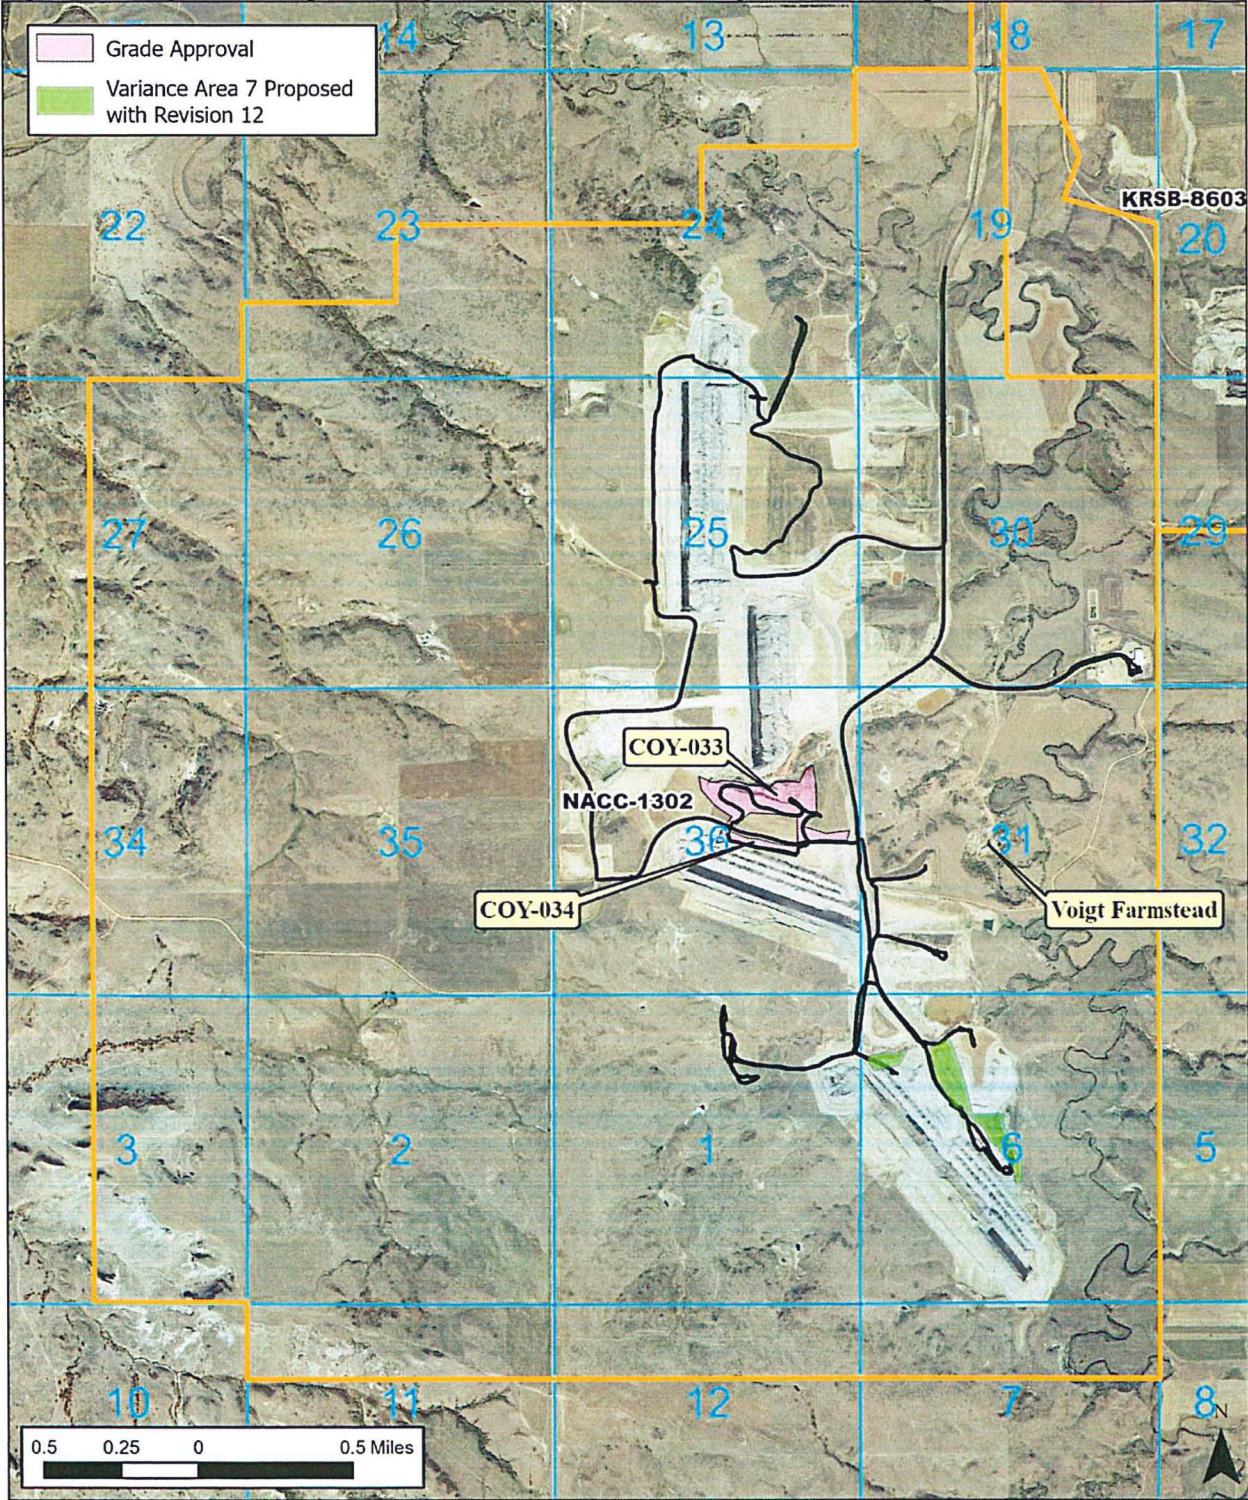
Figure 1: GPS point tracklog of the inspection route (black) and the permit area (orange).

A GPS tracklog of the route traveled is on file with the Reclamation Division as are photographs taken. A map showing the main body of Permit NACC-1302 and the route traveled is depicted in Figure 1. Figure 1 depicts the location of proposed Variance Area No. 7 and grade approval requests — COY-033 and COY-034.
