Public Service Commission State of North Dakota

The Reclamation Division has reviewed your concerns regarding your land located in the NW $\frac{1}{4}$ of Section 34, T146N, R88W, as outlined in your May 4, 2018 email. Your property is located off-permit and adjacent to Surface Coal Mining Permit NACT-9501 at the Coteau Properties Freedom Mine.

Attachments: 1) Pre-Mine Topography, Landuse, & Imagery above NW¼, T146N, R88W
2) Post-Mine Topography, Landuse, & Imagery above NW¼, T146N, R88W
3) Table 3 of Section 2.2.5, PHC, Revision 30 to Permit NACT-9501
4) Results of the Reclamation Division modeling & map
5) April 26, 2018 Inspection Report

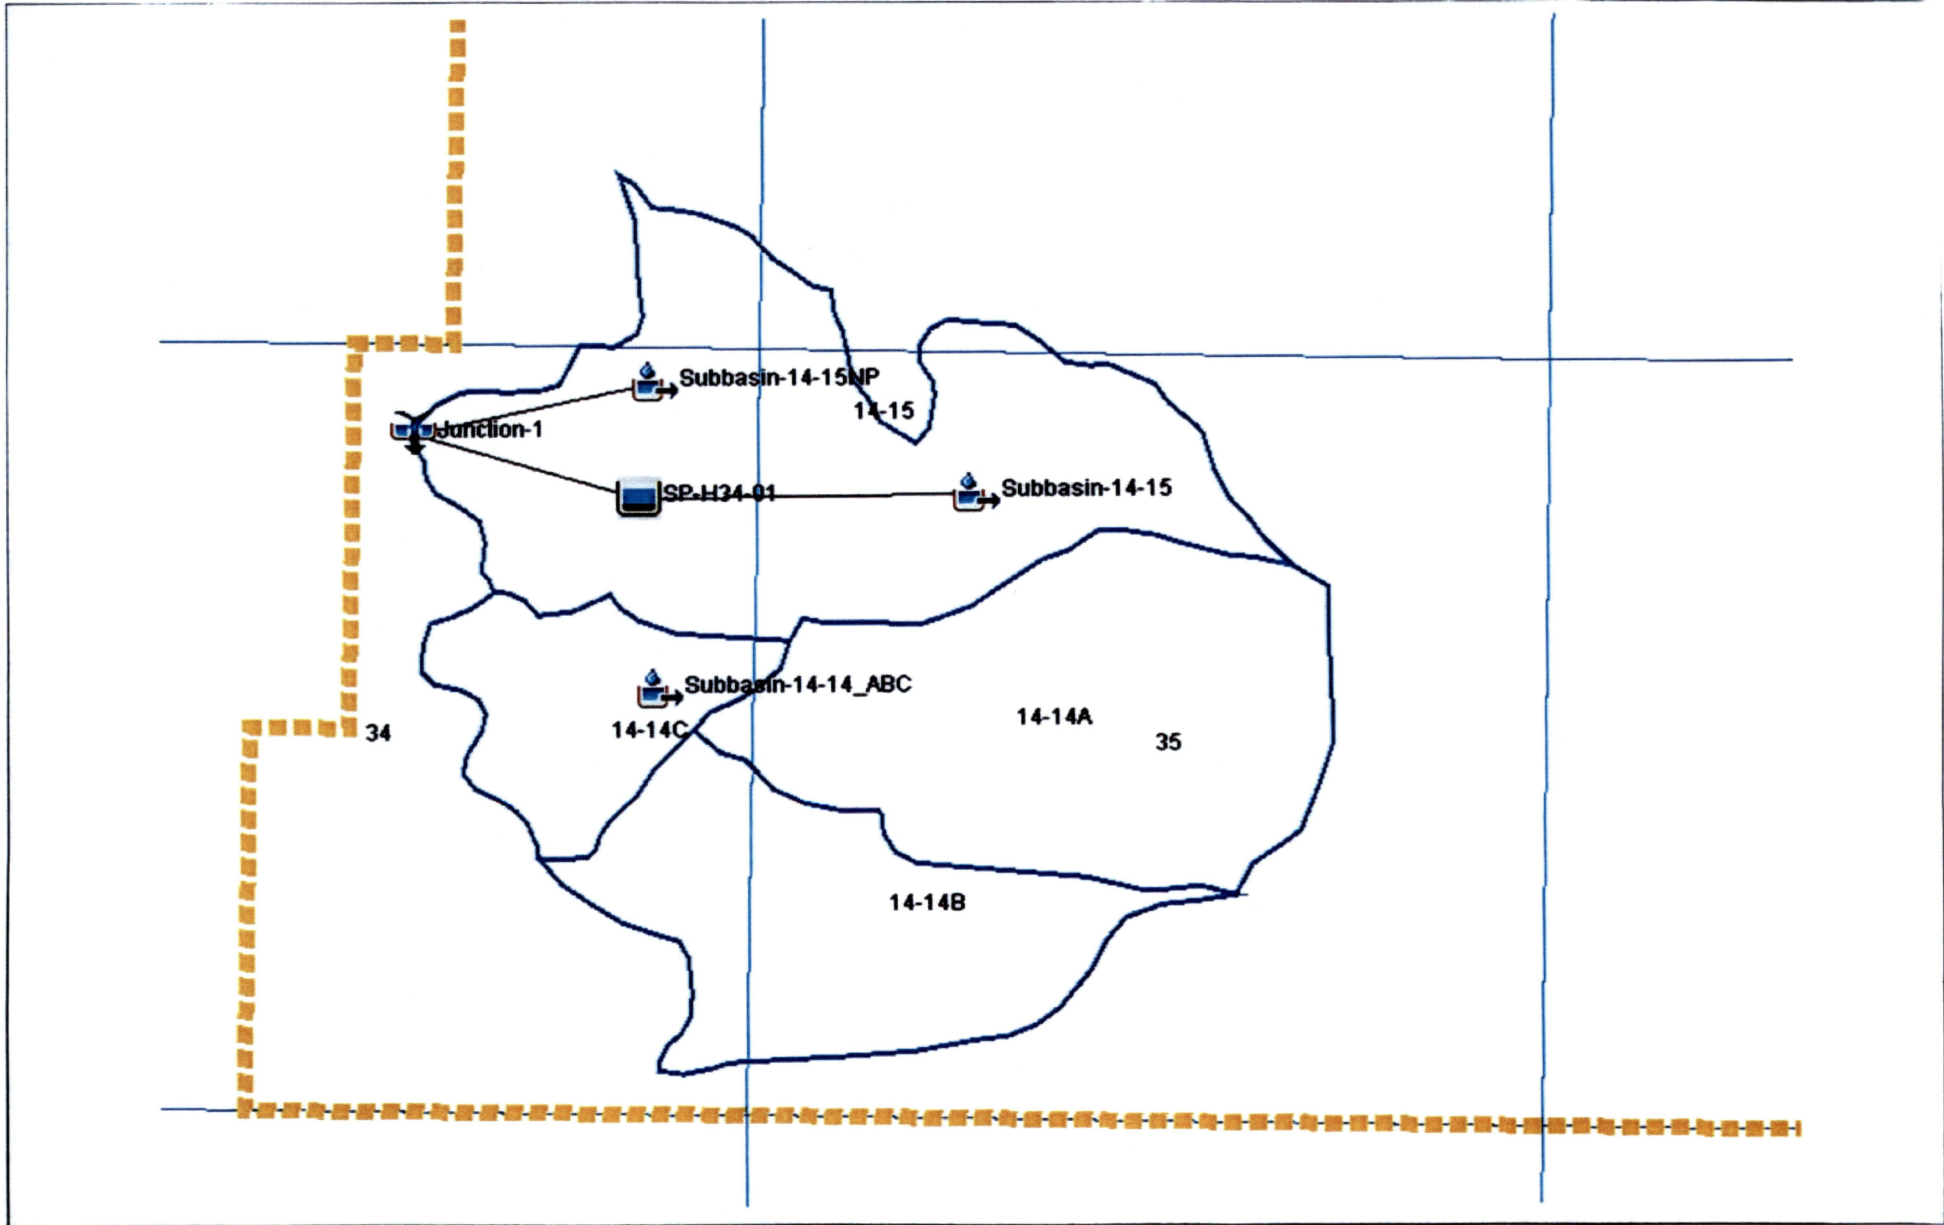
Project: Eisenbeis PostMine2 Simulation Run: Run 10-24

Hydrologic Element	Drainage Area (MI ²)	Peak Discharge (CFS)	Time of Peak	Volume (AC-FT)
Subbasin-14-14_ABC	0.44	103.8	26Jun2018, 20:45	17.1
Subbasin-14-15	0.28	40.8	26Jun2018, 21:45	10.7
SP-H34-01	0.28	43.2	26Jun2018, 21:45	9.0
Subbasin-14-15NP	0.05	18.6	26Jun2018, 20:15	2.0
Junction-1	0.33	45.7	26Jun2018, 21:45	10.9
