658 PU-06-421 Filed: 7/7/2009 Pages: 6
Keystone Independent North Spread Reports for June 2009

PSC CASE NUMBER: PU-06-421

DAILY REPORT

Job Site: North SPREAD

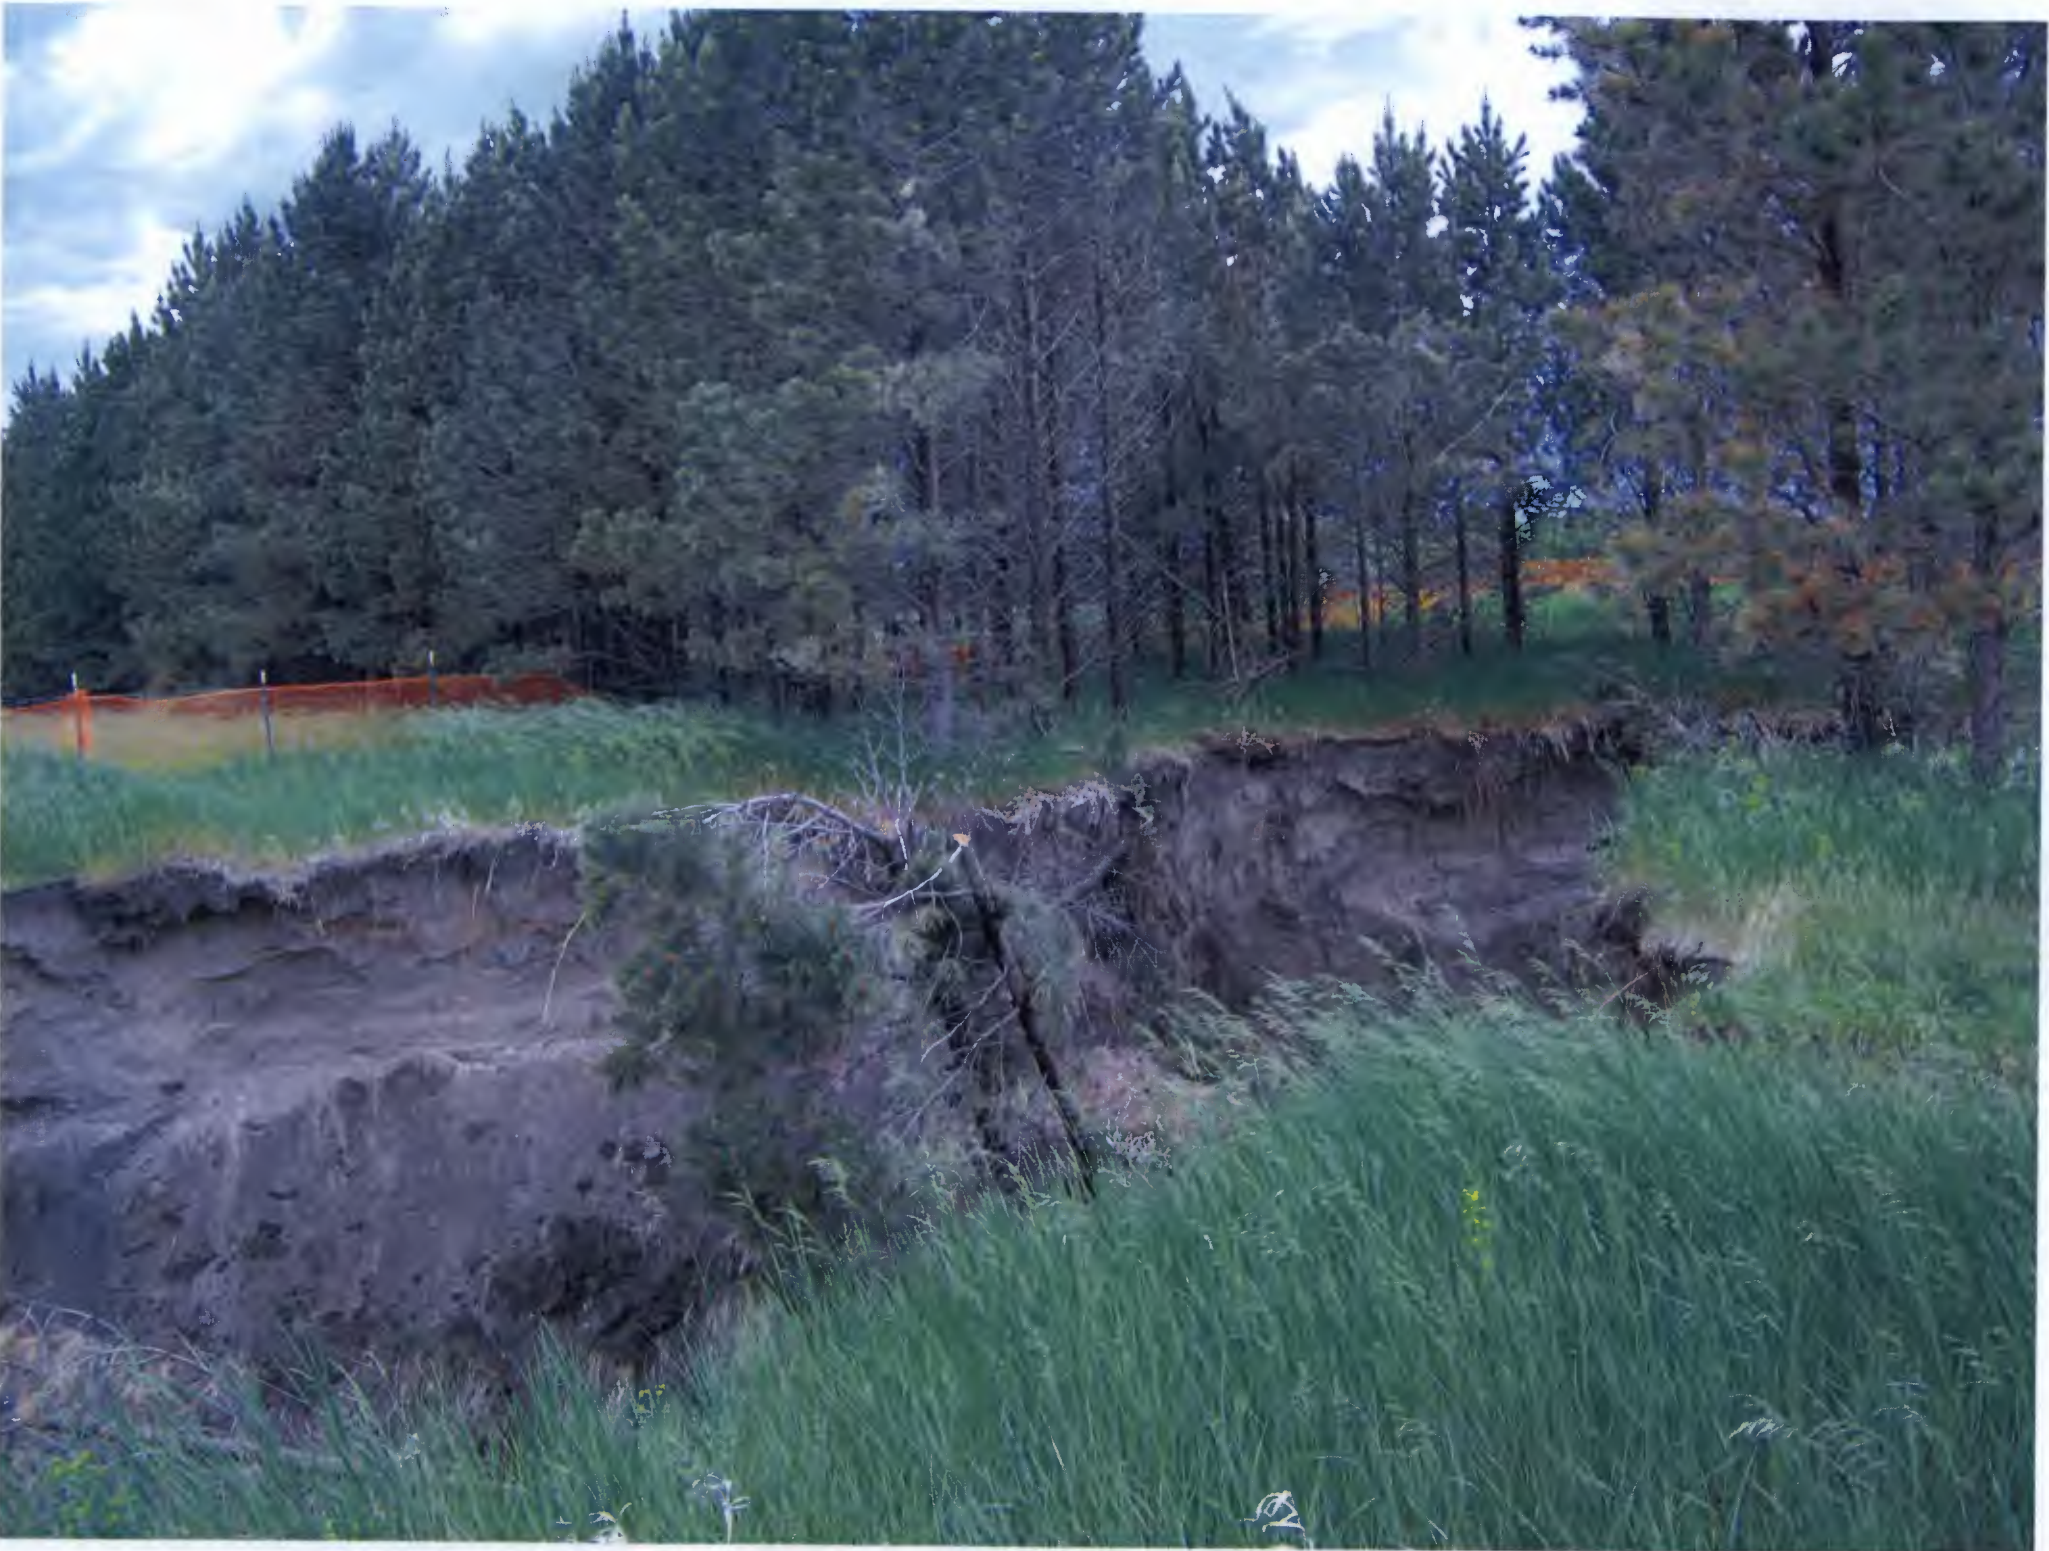
Here is the report for the end of June. Also, attached is a picture that Dennis took of the sink hole in the State Forest. At this point we are not planning any additional work on the project unless we hear different from you. Please let me know if you have any comments or questions regarding Dennis' report.

The sink holes that developed late in the
winter seem to have gotten worse. They are
well marked & cordoned off on the North side
of the River, with orange snow fence.

Sink holes in Mi. 7-8. (see earlier reports) (2-4-09)

In talking to Bill Laffoon, Construction Manager for project, he indicated plans were not yet completed for the rehabilitation of the sinkhole area. He indicated they would share a copy of the report with us when it is completed.
