**EXHIBIT ONE**

**Table 1**  
**As-Built versus Originally Proposed Structure Locations**  
**Tatanka Transmission Line**

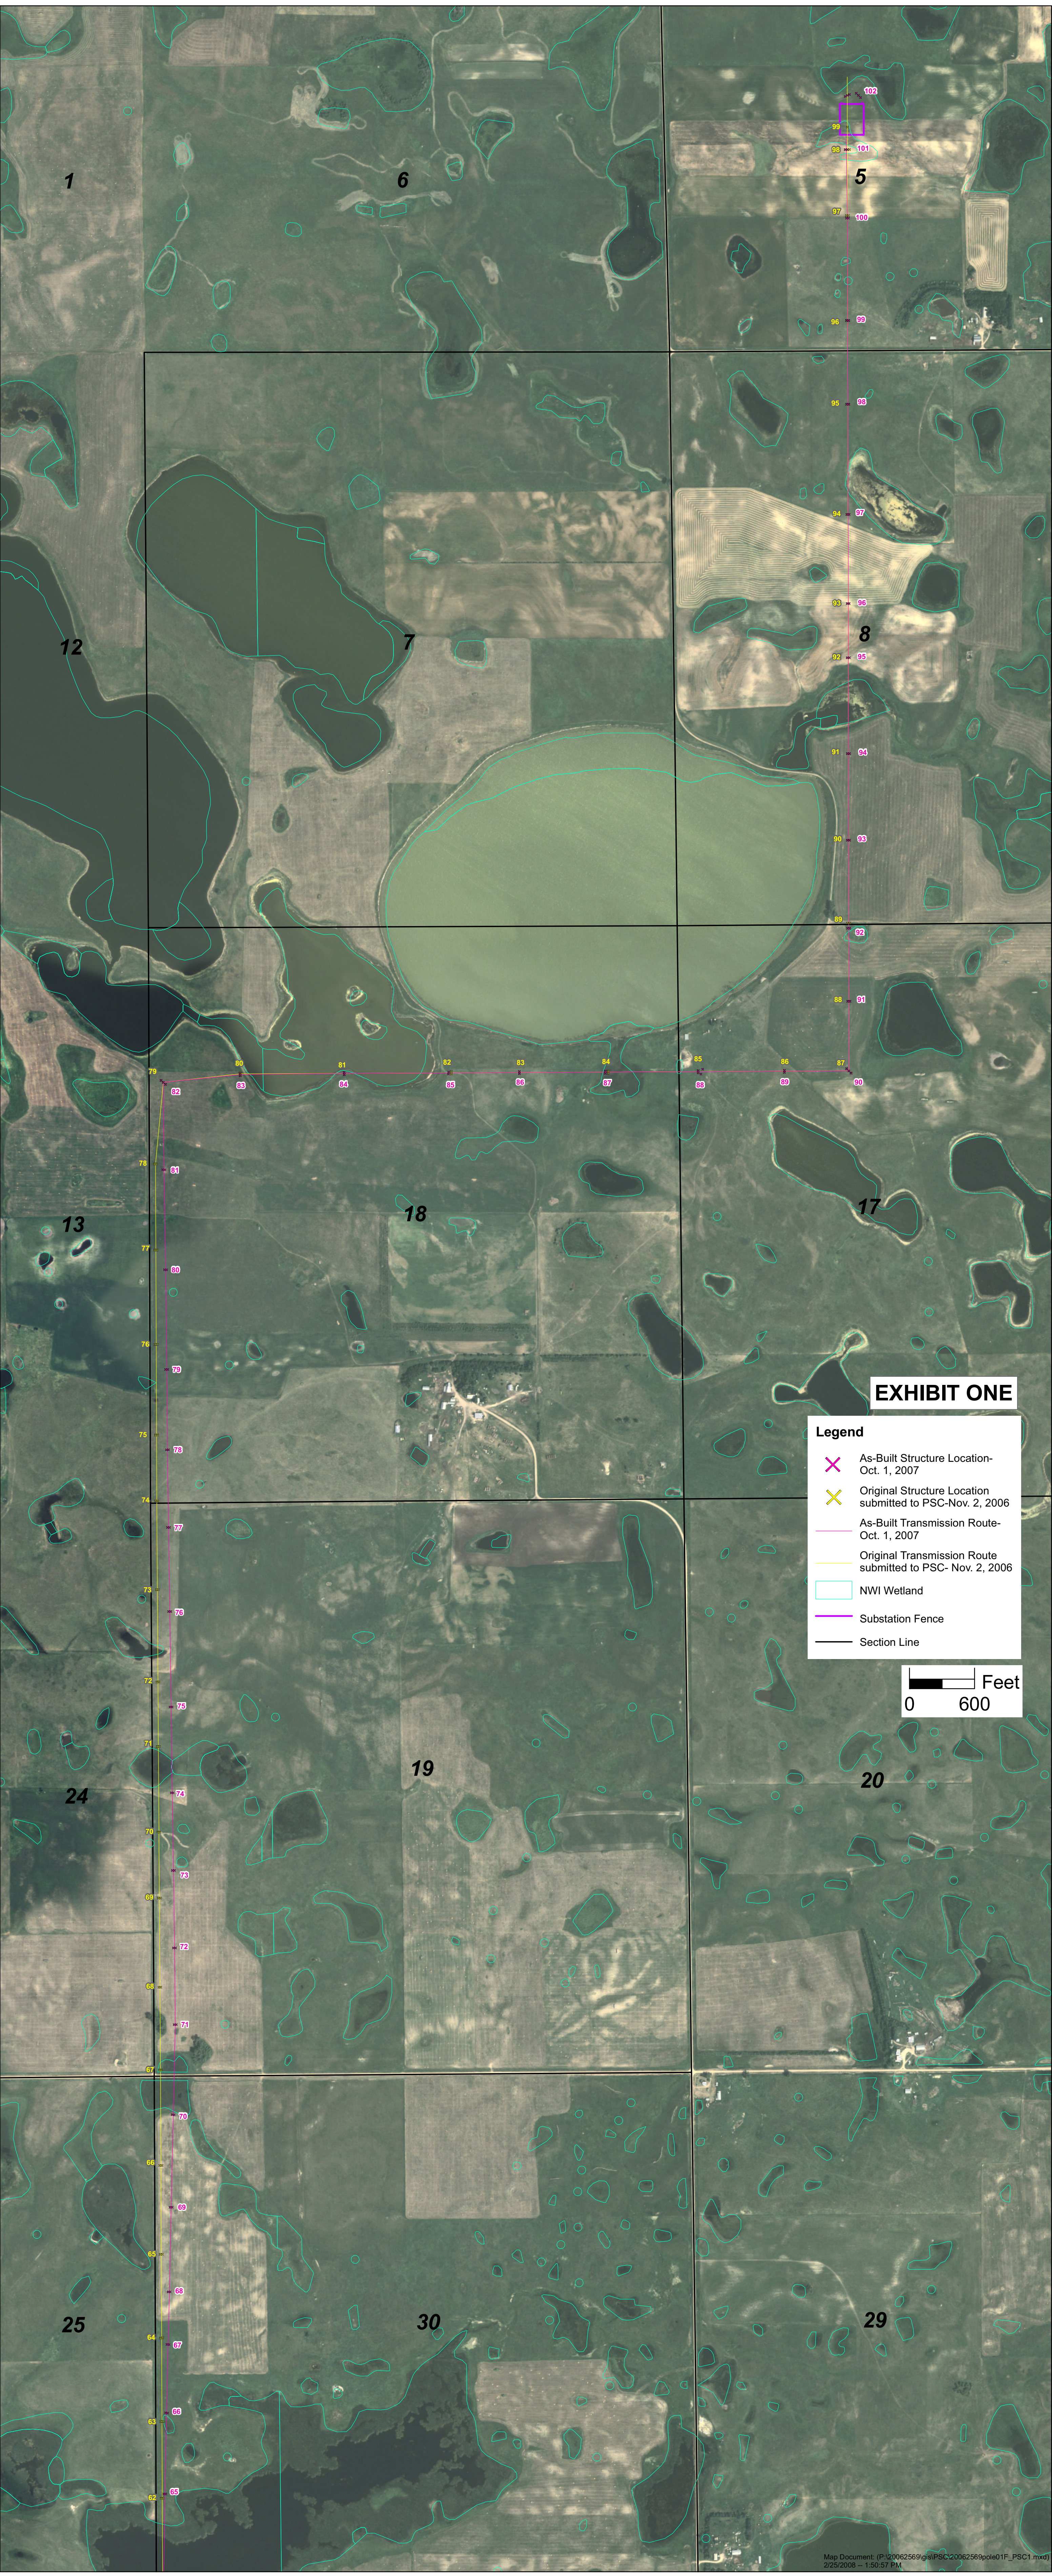
- ✕ As-Built Structure Location- Oct. 1, 2007
- ✕ Original Structure Location submitted to PSC-Nov. 2, 2006
- As-Built Transmission Route- Oct. 1, 2007
- Original Transmission Route submitted to PSC- Nov. 2, 2006
- NWI Wetland
- Substation Fence
- Section Line

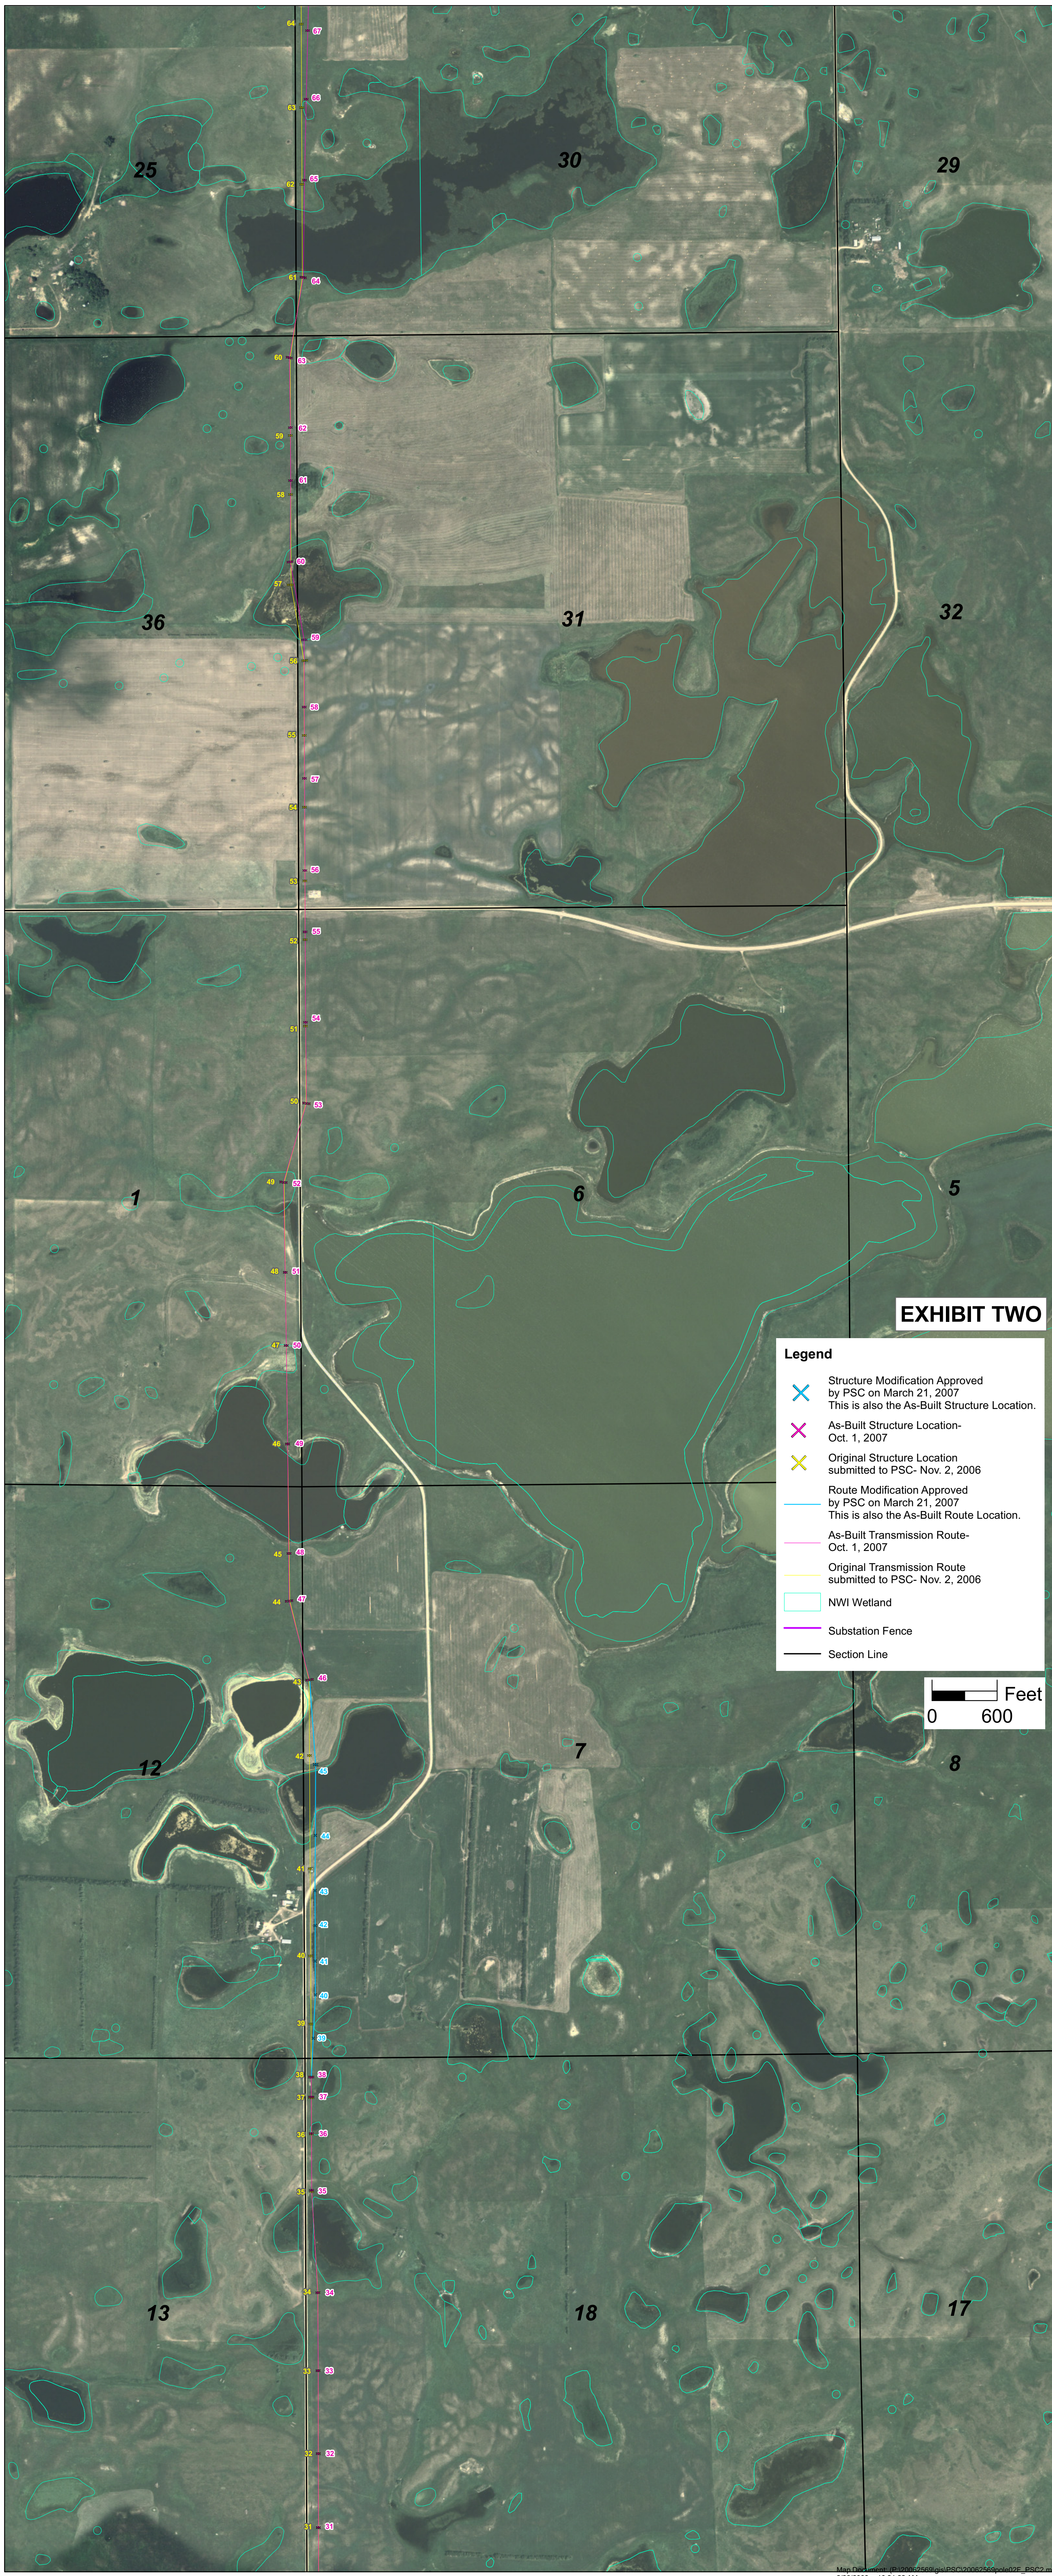
**EXHIBIT TWO**

Structure Modification Approved by PSC on March 21, 2007. This is also the As-Built Structure Location.
-

As-Built Structure Location- Oct. 1, 2007
-

Original Structure Location submitted to PSC- Nov. 2, 2006
-

Route Modification Approved by PSC on March 21, 2007. This is also the As-Built Route Location.
-

As-Built Transmission Route- Oct. 1, 2007
-

Original Transmission Route submitted to PSC- Nov. 2, 2006
-

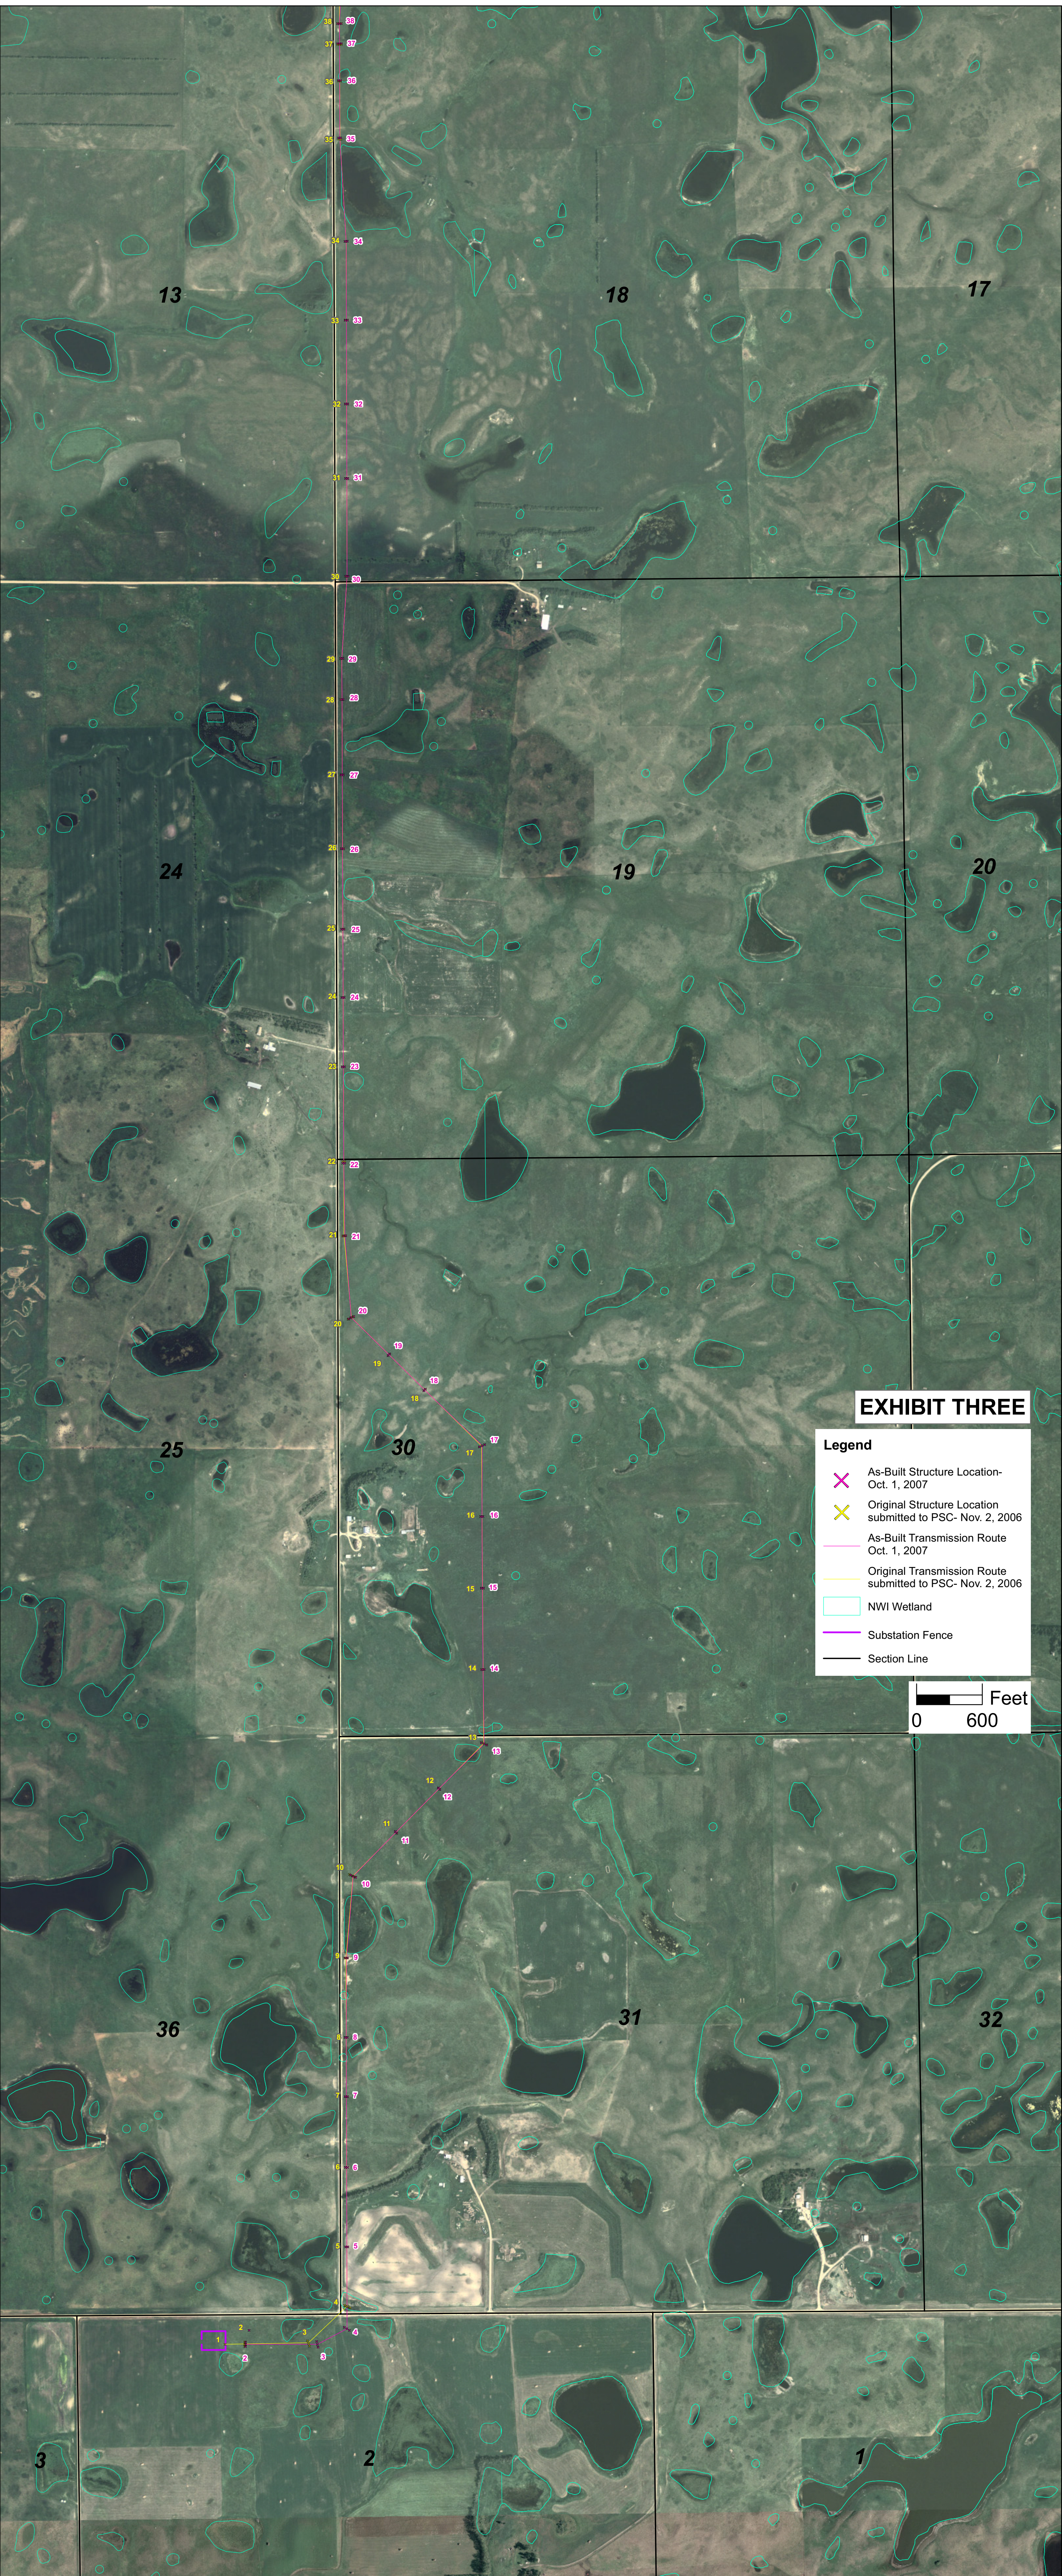
**EXHIBIT THREE**

- Legend**
- As-Built Structure Location- Oct. 1, 2007
  - Original Structure Location submitted to PSC- Nov. 2, 2006
  - As-Built Transmission Route Oct. 1, 2007
  - Original Transmission Route submitted to PSC- Nov. 2, 2006
  - NWI Wetland
  - Substation Fence
  - Section Line
