NORTH DAKOTA PUBLIC SERVICE COMMISSION
CENTER-GRAND FORKS 345KV TRANSMISSION LINE INSPECTION
DATE: 6-12-2014

PRELIMINARY INSPECTION REPORT

DATES OF INSPECTION: AUGUST 4 THRU AUG 6, 2014
INSPECTOR: KEVIN J. BERRETH, MBN ENGINEERING, INC.

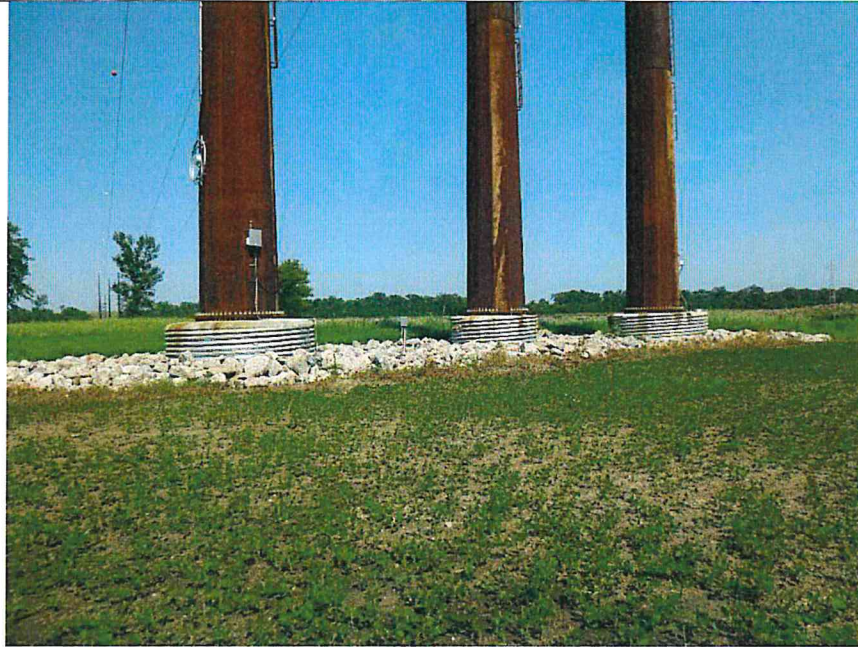
SOVEREIGN LAND PERMIT NO. S-1755 - Permit to construct transmission line across the Missouri River in Oliver and Burleigh Counties. Poles 68 and 69 were inspected on the west side of the river. Construction activities were complete in this area. See picture "STR 69 BASE LOOKING EAST MISSOURI RIVER.JPG". It appears that all material excavated for the drilled pier foundations has been removed from the site. The drilled piers were backfilled by rip-rap just above normal grade, and the area seems to be graded uniformly. See picture "STR 70 LOOKING EAST ACROSS MISSOURI RIVER.JPG". Marker balls were installed on the shield wires. It appears spacers were installed on the conductors. Plan and profile drawing state that they are maintaining 30' of clearance over the river above the 100 year flood elevation. This could not be verified as would require extensive survey. The west side of the river appears to be in compliance with the sovereign land permit No. S-1755. The east side of the river was not inspected at close range due to access.

Photo 1: Pole 69 base, looking east across the Missouri River.

| Pole Name | Sort Name | Critical habitat for T&E | Unique/Rare plant and animal species | Wildlife Management Area (WMA) | Historical / Archaeological Resources | Residence, school, business | Water sources (McClusky Canal) | National Scenic Trail, Historical Trail, McClusky Canal | Floodplain | Wetlands, woodlands, wooded areas | Animal health and safety | Plant Life | NOTES |
|---|---|---|---|---|---|---|---|---|---|---|---|---|---|
| 69 | 0069 | Compliant | Compliant | | | | | | N/A | Compliant | Compliant | | Constructed in ag, shield wires observed. Pole constructed outside of Piping Plover nesting |

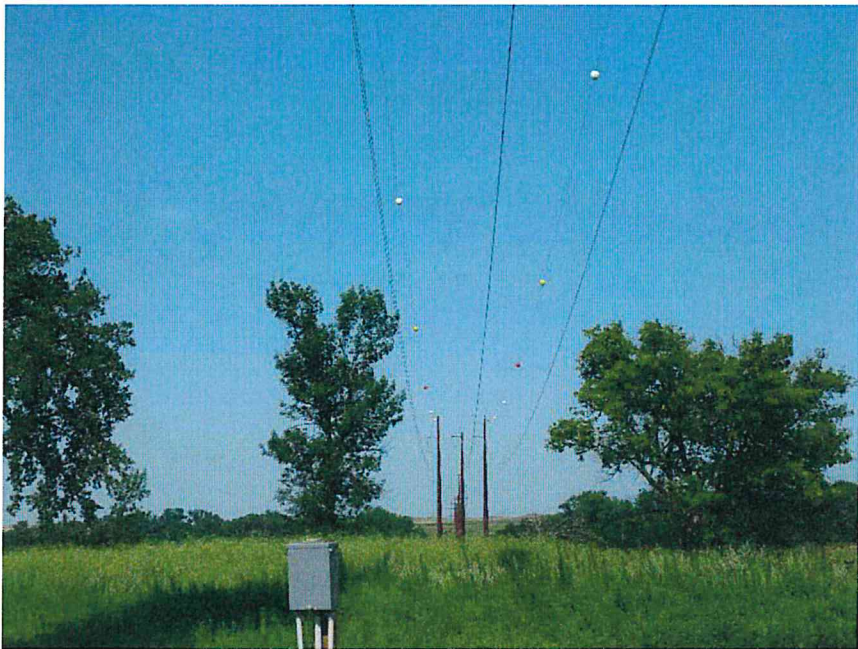
Photo 2: Pole 70, looking east across Missouri River.

| Pole Name | Sort Name | Critical habitat for T&E | Unique/Rare plant and animal species | Wildlife Management Area (WMA) | Historical / Archaeological Resources | Residence, school, business | Water sources (McClusky Canal) | National Scenic Trail, Historical Trail, McClusky Canal | Floodplain | Wetlands, woodlands, wooded areas | Animal health and safety | Plant Life | NOTES |
|---|---|---|---|---|---|---|---|---|---|---|---|---|---|
| 70 | 0070 | Compliant | Compliant | | | | | | | | | | Pole constructed outside of Piping Plover nesting, shield wires observed |

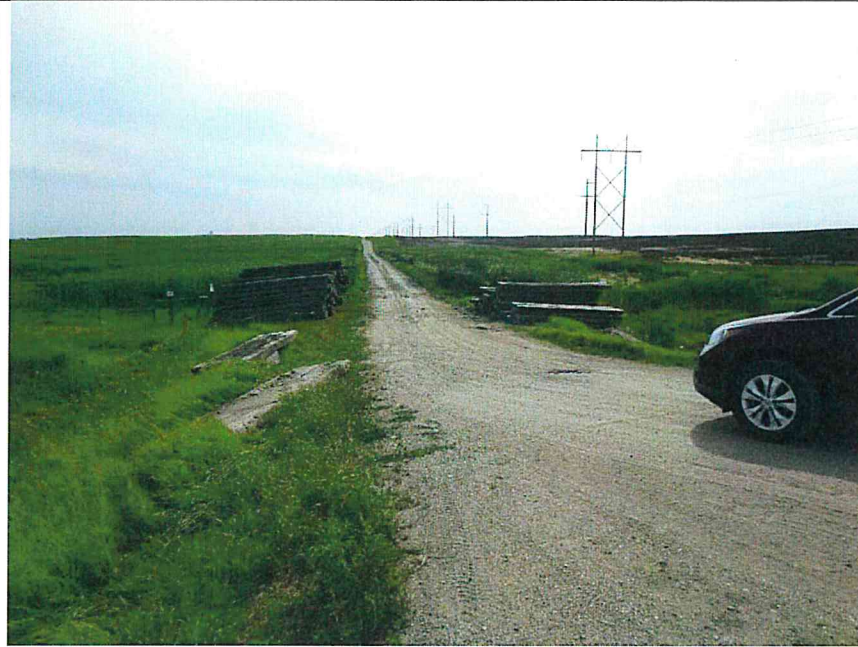
STRUCTURE #256: See picture "STR 256 JUST NORTH OF-CONSTR MATTING LOOK E.JPG". Just north of structure #256 on the east west minimum maintenance road, construction matting is still layed out in the low areas of the road and some is stacked up along side the road.

Photo 3: Pole 256 showing construction matting, looking east.

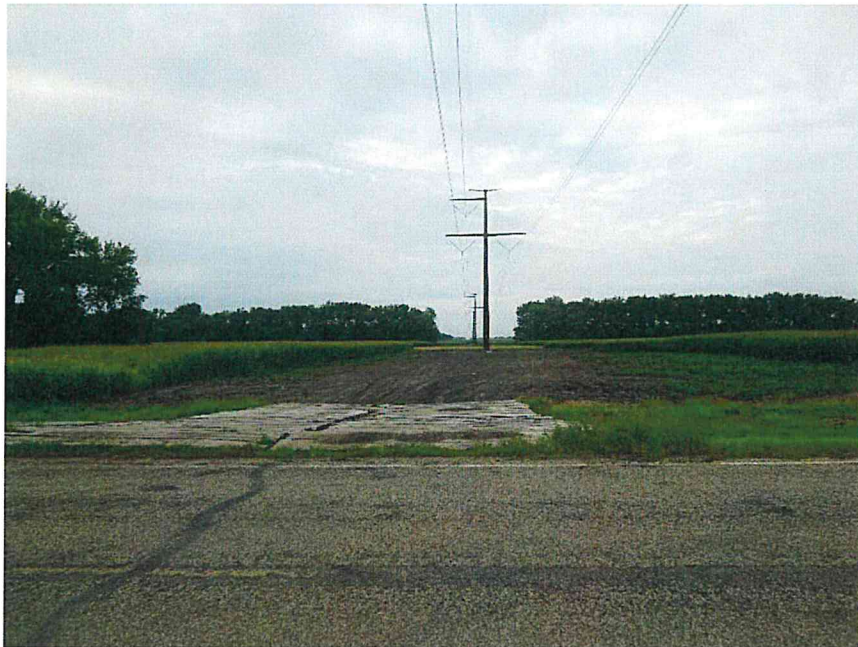
STRUCTURE #753; See picture "STR 753 LOOK E CONSTR MATTING.JPG"; On both sides of the road in the ditches, there still remains construction matting.

Photo 4: Pole 753, showing construction matting, looking east.
