RE: SHERBURNE COUNTY GENERATING STATION UNIT 3
RESTORATION UPDATE (CASE NO. PU-12-12)

Xcel Energy
 SHERCO 3
 Restoration Project
 Update: May 1, 2013

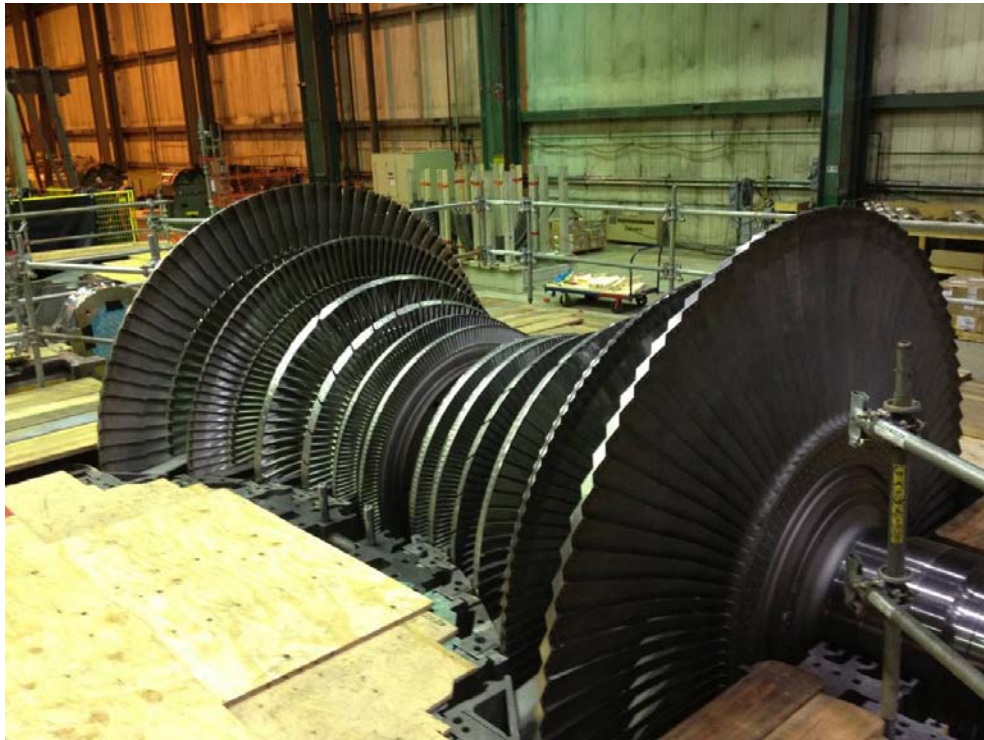
LP-A rotor successfully installed on May 1, 2013.

Minor onsite repairs continue (for all parts of the turbine) as additional work is identified as the parts are fully assembled with each other. The LP turbines have been grouted. Final fit up, alignment, and installation of internal components has started. The extraction and seal steam piping connections to the LP turbines are complete. The first trial installation of the LP-A rotor is complete, as pictured below. Assembly of the two low pressure turbines is forecasted to be substantially complete by mid-August.

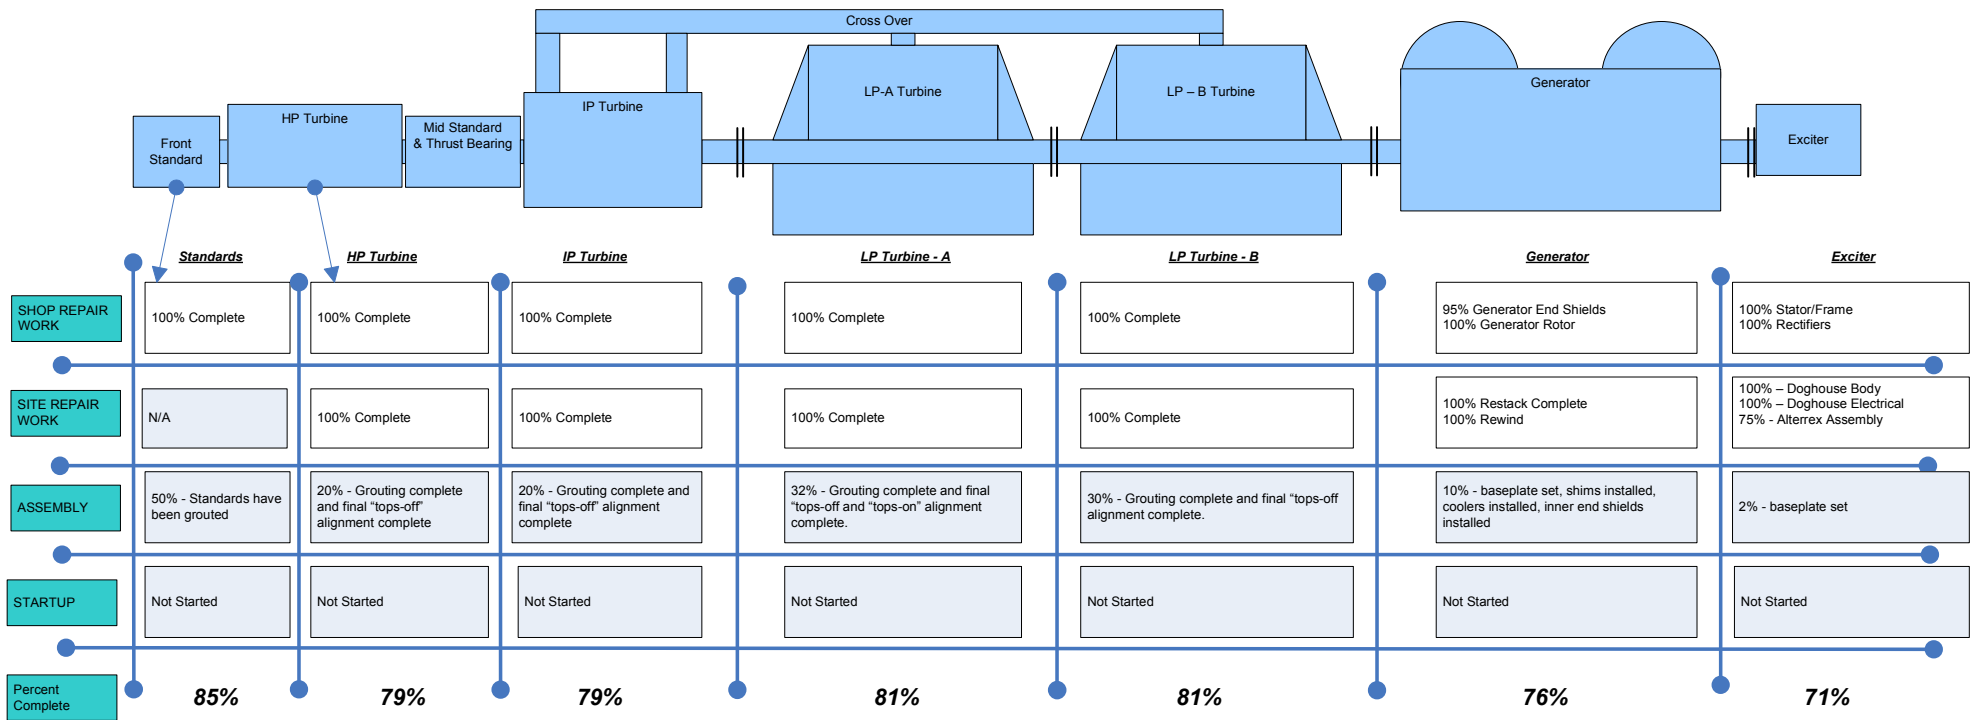
Notes:
 1. BOP Mech/Electrical/Controls/Instrumentation/New Parts orders work not represented here, however, all is on track to support the re-assembly and startup of unit.
