RE: TDPI Asset – Stanley 6-inch Pipeline Repair – November 2012
Montrail County, North Dakota
Case No. PU-12-40

Subject: TDPI Asset - Stanley 6-inch Pipeline Repair - November 2012
Montrail County, North Dakota

Figure 1
STANLEY 6" PIPELINE REPAIR
MOUNTRAIL COUNTY, NORTH DAKOTA
Chevron Environmental Management Company, Houston, Texas

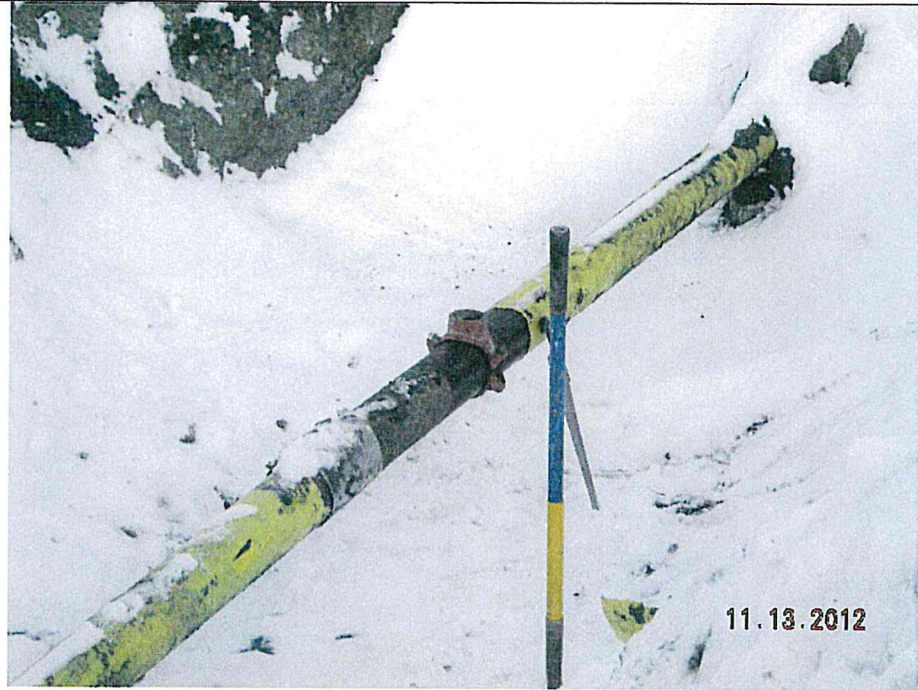
Photograph No. 3
Photographer: Pro Pipe Corporation
Date: 11/13/12
Comments: View of exposed pipeline with damaged plastic corrosion wrap removed.

On October 31, 2012, CEMC, on behalf of TDPI, authorized Plains' contractor, Pro Pipe Corporation (Pro Pipe), to remove the damaged section of the pipeline and cap the two resultant pipeline ends using PLIDCO® mechanical caps provided by Bobcat Contracting, a subcontractor to CRA. On November 13, 2012, Pro Pipe cut and removed an approximate 4-foot section of pipe, including the section with the temporary clamp, and affixed the mechanical caps to the open ends of the pipeline. All of the work was conducted using cold techniques, including tapping and cutting of the pipeline. According to Pro Pipe, there were no fluids encountered in the pipeline, and there was only a small amount of pressure on the pipeline, roughly 5 pounds or less, during these activities. Once the caps were installed, the pipeline was reburied and the surface was graded to match the existing topography.

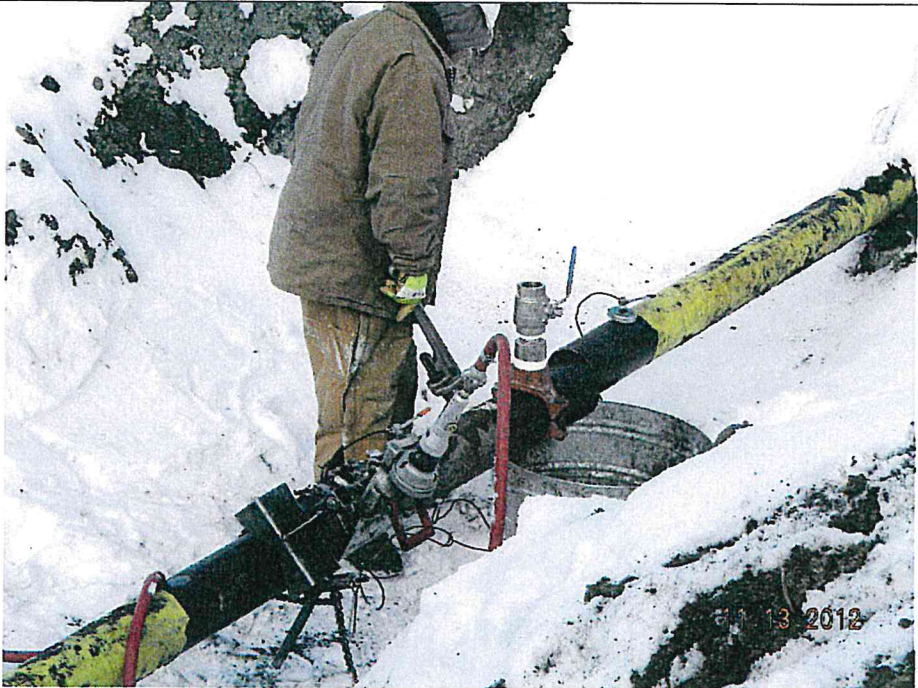
Photograph No. 4
Photographer: Pro Pipe Corporation
Date: 11/13/12
Comments: View of cutting activities with precautionary containment tub beneath pipeline to capture free liquids (none).

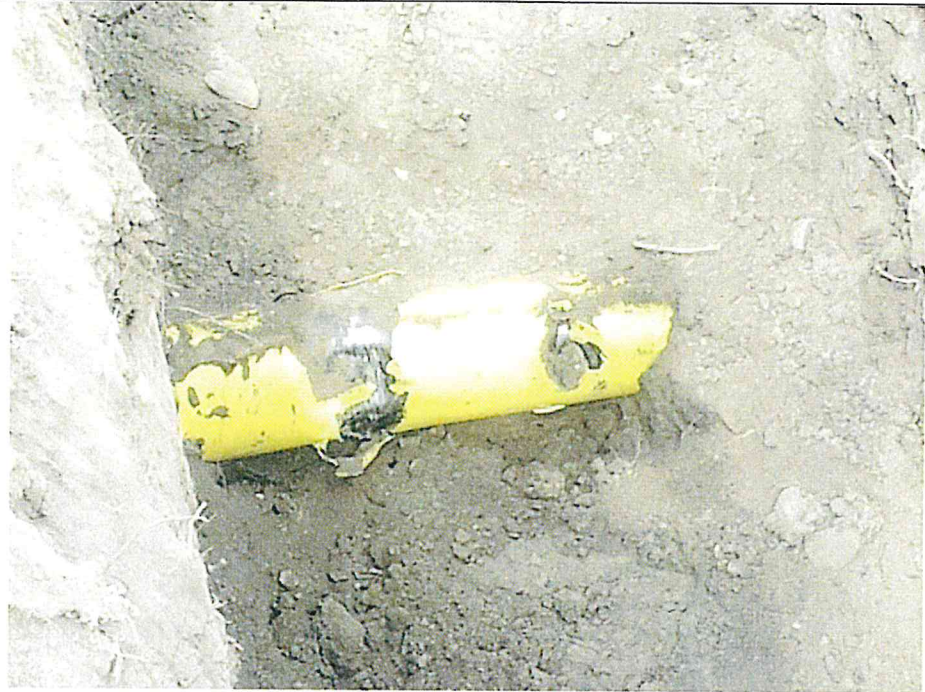
Photograph No.
1

Comments:
View of damaged plastic corrosion wrap.

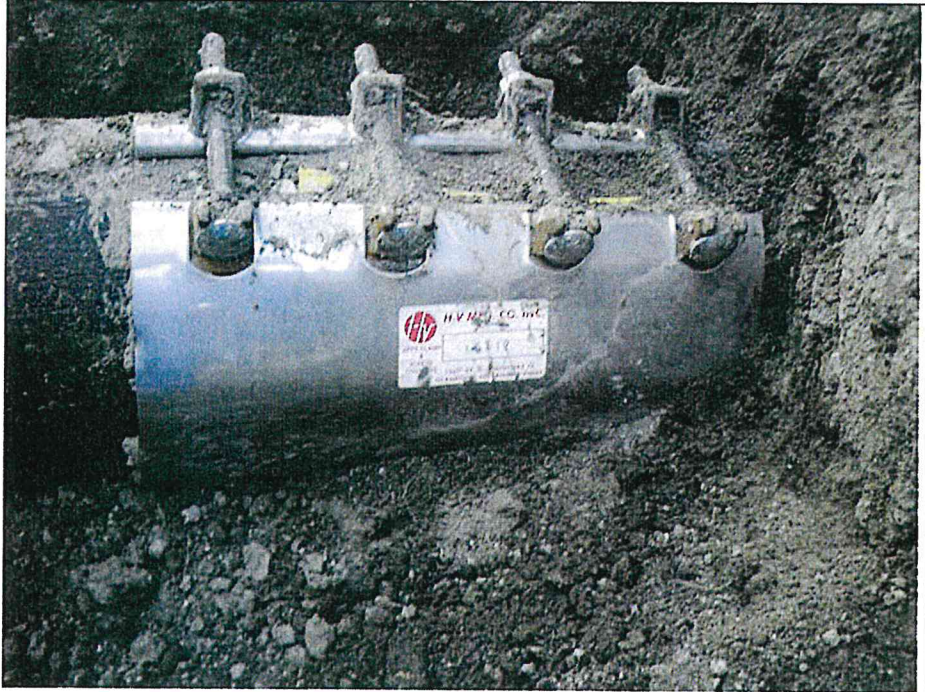
Photograph No.
2

Comments:
View of temporary clamp.

measure, the Plains contractor installed a temporary clamp around the most damaged area of the pipe.

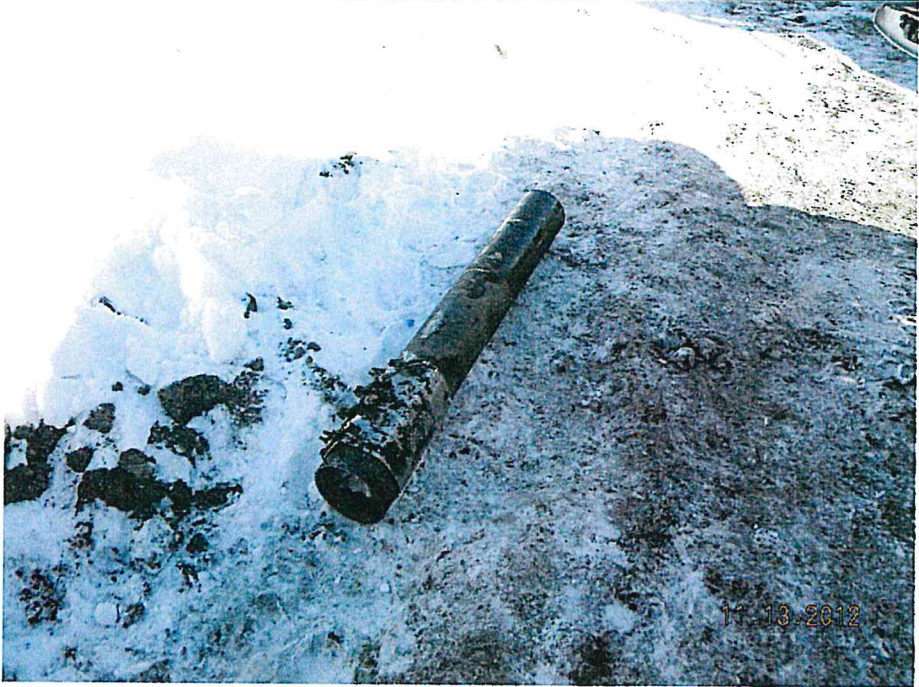
Description: Stanley 6" Pipeline at GPS coordinate location of 48° 17' 14.14153" N and 102° 21' 43.07792" W	
Photograph No. 5

Photographer: Pro Pipe Corporation	
Date: 11/13/12	
Comments: View of cut section of pipe with temporary clamp.

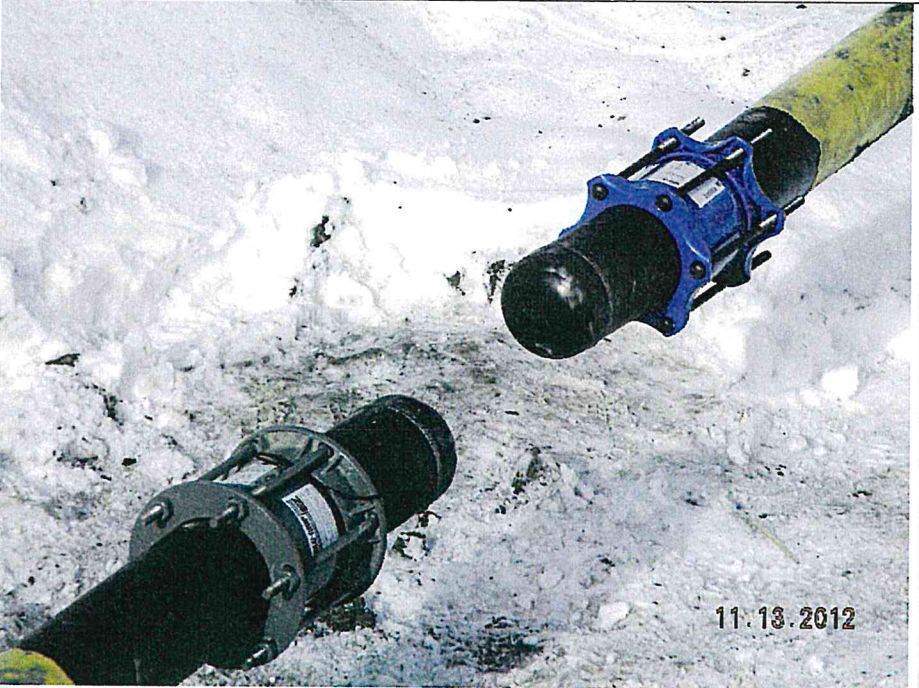
Description: Stanley 6" Pipeline at GPS coordinate location of 48° 17' 14.14153" N and 102° 21' 43.07792" W	
Photograph No. 6

Photographer: Pro Pipe Corporation	
Date: 11/13/12	
Comments: View of pipeline with affixed PLIDCO® mechanical caps.
