## Project Inspection Report

**Project Name:** Basin Transload Lignite Pipeline Project 10" Crude Line, Burke County ND

**PSC Case Number:** PU-12-775

**Date:** 11/13/2014

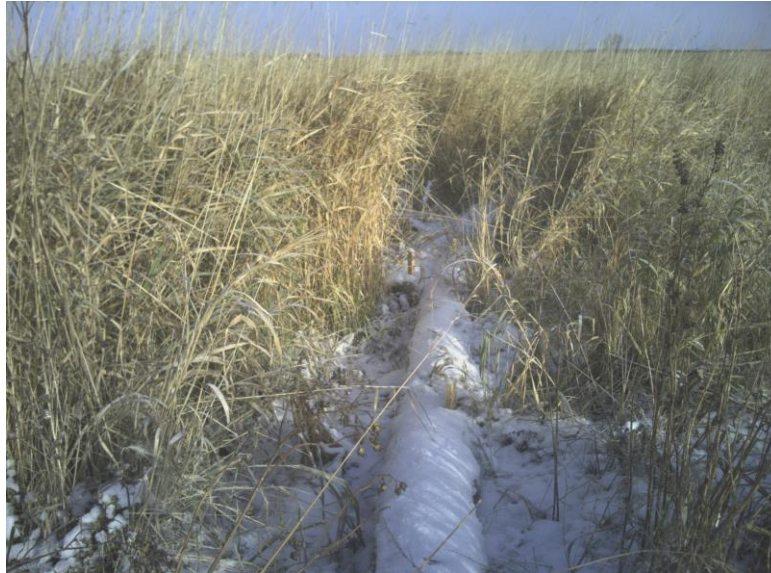
**Photo 1:** Straw wattle still present at STA 347+85 and 352+49, straw wattles may be left in place provided they degrade naturally over time.

These ECDs may need to be removed per landowner requests otherwise these straw wattles may be allowed to degrade naturally over time.

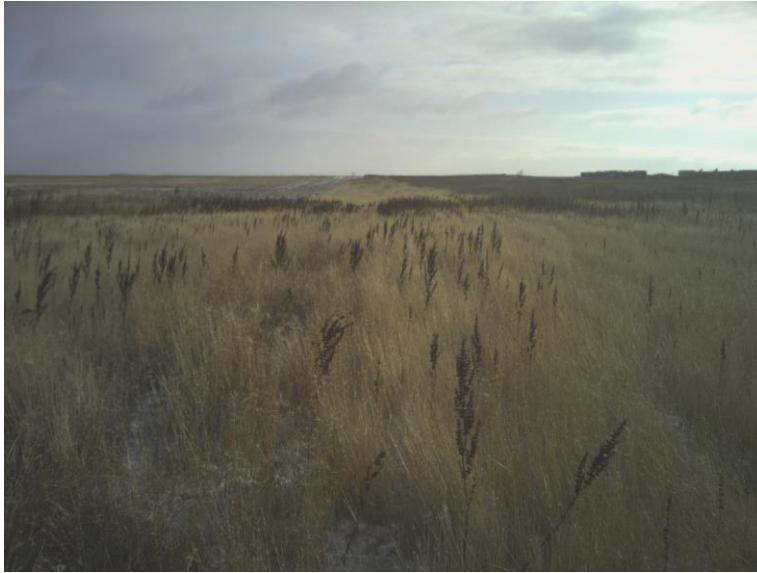
**Photo 2:** Looking east along pipeline right-of-way near STA 340+00. Final stabilization has been achieved.

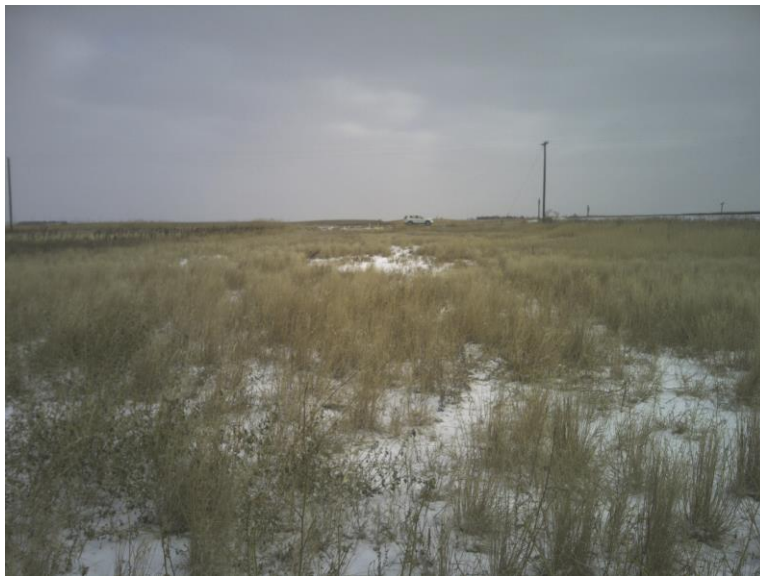
**Photo 3:** Looking east along pipeline right-of-way near STA 220+00. Final stabilization has been achieved.

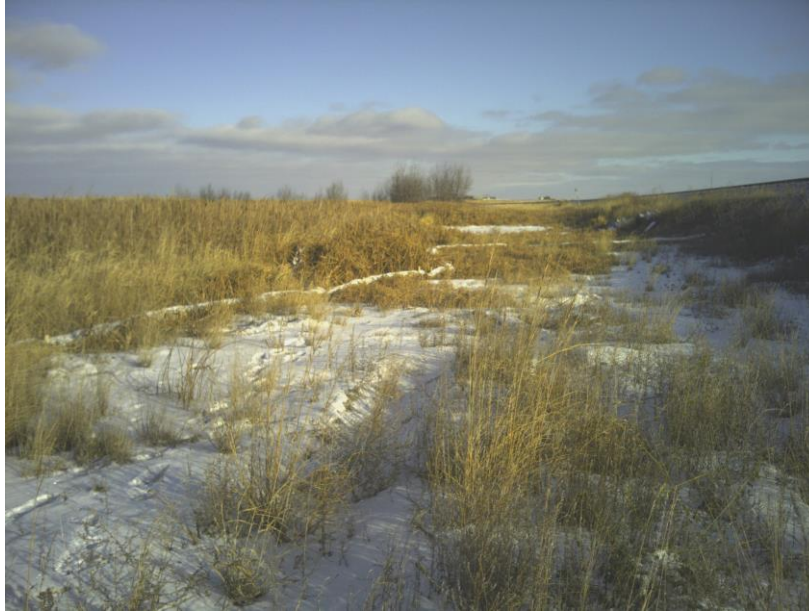
**Photo 4:** Straw wattle still present at STA 40+00, straw wattles may be left in place provided they degrade naturally over time
