September 19, 2014

RE: Notice of Violation 1402

Letter addressing the required remedial measures filed by the mine operator  
BNI Coal, Ltd.  
Jay Volk

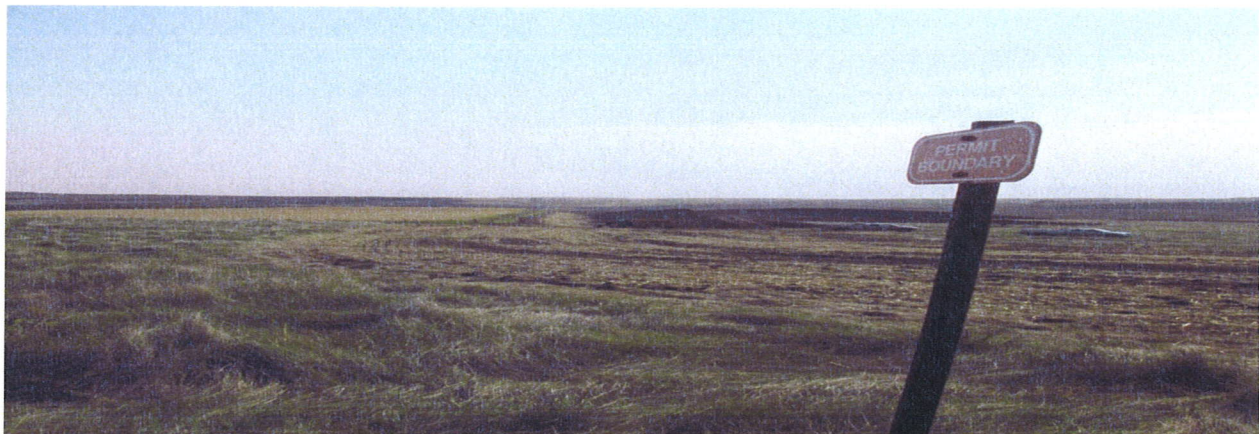
With regards to the first item and the required abatement, the permit boundary signs have been installed around section 6 and other active areas within Permit BNCR-1101, including on the closed county road; while the remainder of the permit boundary signs on the non-active portions of BNCR-1101 is underway.

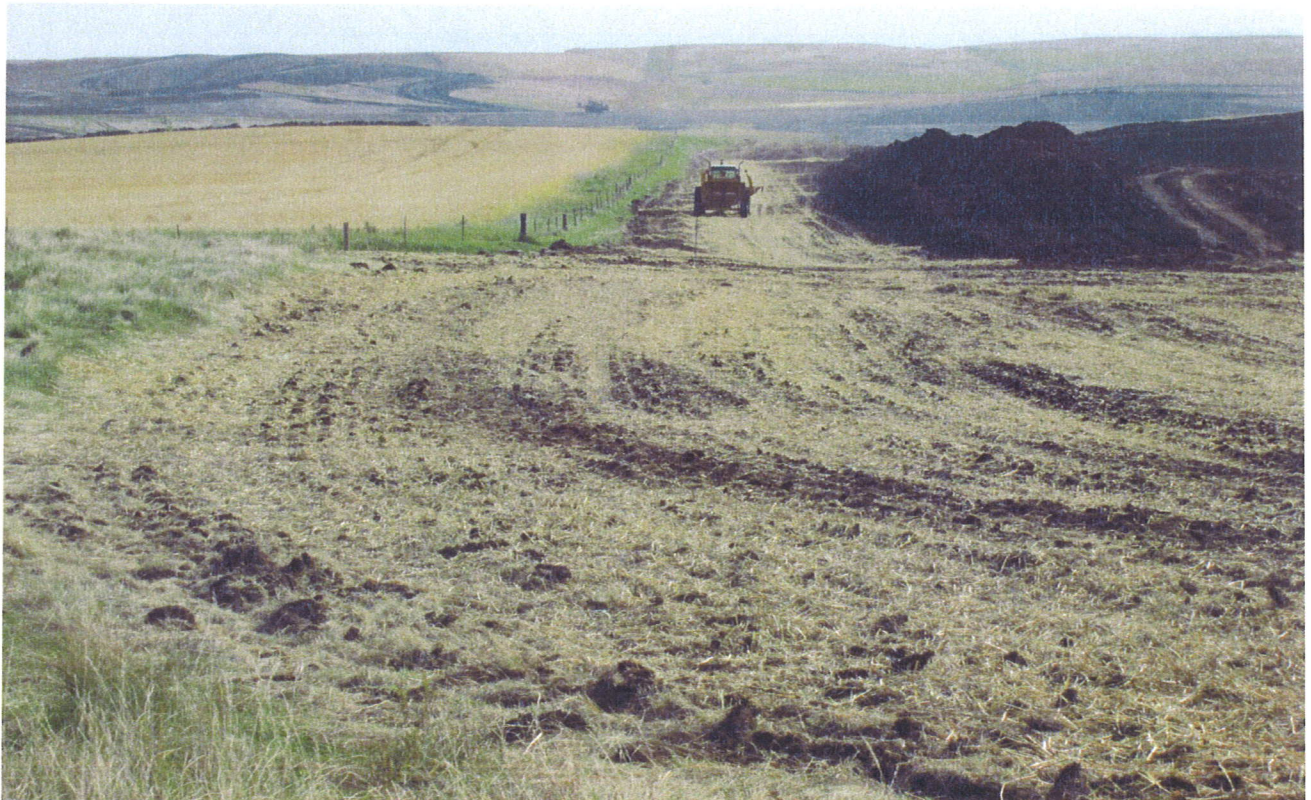
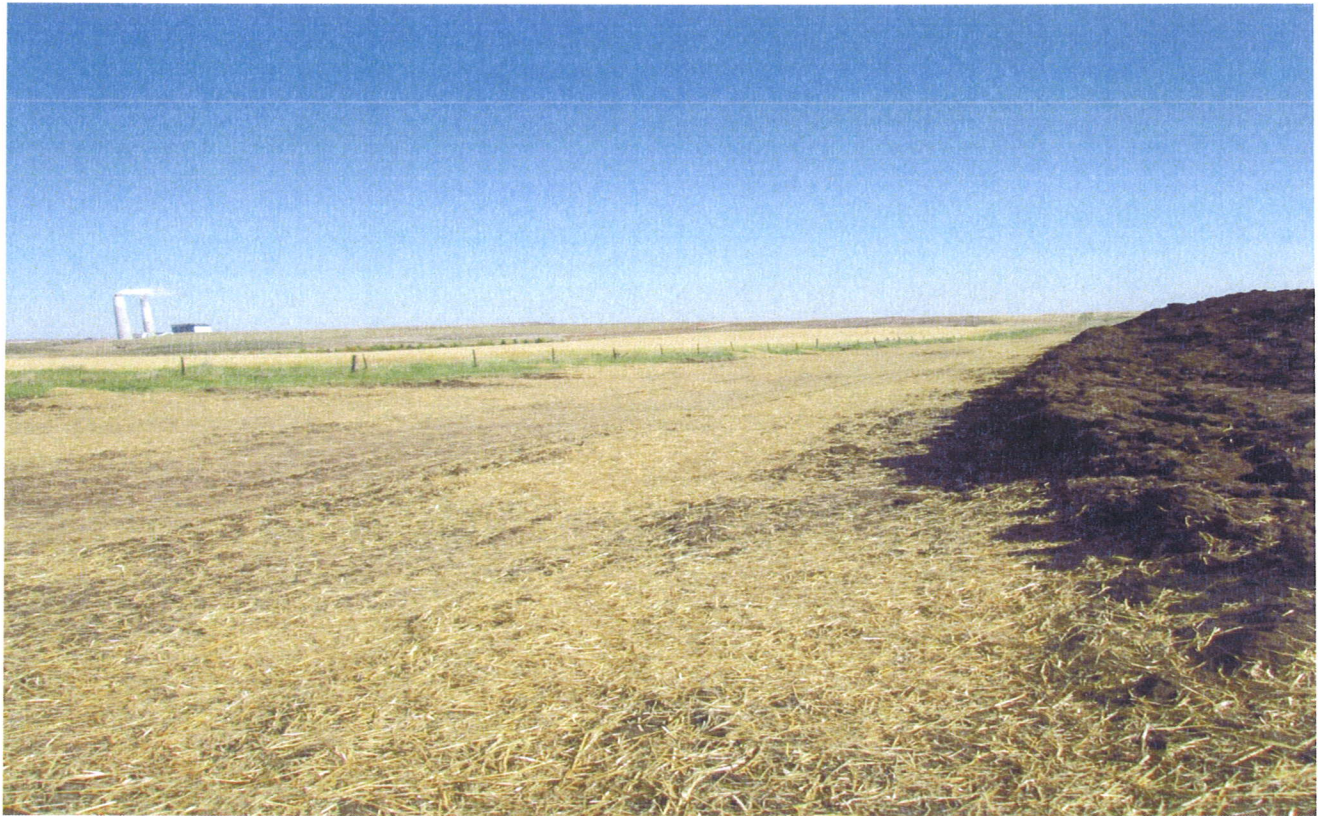
Secondly, the area that was disturbed north of the topsoil pile has been tilled, seeded to BNI's native mix, and mulched/crimped. Likewise, the topsoil pile itself has been moved to the south allowing a larger buffer area for drainage control; this buffer area has also been seeded and mulched as well. A timeframe of the abatement events is as follows:

- 9-3-2014 – The morning of the inspection BNI had a contractor pulling back the topsoil that was 2-4' over the permit boundary.
- 9-5-2014 – Signs were installed around section 6 and other active work areas.
- 9-16-2014 – Finished moving the existing pile south from permit boundary
- 9-17-2014 – Finished grading area between stockpile and permit boundary for drainage control
- 9-18-2014 – Area was tilled, prepped, seeded to native mix, and mulched/crimped.
