ND ONE-CALL COMPLAINT

Damage Investigation Form

Damage Date:	<u>7/24/2014</u>	Date Notified:	<u>7/24/2014</u>	Date Investigated:	<u>7/24/2014</u>
Address:	<u>3342 1st St E</u>	City:	<u>West Fargo</u>	Notified by:	<u>Xcel Energy</u>
Excavator:	<u>Aqua Lawn</u>	Ticket #:	<u>N/A</u>	Damage Ticket:	<u>N/A</u>
Locator:	<u>N/A</u>	Locate Date:	<u>N/A</u>	Work Type:	<u>Sprinkler System</u>
Facility Damaged:	<u>5/8" Gas Service</u>	Equipment Used:	<u>Trencher</u>

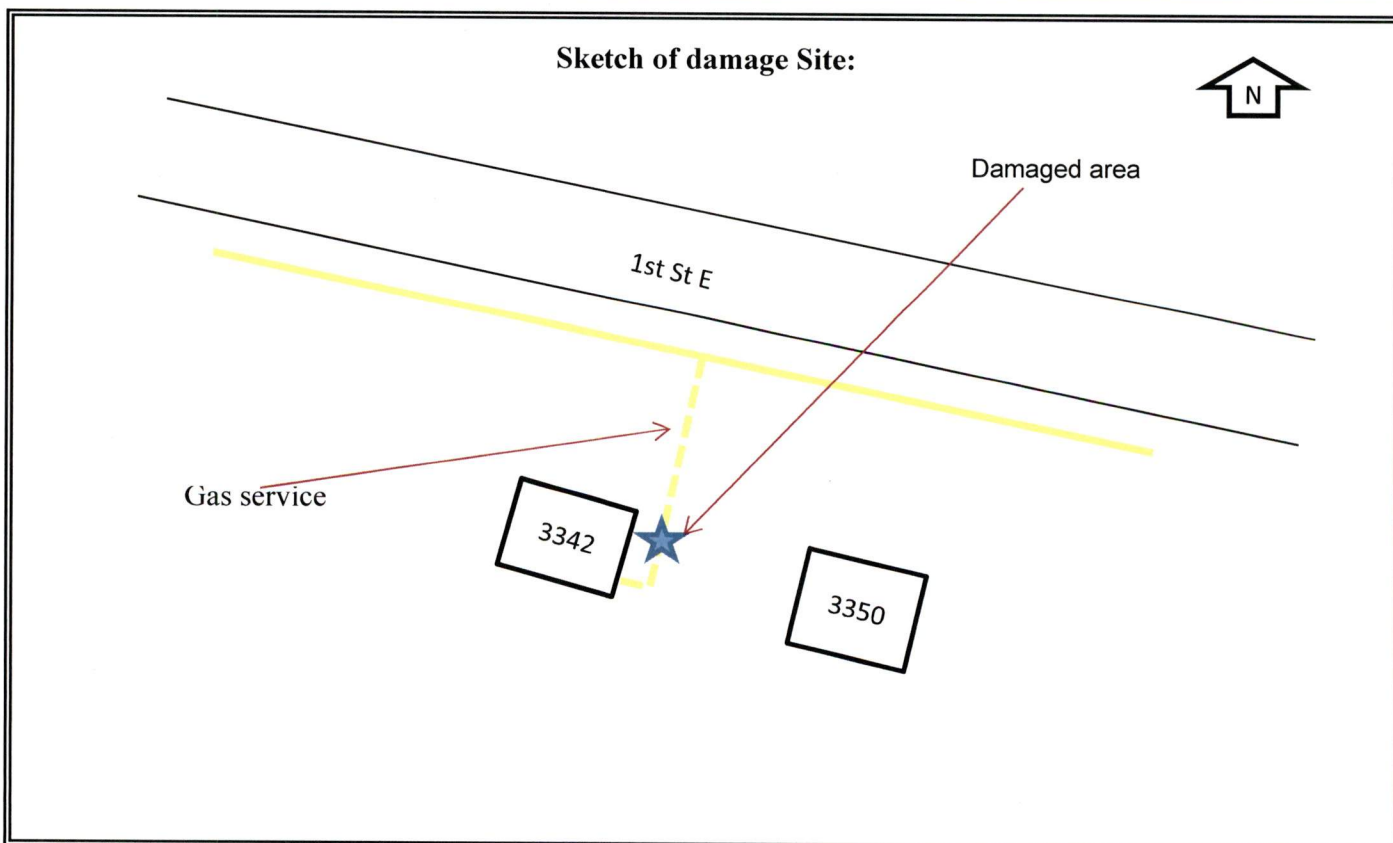
Description of site and facility indicators: This is a new home. Some of the marks were still visible.

Aqua Lawn was installing a sprinkler system when they damaged an accurately marked gas service. The contractor was did not have a ticket to perform this work. Aqua Lawn was digging off of Signature Landscapes ticket (14111634).
