## LIUNA North Dakota Investigation of Loenbro Pipeline Construction – Part 2 (6/26/15)

In March 2015, LIUNA produced a report based on an investigation into pipeline work then being performed by contractor Loenbro, Inc. The March report documented multiple instances of apparent poor-quality work including evident failure to properly implement several basic environmental, safety, and pipeline integrity measures. The report documented what appeared to be failure to maintain proper erosion controls, unsafe bore pits, collapsed skids, and pipe left lying on the ground.

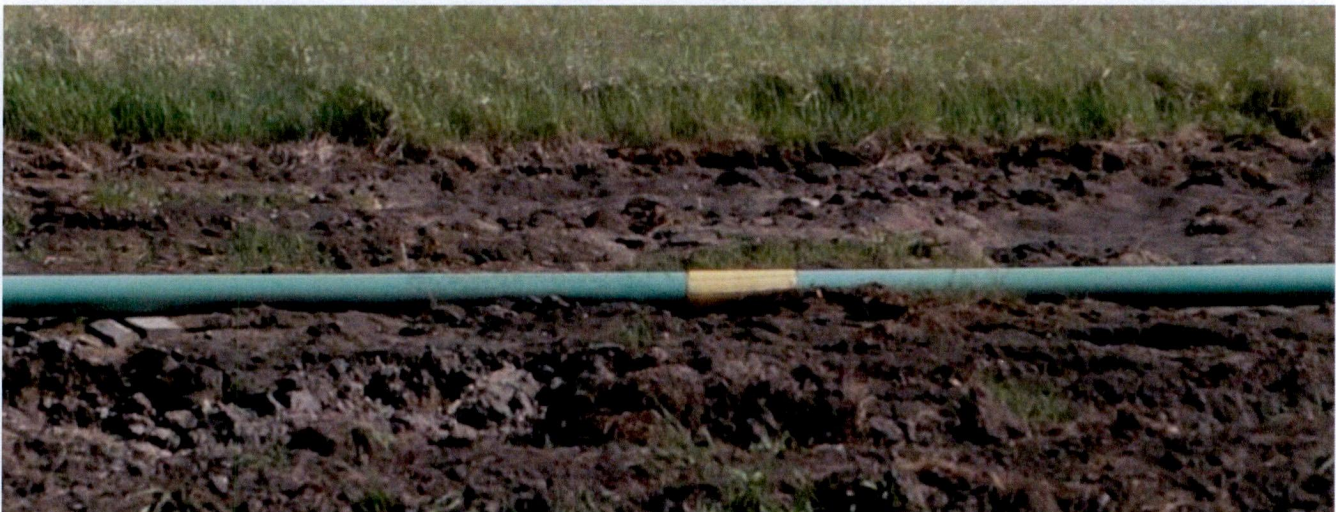
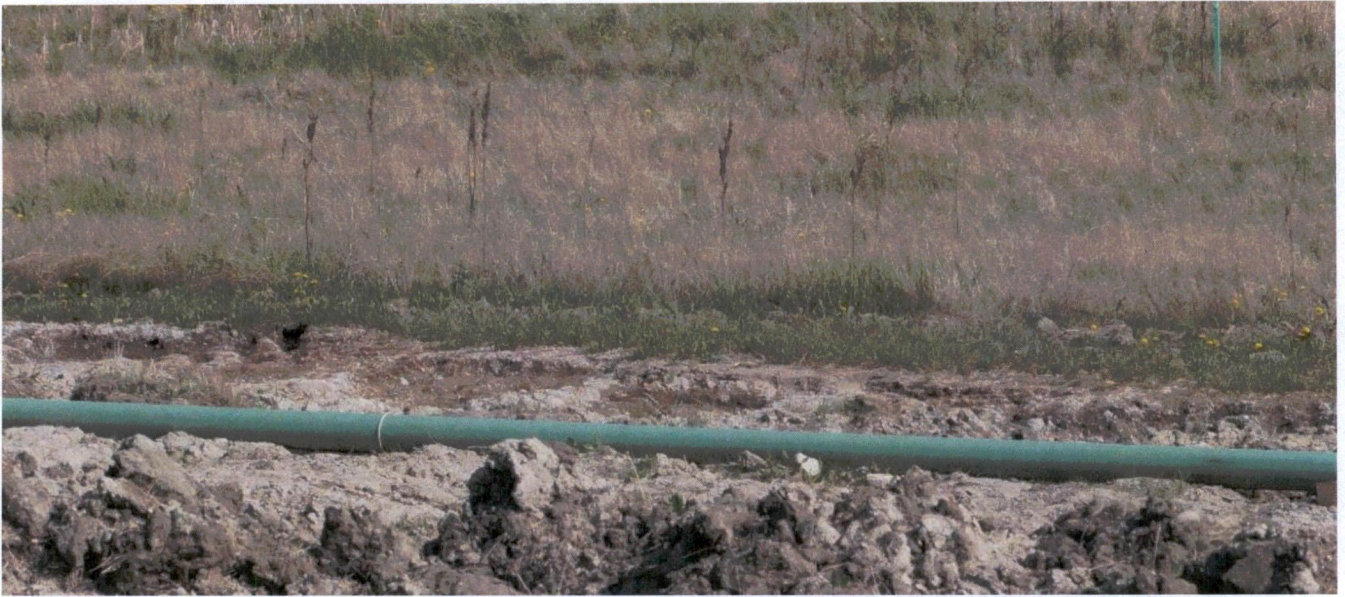
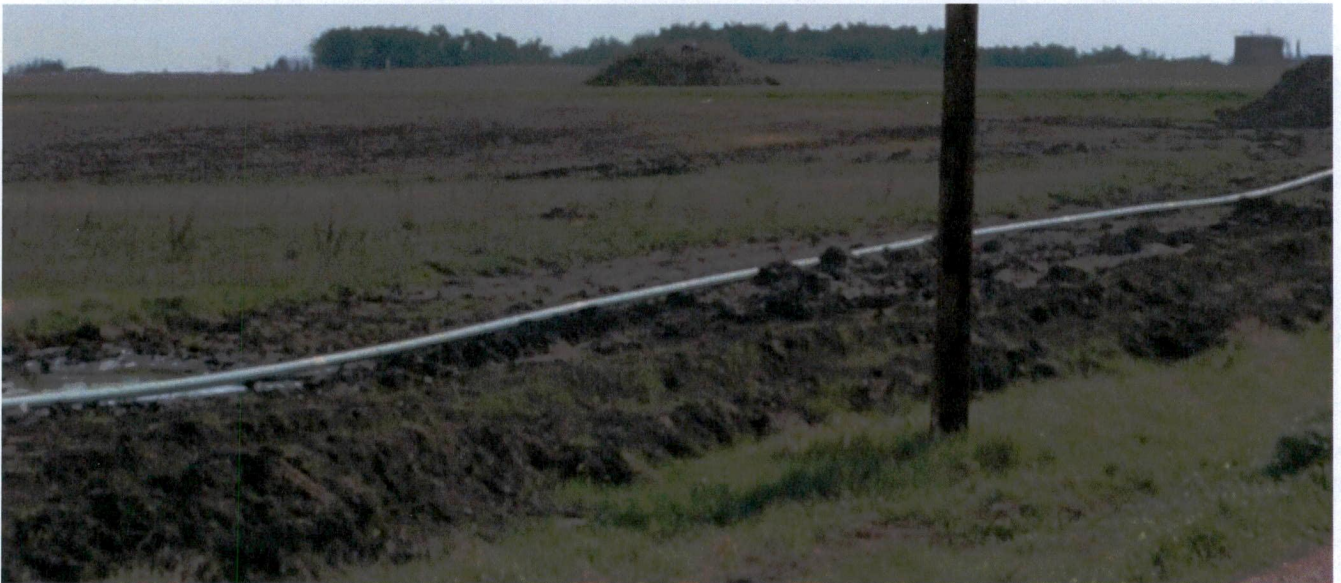
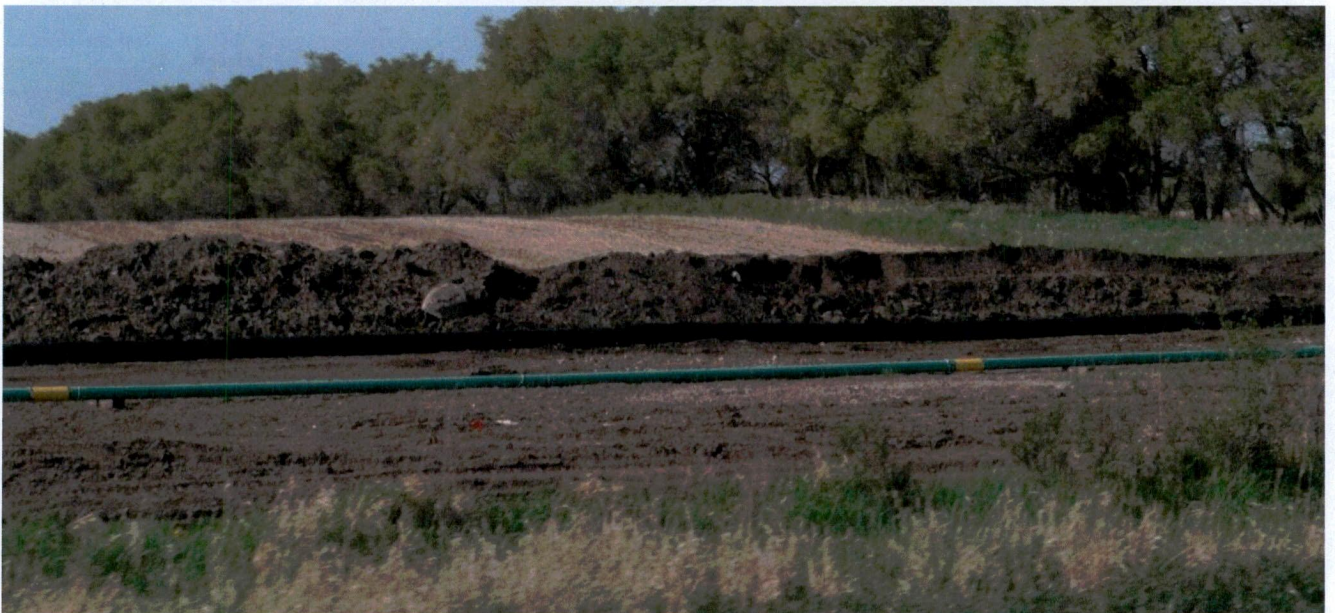
### Improper handling of pipe can threaten pipeline integrity

Pipe should never be placed on the ground where rocks and dirt can scratch the factory coating, potentially causing corrosion and integrity problems down the line but there was ample pipe on the ground at an apparent Loenbro project eight miles north of Ray, ND.

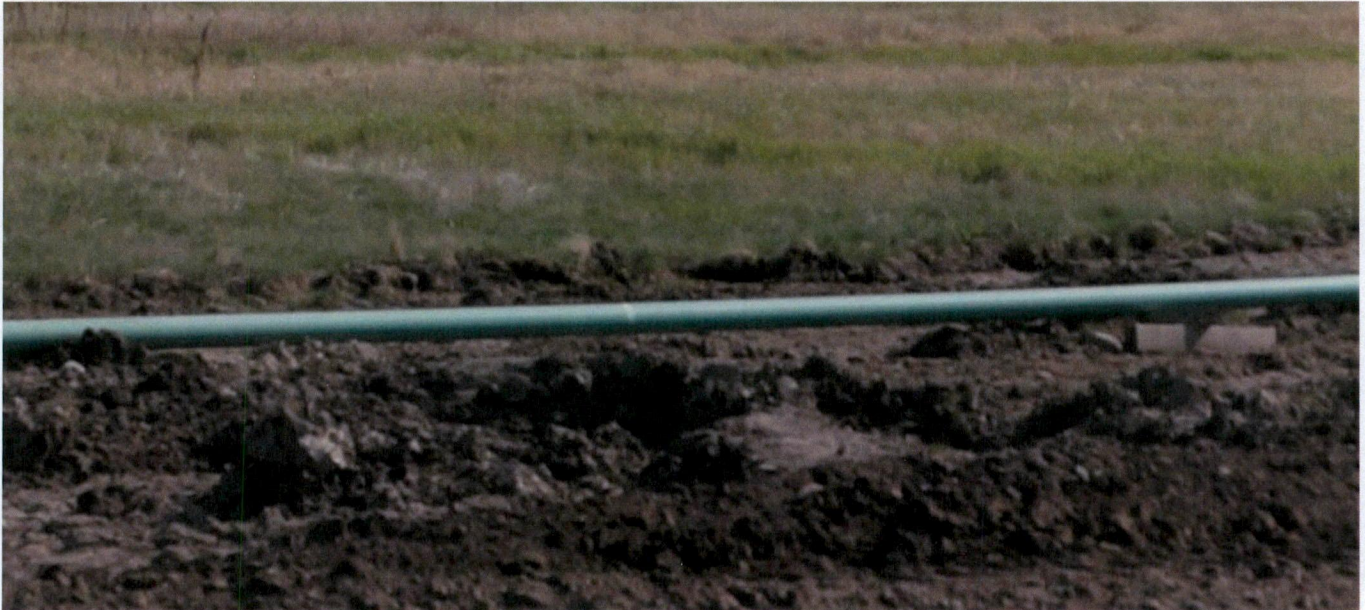
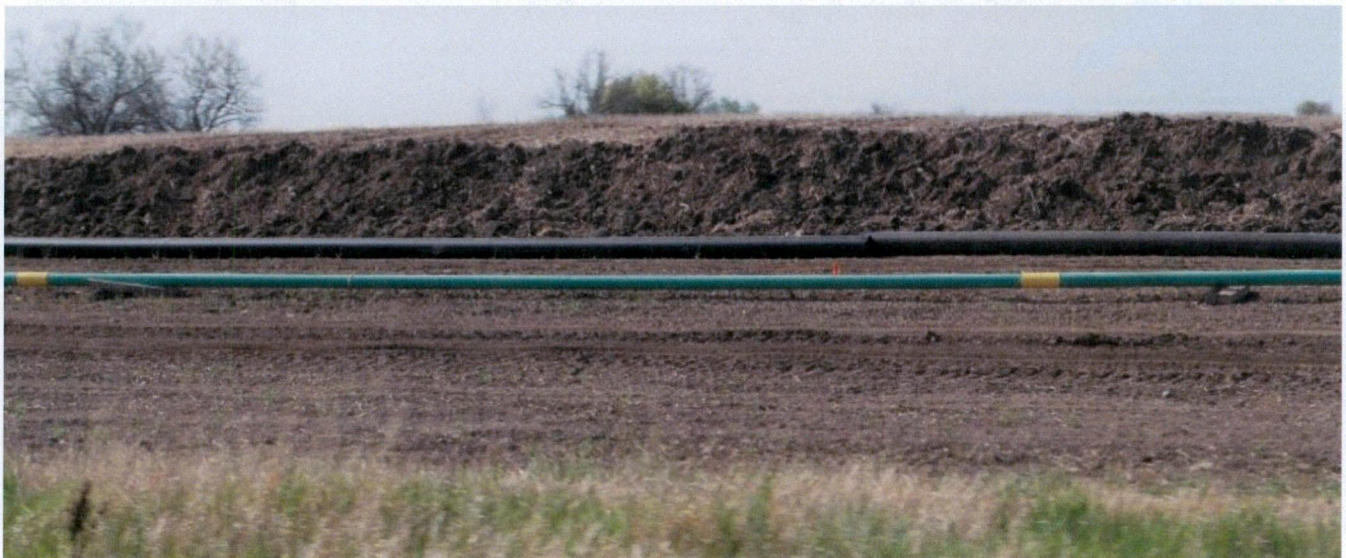
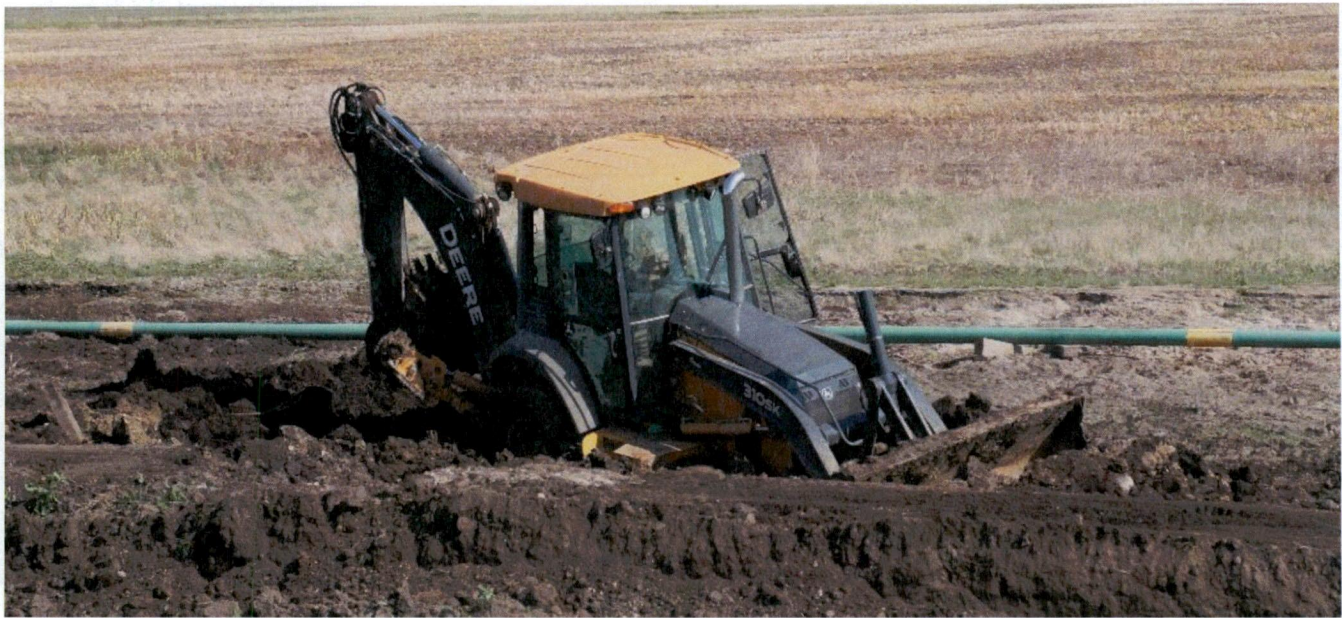
## **Collapsed skids are a hazard to workers, pipe integrity**

Once again, LIUNA staff witnessed collapsed skids on the project. Poorly-built and maintained skids can be dangerous to the ground crews handling and working around the pipe. Daily weather-related temperature changes cause the pipe to expand and contract, which in turn causes the pipe to shift on the skids. A coating crew will typically work on this pipe, and if the pipe falls during the process, the result could be fatal. A fall off collapsed skids can also damage the factory coating, potentially causing corrosion and integrity problems. The third picture also shows a piece of heavy equipment apparently stuck in the ditch, which is hardly a ringing endorsement of Loenbro's competence.

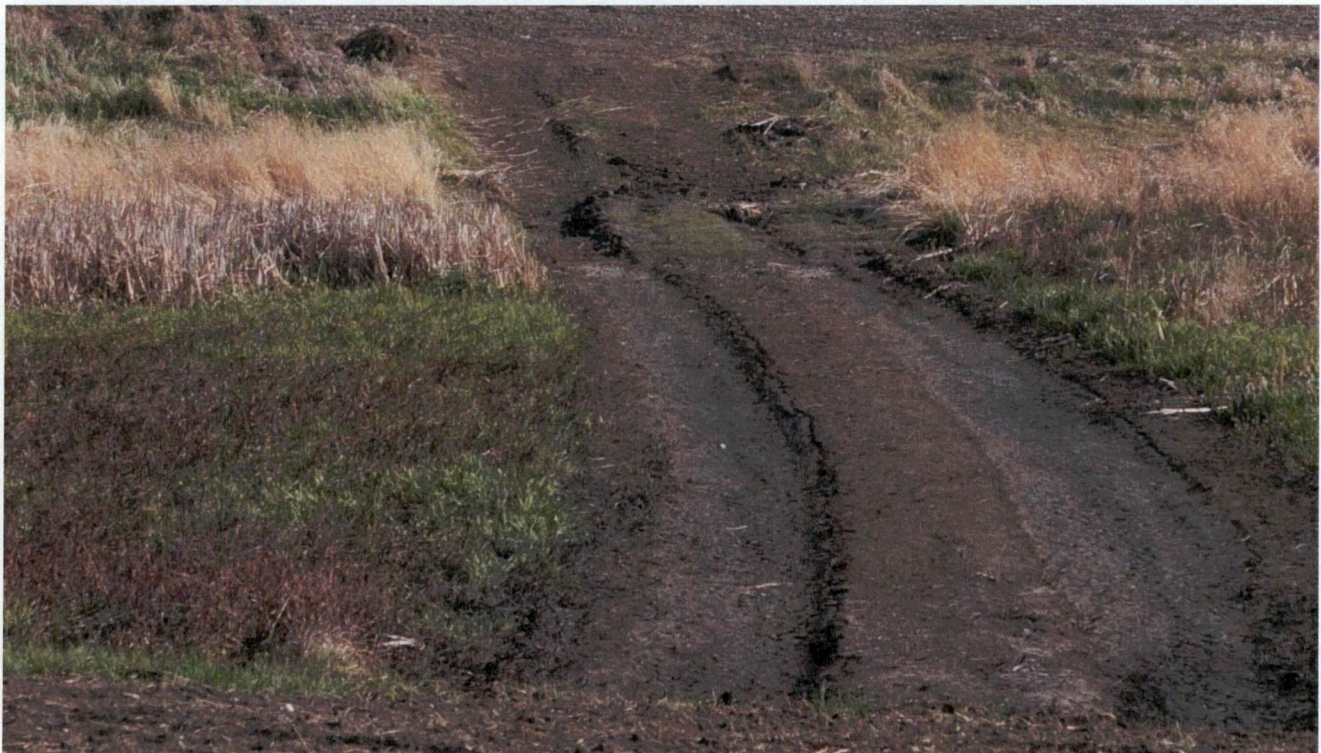
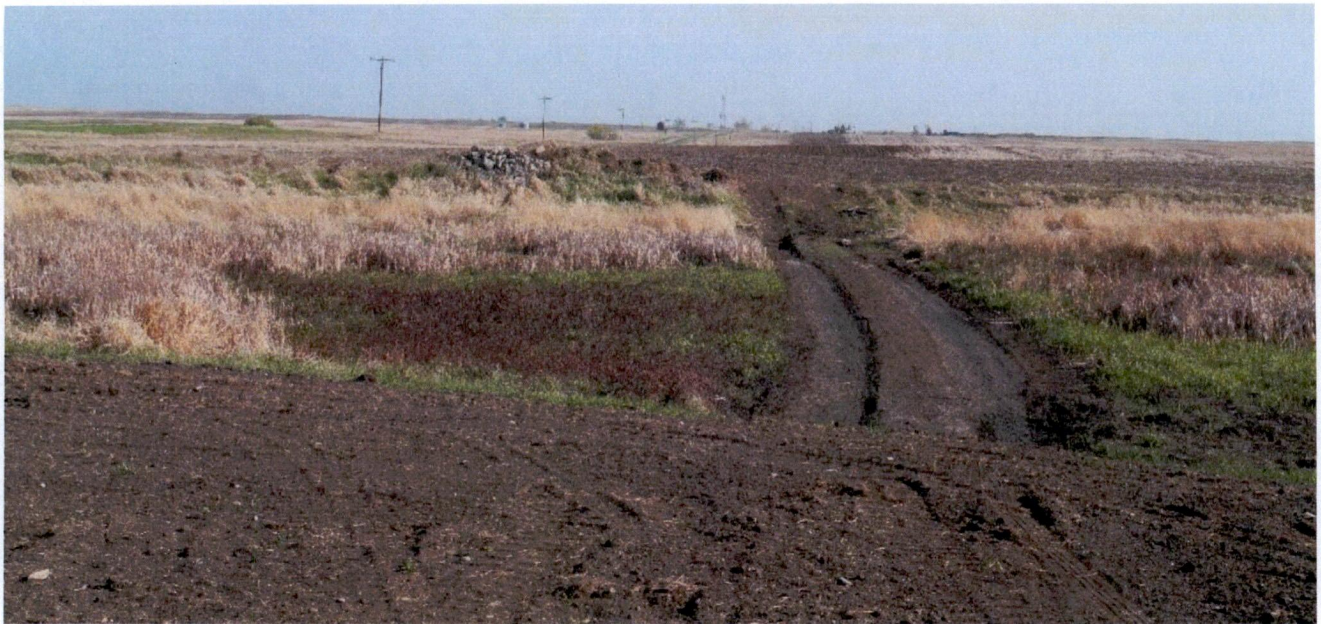
### **Damage to wetlands**

The following photos show an area about a mile south of the intersection between Highway 50 and 121<sup>st</sup> Ave NW in Alamo, ND, where heavy equipment was apparently driven straight through a wetland without using a mat bridge to minimize compaction of sensitive soil. The wetland area is not apparently part of the right-of-way and ideally the contractor would have avoided taking heavy equipment across it at all, much less crossing without a mat bridge. Obviously, the area has not been restored to anything approximating its original condition.

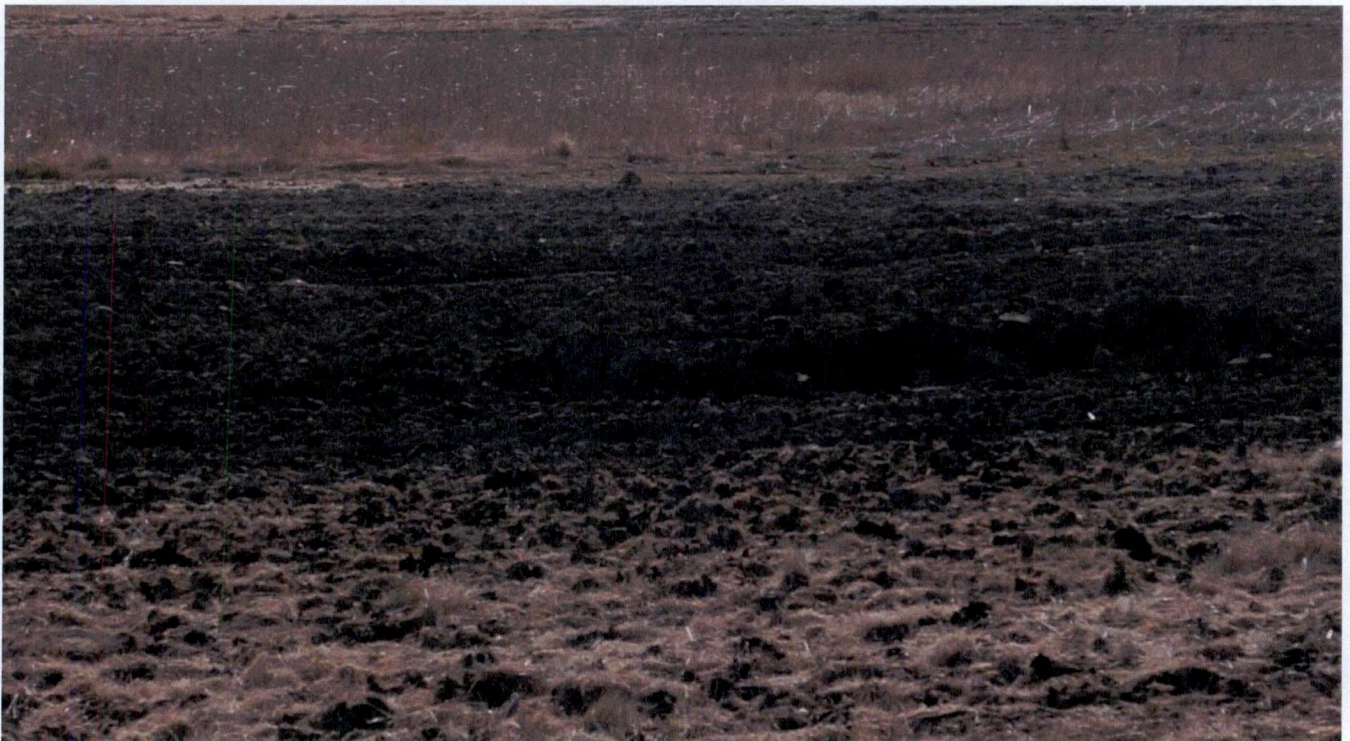
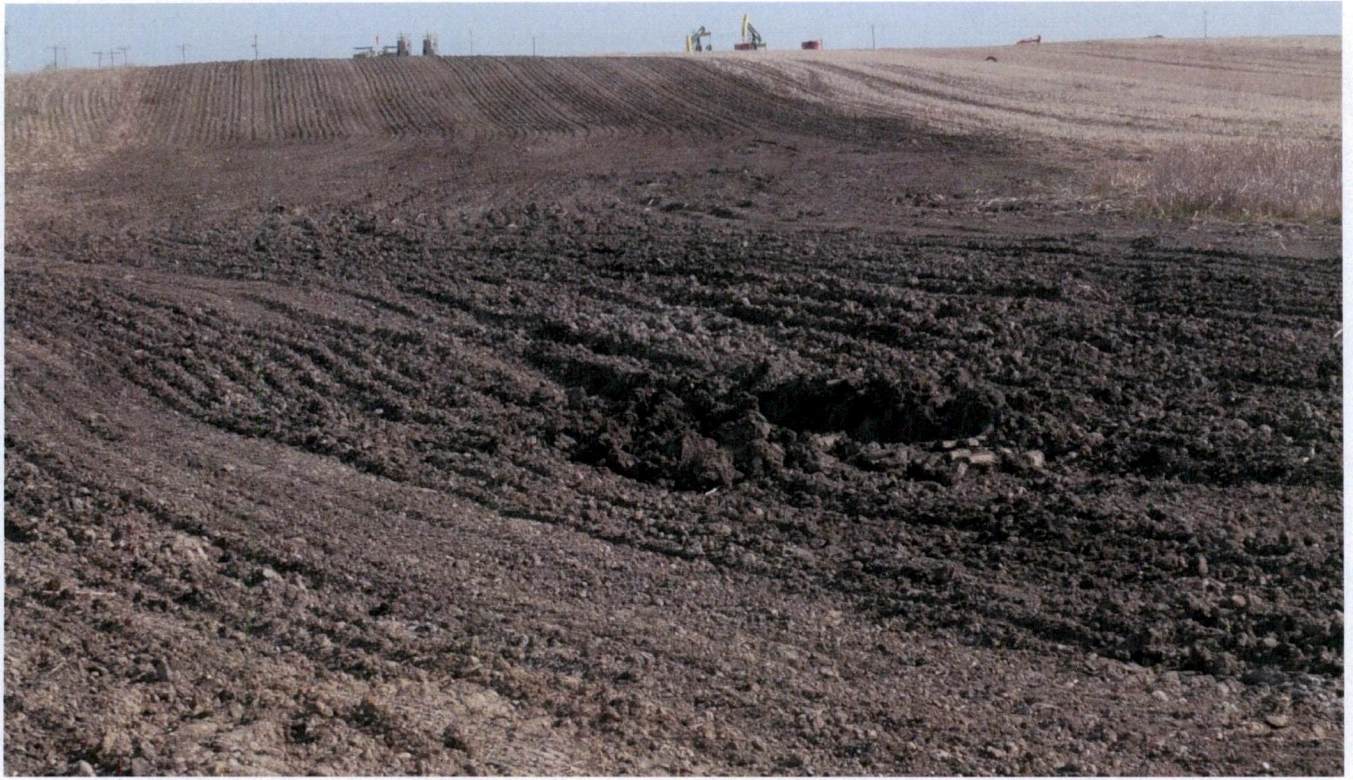
### **Poor-quality restoration threatens agricultural productivity**

The last set of photos shows a sunken ditch in an agricultural field along a company right-of-way located about a mile south of Highway 50 and 121<sup>st</sup> Avenue NW in Alamo. A sunken ditch often results from the failure of a contractor to properly compact the soil when the trench is filled. Sunken ditches tend to flood, rendering them unproductive, and many North Dakota landowners complain of farm equipment getting stuck in sunken ditch on pipeline right-of-way.
