RE: 230 kV TRANSMISSION LINE (MCHENRY & WARD COUNTIES)
REVEGETATION REPORT AND TREE AND SHRUB SURVIVAL INSPECTION
(CASE NO. PU-17-102)

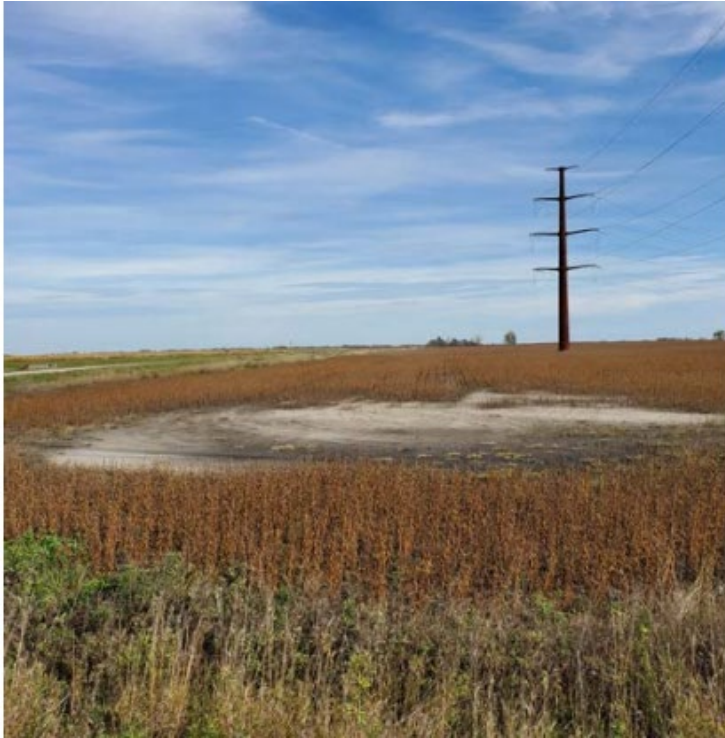
“During the reclamation and revegetation inspection, as shown in photos 8 and 23, a few minor areas need correction. Otherwise, no concerns were observed at either substation site or the transmission line.”

Photo 8 (Attachment A to this letter) is of a bare spot in a soybean field; the photo was taken over one year after the Company’s construction and restoration activities were completed. The bare spot appears to be an area where flooding or retained water prevented soybean germination or growth and therefore is not the result of any unsuccessful restoration work. Photo 23 (also shown on Attachment A) is a picture of the McHenry substation, and the project work done there was completed by Great River Energy (GRE). We have been in contact with GRE on the sediment issue shown in the photo and GRE has field personnel checking on the site this week. They have committed to taking the steps necessary to remedy the issue.
