Public Service Commission

<input type="checkbox"/> Operator failed to provide or update the information provided to the notification center on a timely basis <input type="checkbox"/> Excavator failed to provide excavation or location notice at least 48 hours before beginning any excavation <input type="checkbox"/> Excavator failed to provide required information in excavation or location notice <input type="checkbox"/> Notification center failed to transmit the notice to every operator that has an underground facility in the area of the excavation <input type="checkbox"/> Notification center failed to inform the excavator of the names of operators of underground facilities in the area <input type="checkbox"/> Operator failed to locate and mark underground facility within 48 hours <input type="checkbox"/> Excavation started prior to underground facility locate <input type="checkbox"/> Operator failed to mark underground facility within 24 inches horizontally <input type="checkbox"/> Excavator failed to renew excavation or location request prior to the expiration of the twenty-one-day period <input checked="" type="checkbox"/> Excavator failed to conduct the excavation in a careful

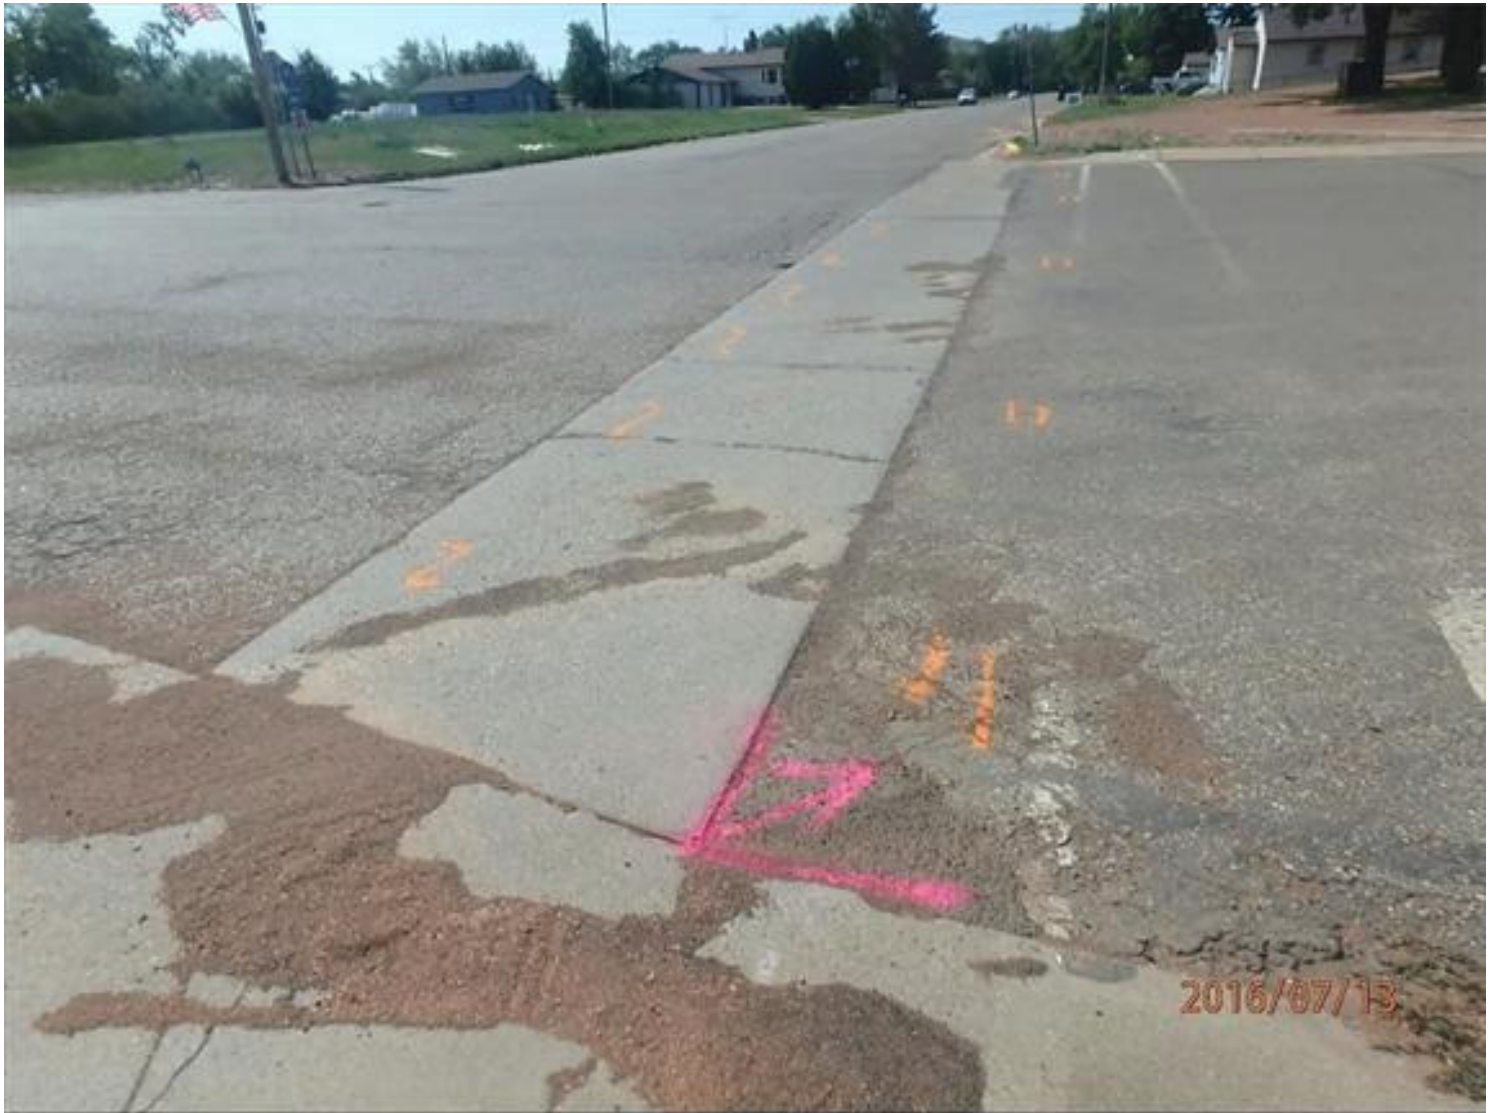
Ticket: 14092807.0 Timestamp: 7/13/2016 9:32:04 AM

The attached picture 7-13-16 (1) is a picture taken by ELM on 7-13-16. In this picture you are looking south. It was the South West corner of this intersection that Veit damaged WRT facilities. WRT have two areas of facilities running North and South in this intersection. The west facilities to the right of the center of the picture are marked by two stripes on the asphalt between the crosswalk and the concrete valley gutter. The second facilities are marked by one stripe on the left side of the concrete valley gutter. This is the specific facilities that VEIT damaged in the South West corner of this intersection.

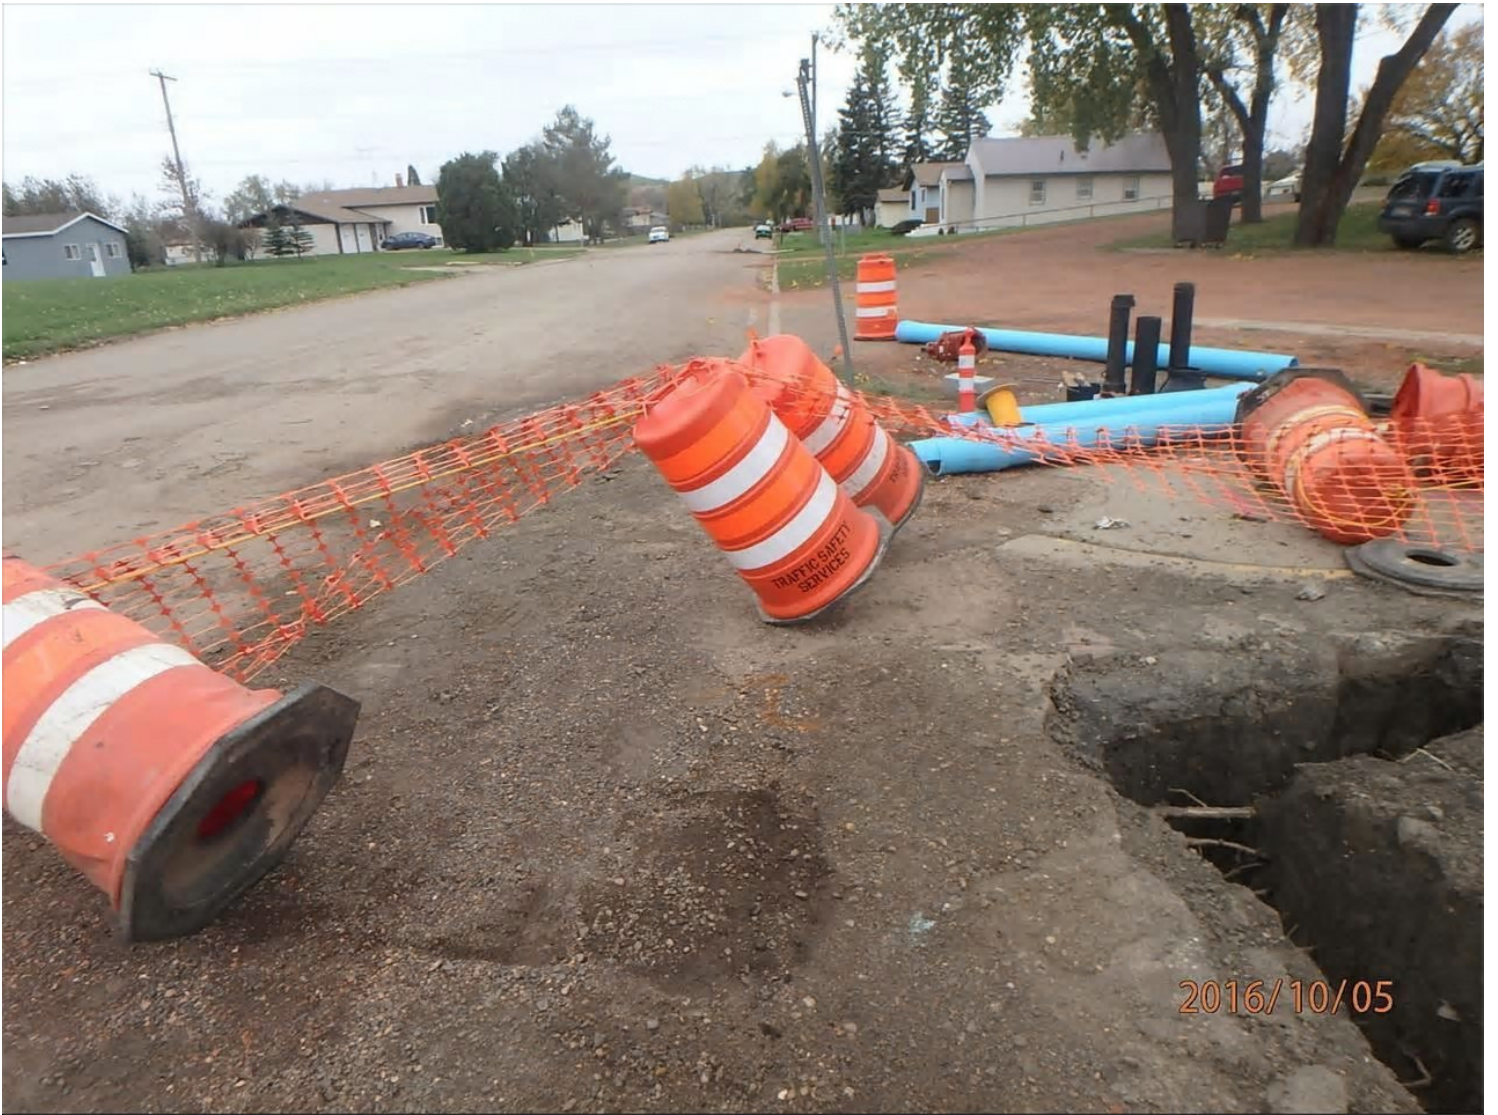
Ticket: 16152541.0 Timestamp: 10/5/2016 1:24:00 PM

The attached picture 10-5-16(1) is a picture taken by ELM on 10-5-16. In this picture it shows excavation on the right side where it seems the fiber has been spotted. Note the center of the picture just north of the two barricade barrels is an orange mark indicating the fiber that was eventually damaged on October 13 by Veit.

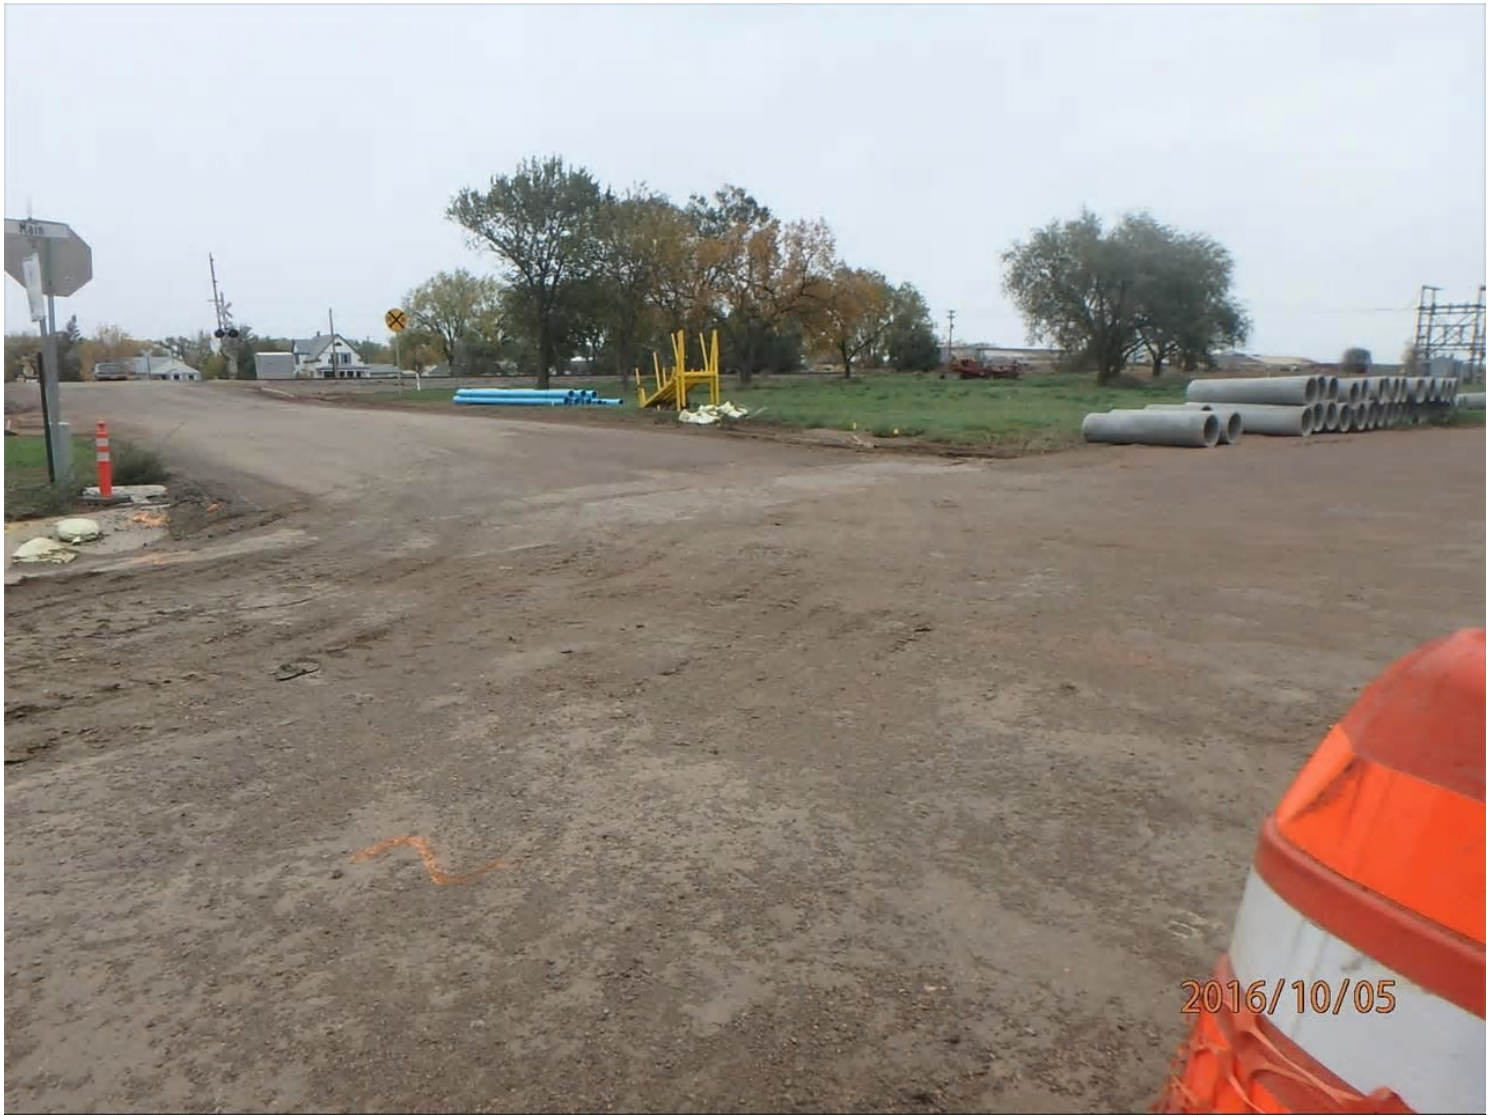
Ticket: 16152541.0 Timestamp: 10/5/2016 1:24:06 PM

The attached picture 10-5-16(3) is a picture taken by ELM on 10-5-16. This is the same area as picture 10-5-16(1). Just to the south of the two traffic barrels is another orange marking indicating the path of the fiber facility damaged by Veit.

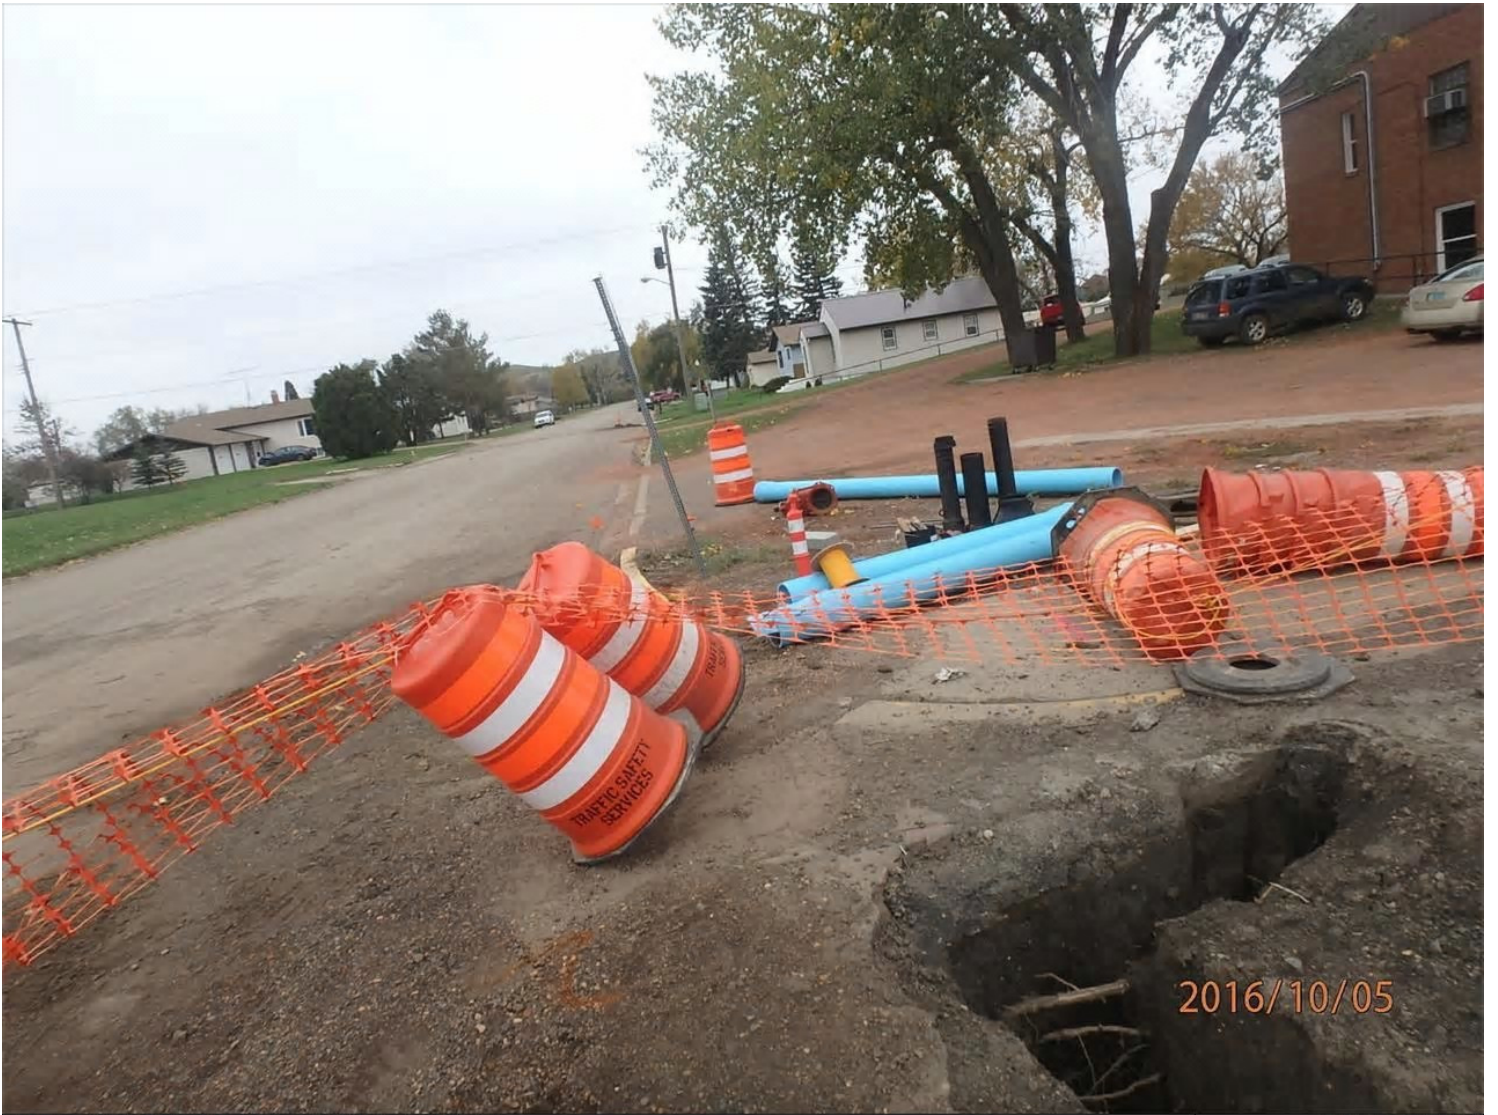
Ticket: 16152541.0 Timestamp: 10/5/2016 1:24:00 PM

The attached picture 10-5-16(2) is a picture taken by ELM on 10-5-16. This picture shows an orange mark in the lower left corner. This was the fiber eventually damaged by Veit. The damage occurred in about the location of the traffic barrel shown in this picture.

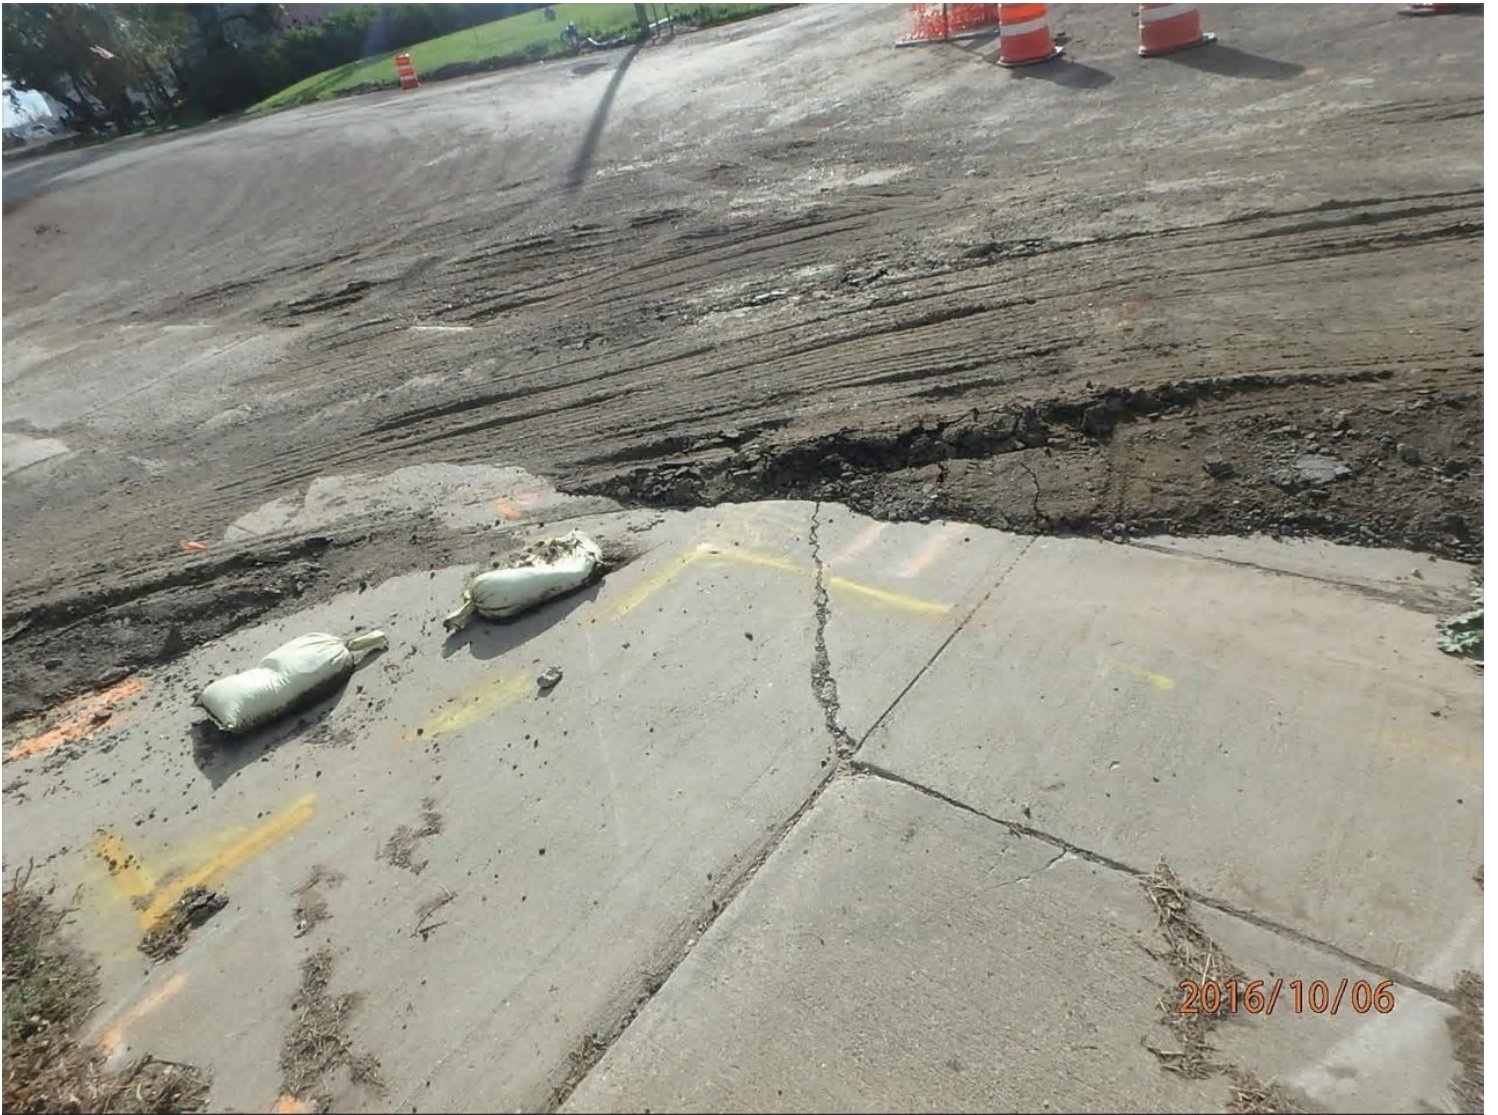
Ticket: 16154000.0 Timestamp: 10/6/2016 9:47:46 AM

The attached picture 10-6-16(2) is a picture taken by ELM on 10-6-16. This picture shows two orange marks on the sidewalk located at the top edge of the concrete. Approximately three feet to the left of the two orange marks is a single orange mark. This is the fiber that was damaged in the south west corner of this intersection.

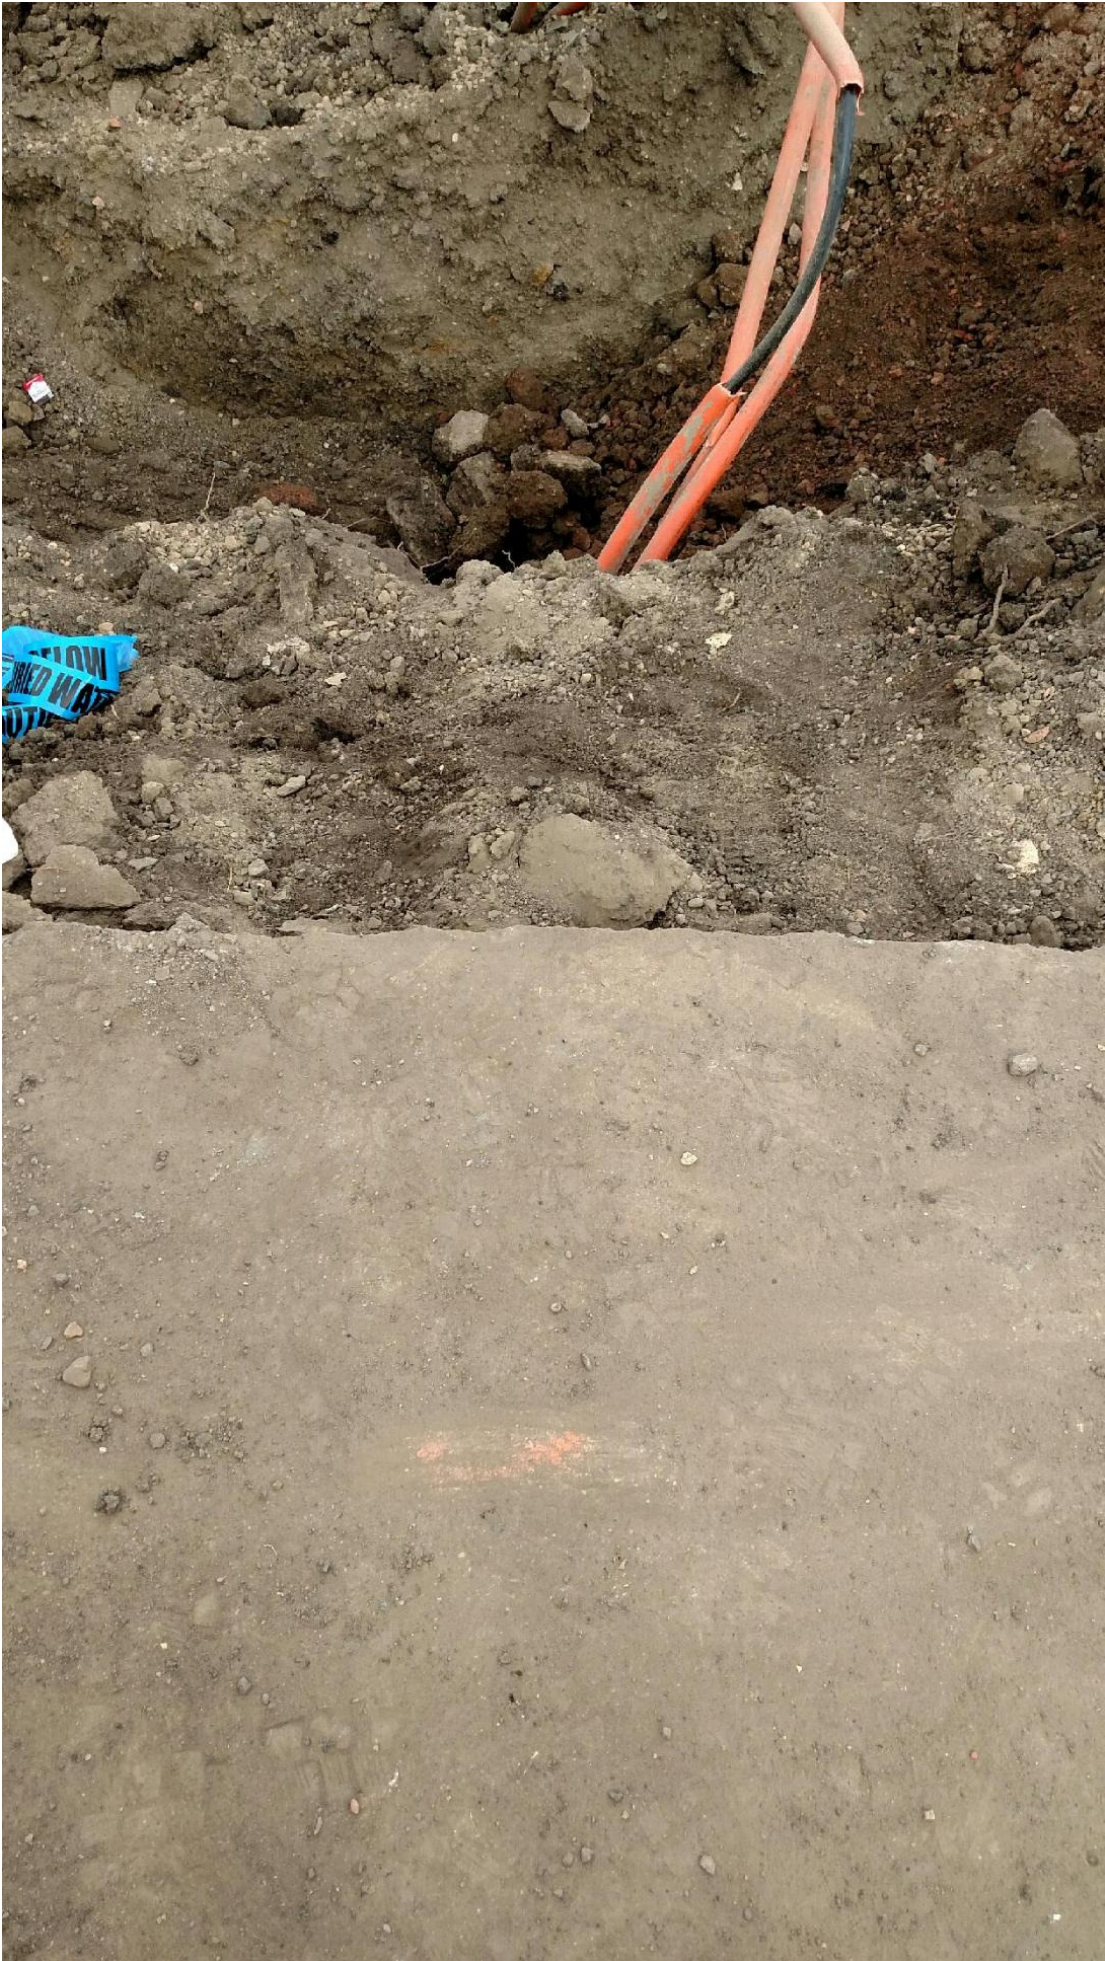
The attached picture 10-13-16(1) is a picture taken by ELM on 10-13-16. This picture shows an orange mark indicating the facilities damaged. Construction dirt was moved away with the investigators boot to clearly see the orange marking.

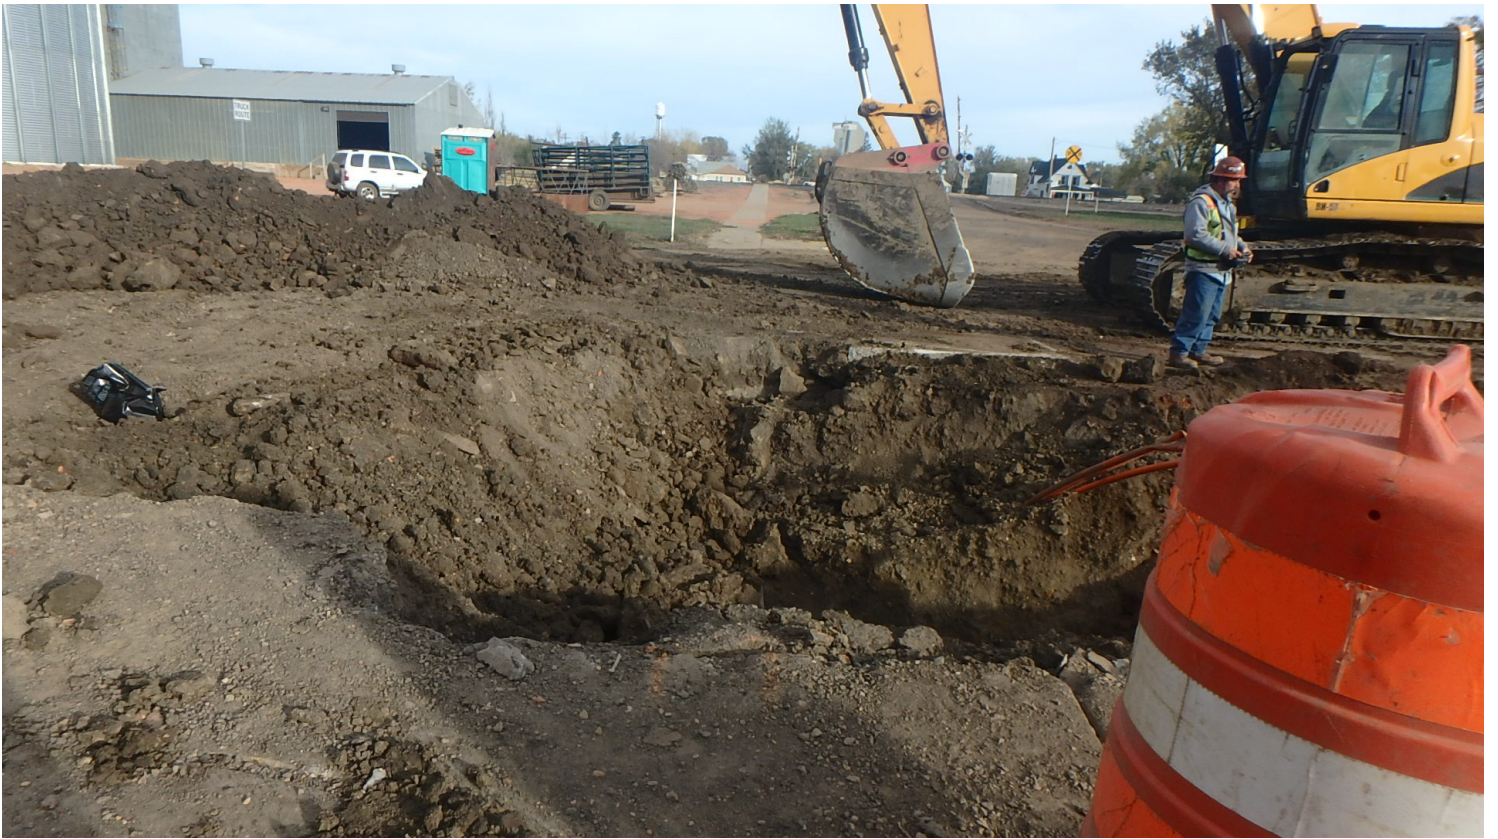
The attached picture 10-13-16(2) is a picture taken by ELM on 10-13-16. In this picture you can see the two orange marks indicating the fiber that was not damaged by Veit. The marks are in the center of the picture on this side of the excavation edge.

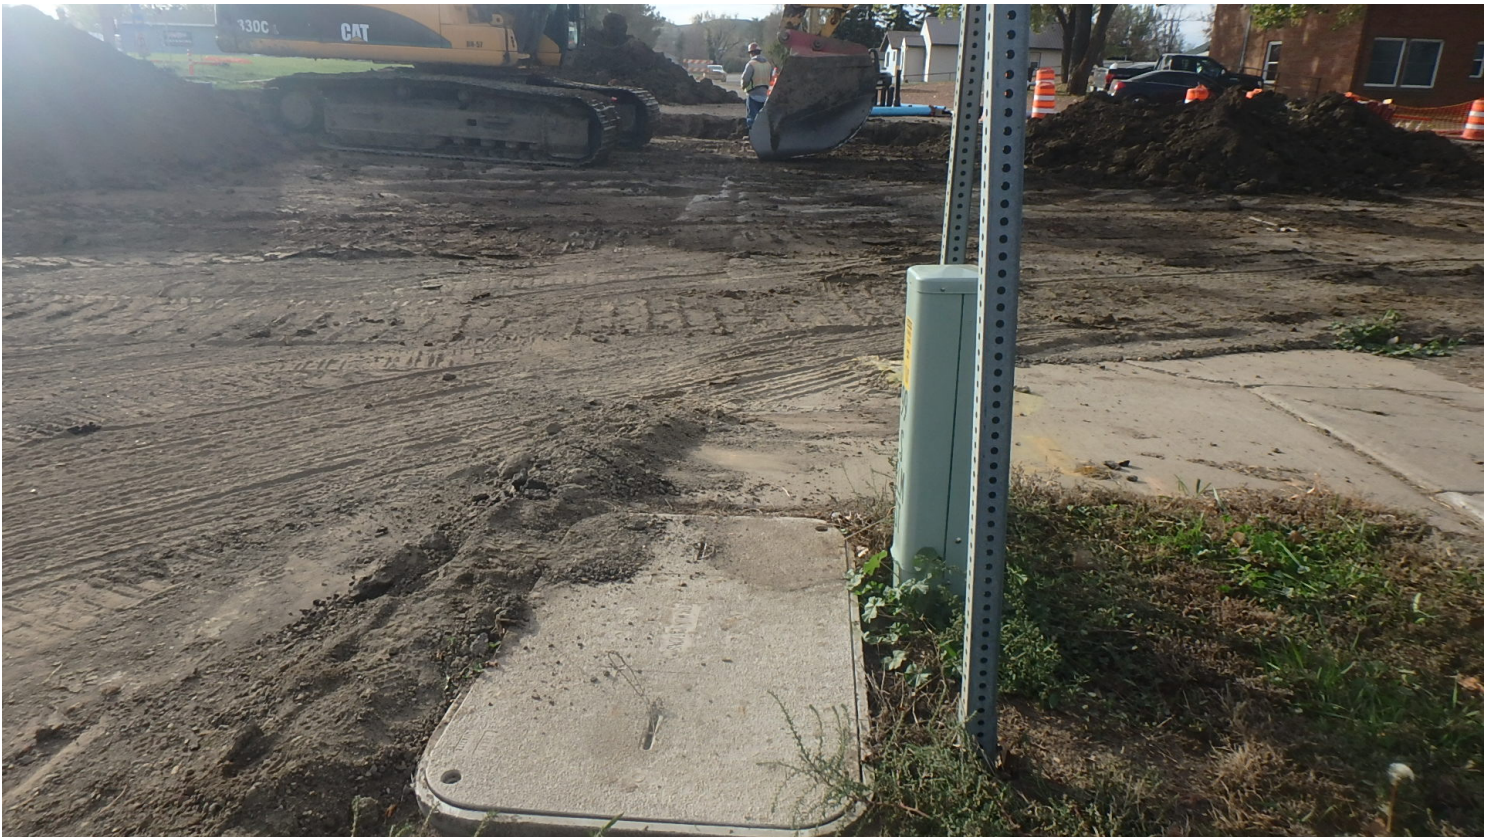
The attached picture 10-13-16(3) taken by WRT on 10-13-16. In this picture the orange mark a few feet south of the hand hole was covered with dirt. We move the dirt away to expose the marking. The damaged facilities is just south of the construction person in the picture.
