Application for a Certificate of Site Compatibility

Harmony Solar Project

Cass County, North Dakota

Harmony Solar ND, LLC

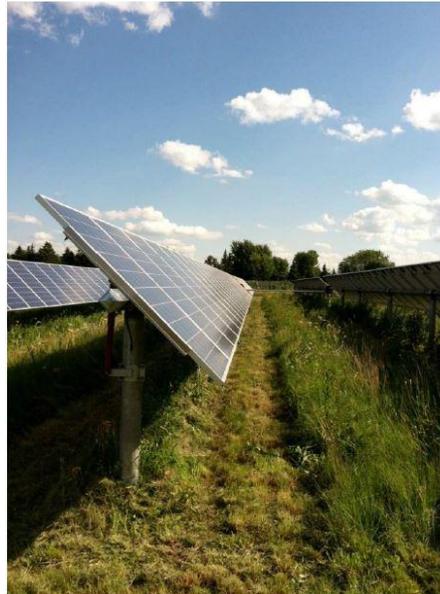
Image 1: Tracking System Racking

Images 1-3 below visually show the general racking equipment and dimensions of a linear axis tracking system.

The Project will utilize photovoltaic (PV) panels with tempered glass varying in size approximately 4 to 6.5 feet long by 2 to 3.5 feet wide, and 1 to 2 inches thick. The panels will be installed on a tracking racking system that utilizes galvanized steel and aluminum for the foundations and frame. Each rack will contain multiple panels. On the tracking system, panels will be up to 15 feet in height. Height may vary due to manufacturer, topography and vegetation constraints. Depending on the technology selected, the PV panels may have an aluminum frame, silicon, and weatherized plastic backing or a side-mount or under-mount aluminum frame, heat strengthened front glass, and laminate material encapsulation for weather protection.

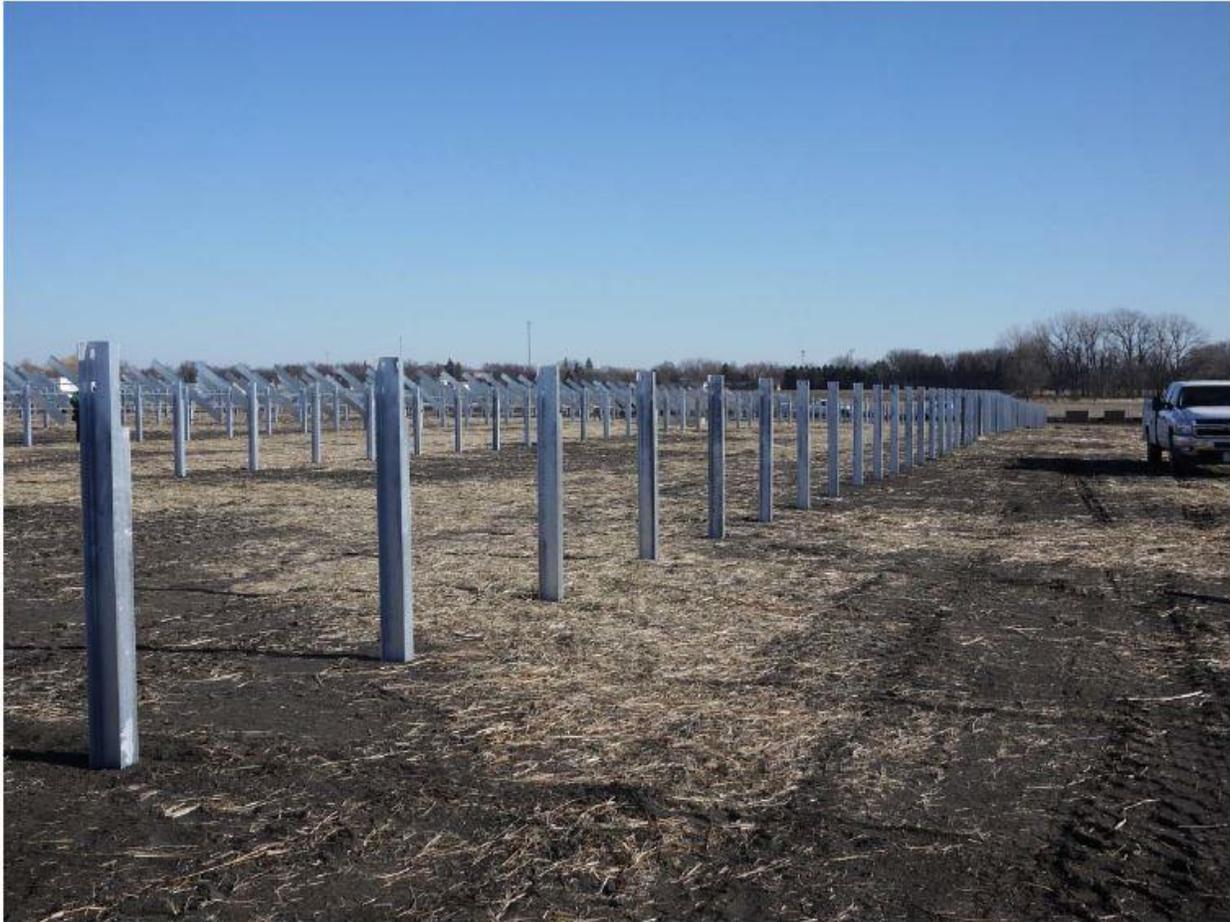
Image 3: Standard Steel Pier Foundations

Geotechnical and pull testing studies will be performed to determine the topsoil and subsoil types, and the mechanical properties of the soils. These variables will be used to engineer the solar array foundation system. Typically, the foundation is a steel pile, which is driven into the ground with a hydraulically powered high-frequency hammer mounted on a tracked carrier. The piles are installed at pre-defined locations throughout the array area to a depth of 8' to 14' below grade, depending on soils, frost depth, and other factors.

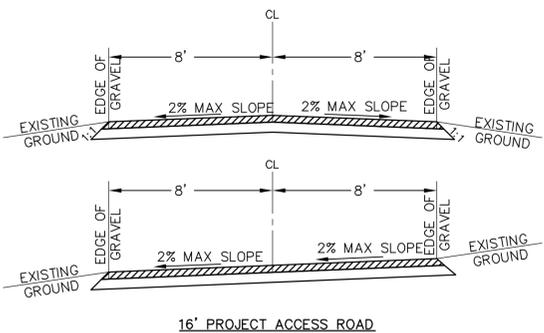
16' PROJECT ACCESS ROAD

Westwood	TYPICAL STRUCTURAL CROSS SECTIONS	LAST REVISED: 05/02/17
		RD02

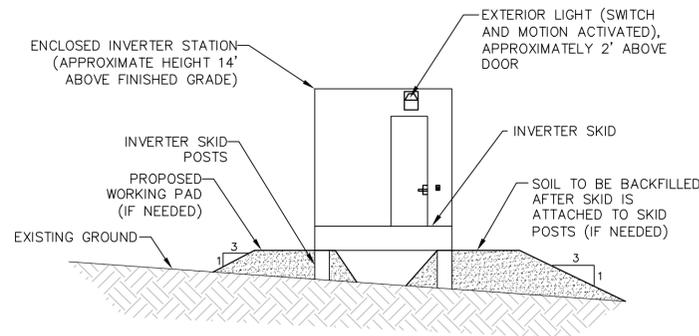
Westwood	TYPICAL SOLAR INVERTER ON DRIVEN PILES	LAST REVISED: 08/20/15
		INV01

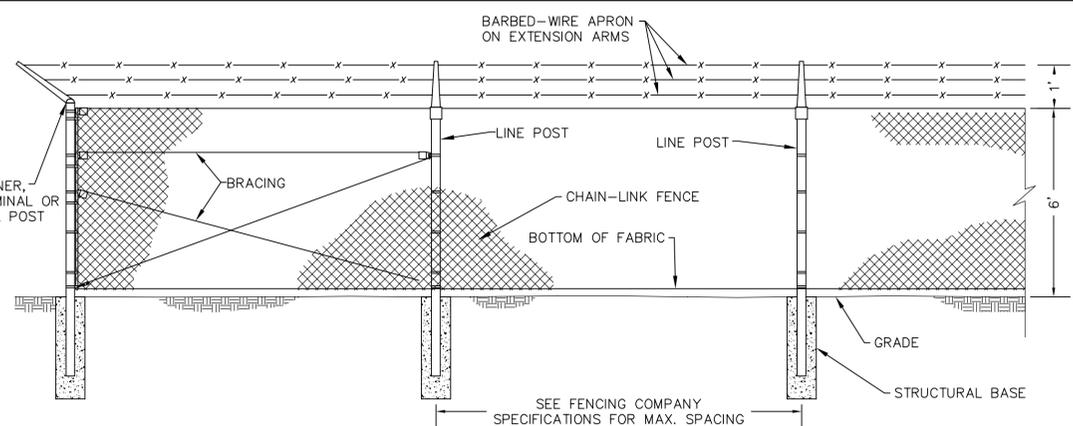
1. FENCE AND GATE TYPE TO BE APPROVED BY OWNER PRIOR TO CONSTRUCTION
2. STRUCTURAL DESIGN TO BE PROVIDED BY FENCE SUPPLIER
3. DIMENSIONS AND INFORMATION SHOWN ABOVE ARE FOR REFERENCE ONLY. ACTUAL DIMENSIONS AND INFORMATION TO BE PROVIDED BY MANUFACTURER/SUPPLIER
4. FENCING TO BE USED SHALL BE BLACK VINYL CHAIN LINK

Westwood	CHAIN-LINK SECURITY FENCE DETAIL	LAST REVISED: 08/04/16
	(NOT TO SCALE)	FN01

A 6-foot chain link with 1-foot of barbed wire will comprise the security fence that surrounds the perimeter of the Project. The Project will also have security cameras. Harmony may have security lighting at the entrances that will be down lit. There may be lights at each inverter that will be down lit and switch controlled for repair purposes. For more detail about the lighting proposed at the Project site, see Appendix A.

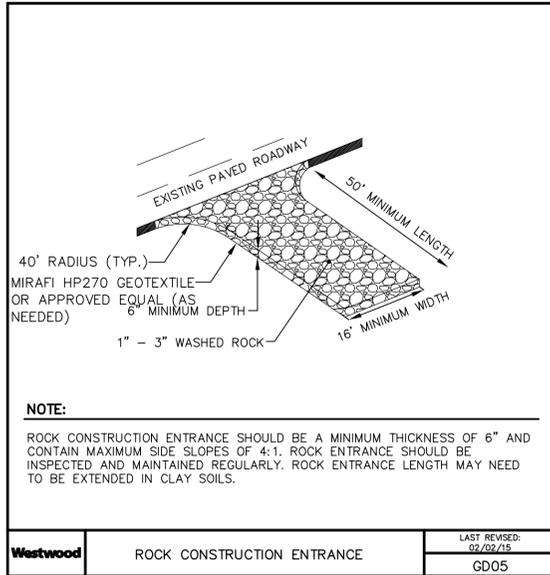
Westwood	ROCK CONSTRUCTION ENTRANCE	LAST REVISED: 02/02/15 GD05
----------	----------------------------	-----------------------------------

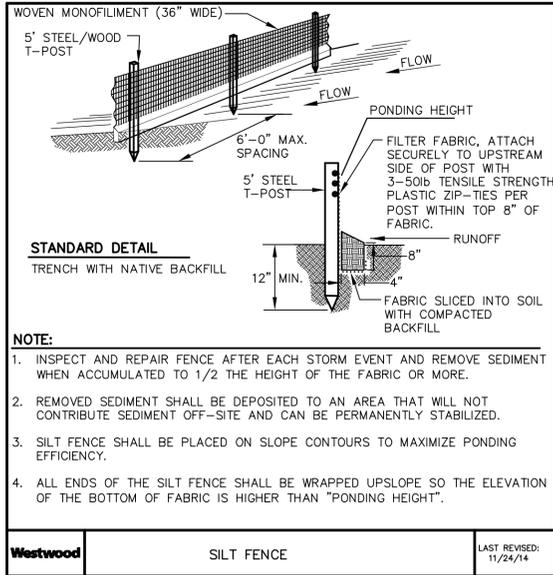
Westwood	SILT FENCE	LAST REVISED: 11/24/14
----------	------------	---------------------------

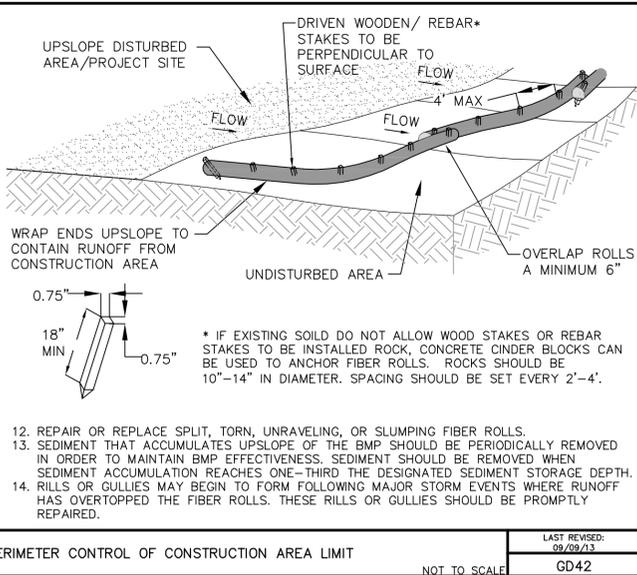
- NOTES:**
- FIBER ROLLS SHALL BE INSTALLED PRIOR TO UPSLOPE DISTURBANCE ACTIVITIES COMMENCE.
 - FIBER ROLLS SHALL BE PREFABRICATED AND MADE FROM WEED FREE RICE STRAW, FLAX, OR A SIMILAR AGRICULTURAL MATERIAL BOUND INTO A TIGHT TUBULAR ROLL BY NETTING. USE A 6" [152mm] OR 12" [305mm] DIA. ROLL.

- FIBER ROLLS MUST BE INSPECTED IN ACCORDANCE WITH GENERAL PERMIT REQUIREMENTS FOR THE ASSOCIATED PROJECT TYPE AND RISK LEVEL. IT IS RECOMMENDED THAT AT A MINIMUM, THE BMPs BE INSPECTED WEEKLY, PRIOR TO FORECASTED RAIN EVENTS, DAILY DURING EXTENDED RAIN EVENTS, AND AFTER THE CONCLUSION OF RAIN EVENTS.

Westwood	TYPICAL FIBER ROLLS FOR PERIMETER CONTROL OF CONSTRUCTION AREA LIMIT	LAST REVISED: 09/09/13 GD42
----------	--	-----------------------------------

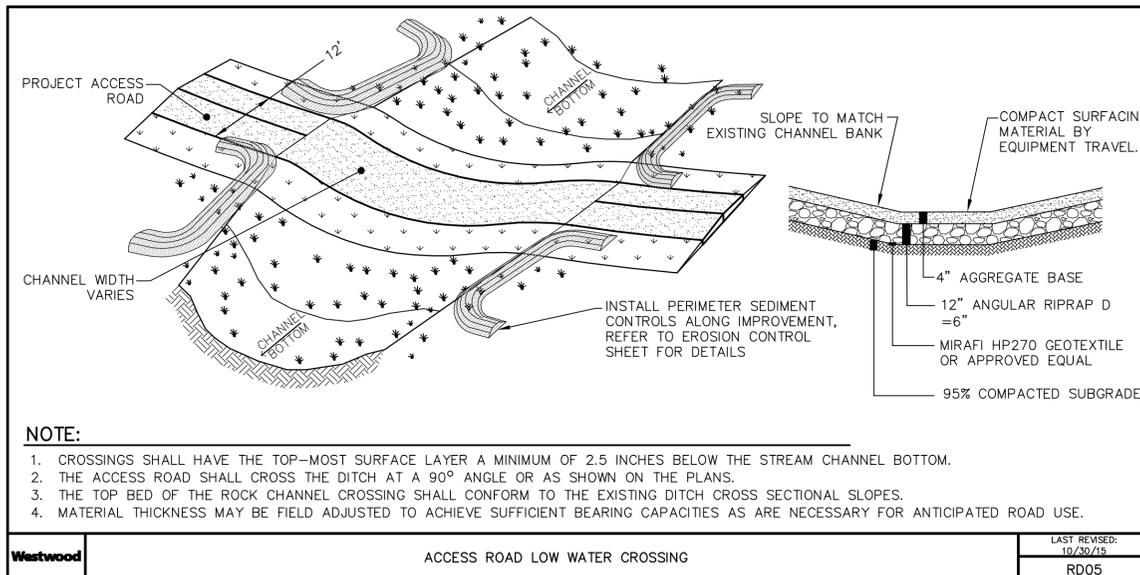
Westwood	ACCESS ROAD LOW WATER CROSSING	LAST REVISED: 10/30/15 RD05
----------	--------------------------------	-----------------------------------

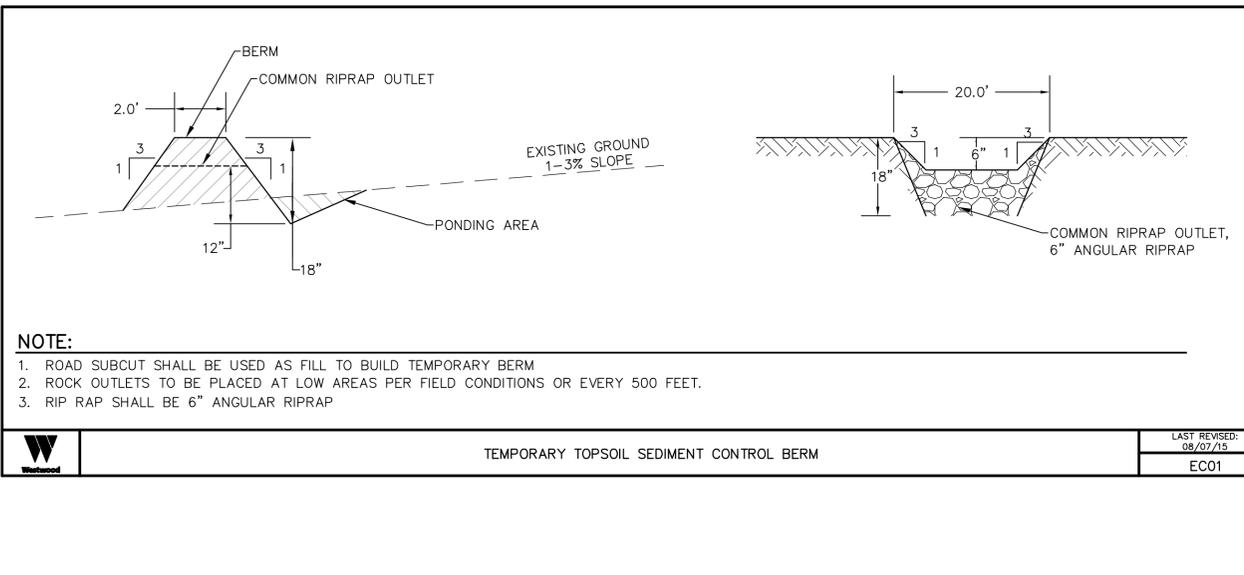
Westwood	TEMPORARY TOPSOIL SEDIMENT CONTROL BERM	LAST REVISED: 08/07/15 EC01
----------	---	-----------------------------------

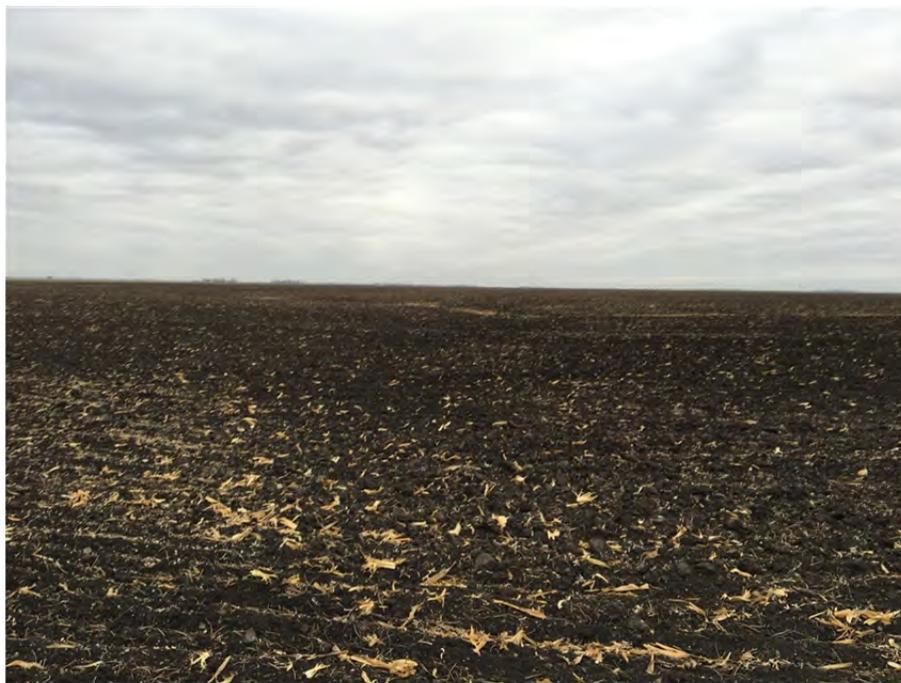
Photo 1. USGS 1:24,000 scale topography intermittent stream and NWI classification R4SBC in Section 16. Looking north from 33rd St. SE.

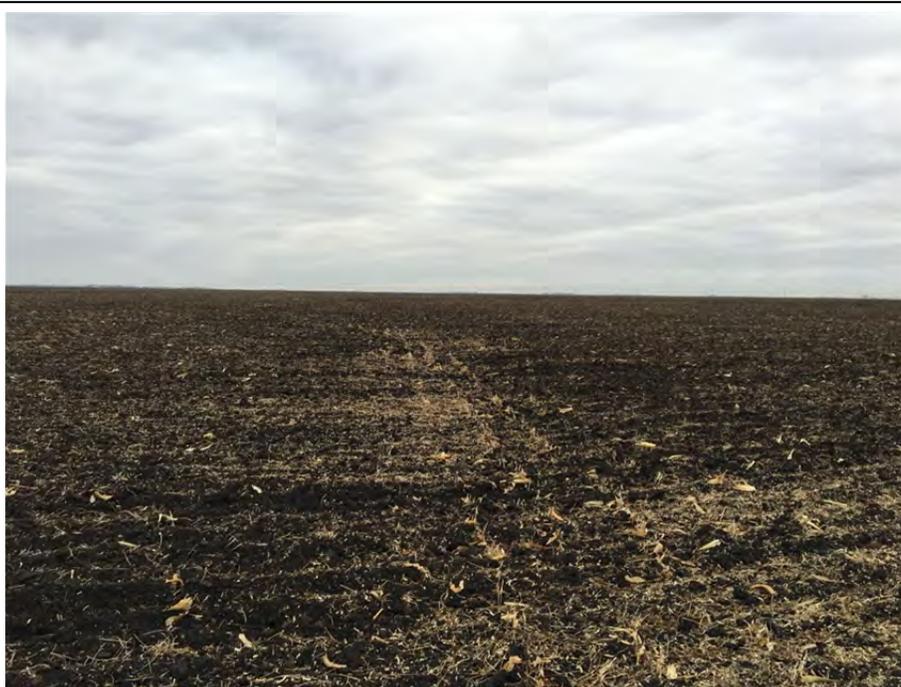
Photo 2. Looking north at same drainage feature as Photo 1, 230 yards north of 33rd St. SE.

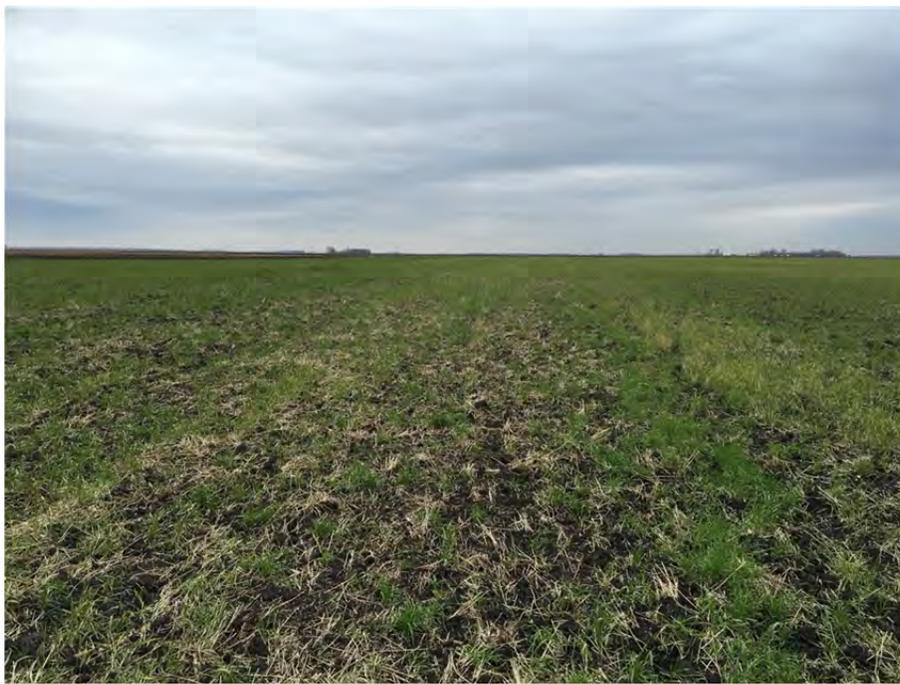
Photo 3. Looking west, general view of NE $\frac{1}{4}$ of Section 16. View exemplifies lack of topographic features indicative of Project area.

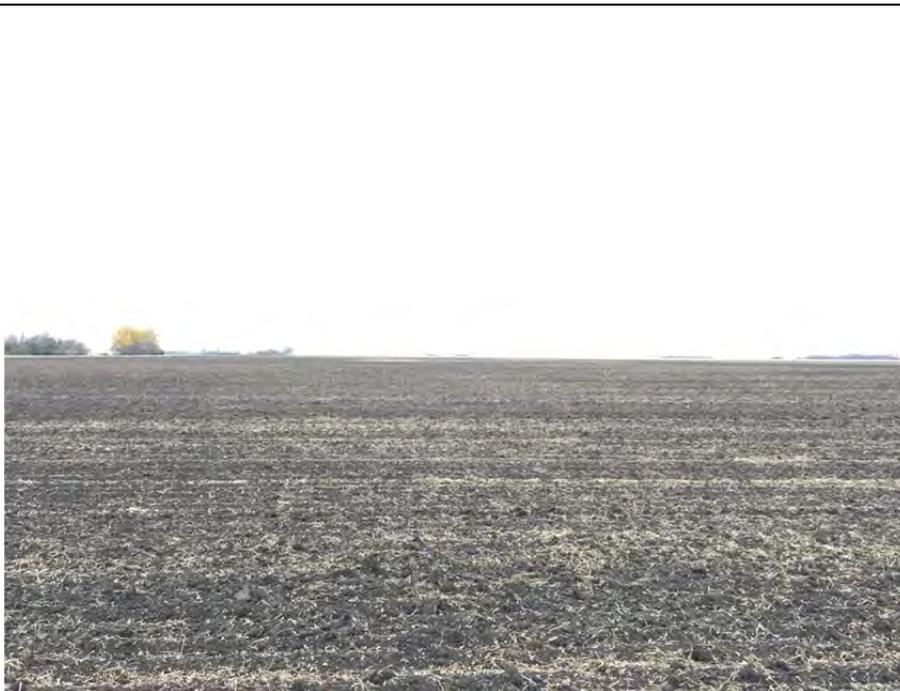
Photo 4. Looking south down drainage feature from NE $\frac{1}{4}$ of Section 16 towards the SE $\frac{1}{4}$ of Section 16.

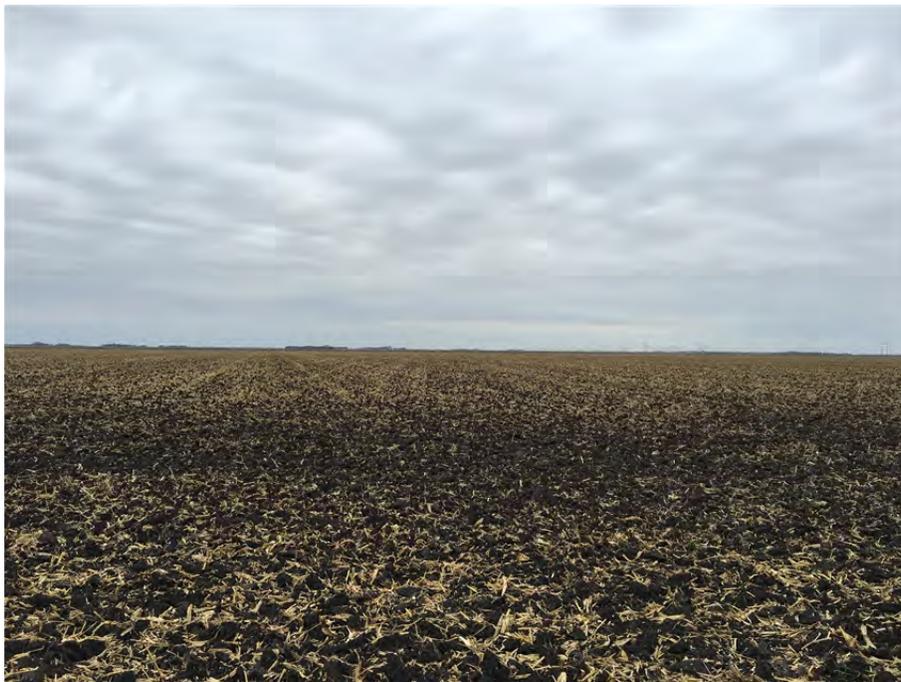
Photo 6. View looking east at NW $\frac{1}{4}$ of Section 10. Exemplifies lack of drainage feature aerial images suggest would run towards the horizon.

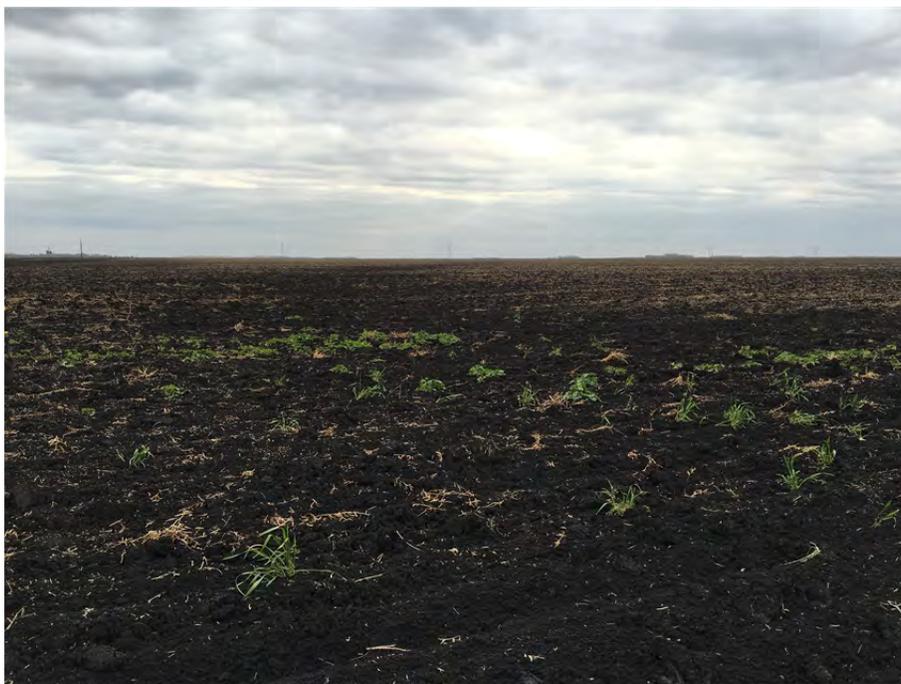
Photo 8. View south at NWI feature located in NE $\frac{1}{4}$ of the NW $\frac{1}{4}$ of Section 11. Water ponds in the area but does not create hydric soils.
