Reclamation Division

Memorandum

SUBJECT: Bond Release No. 8 to Surface Coal Mining Permit NACT-9101 held by the Coteau Properties Company, Case No. RC-19-180

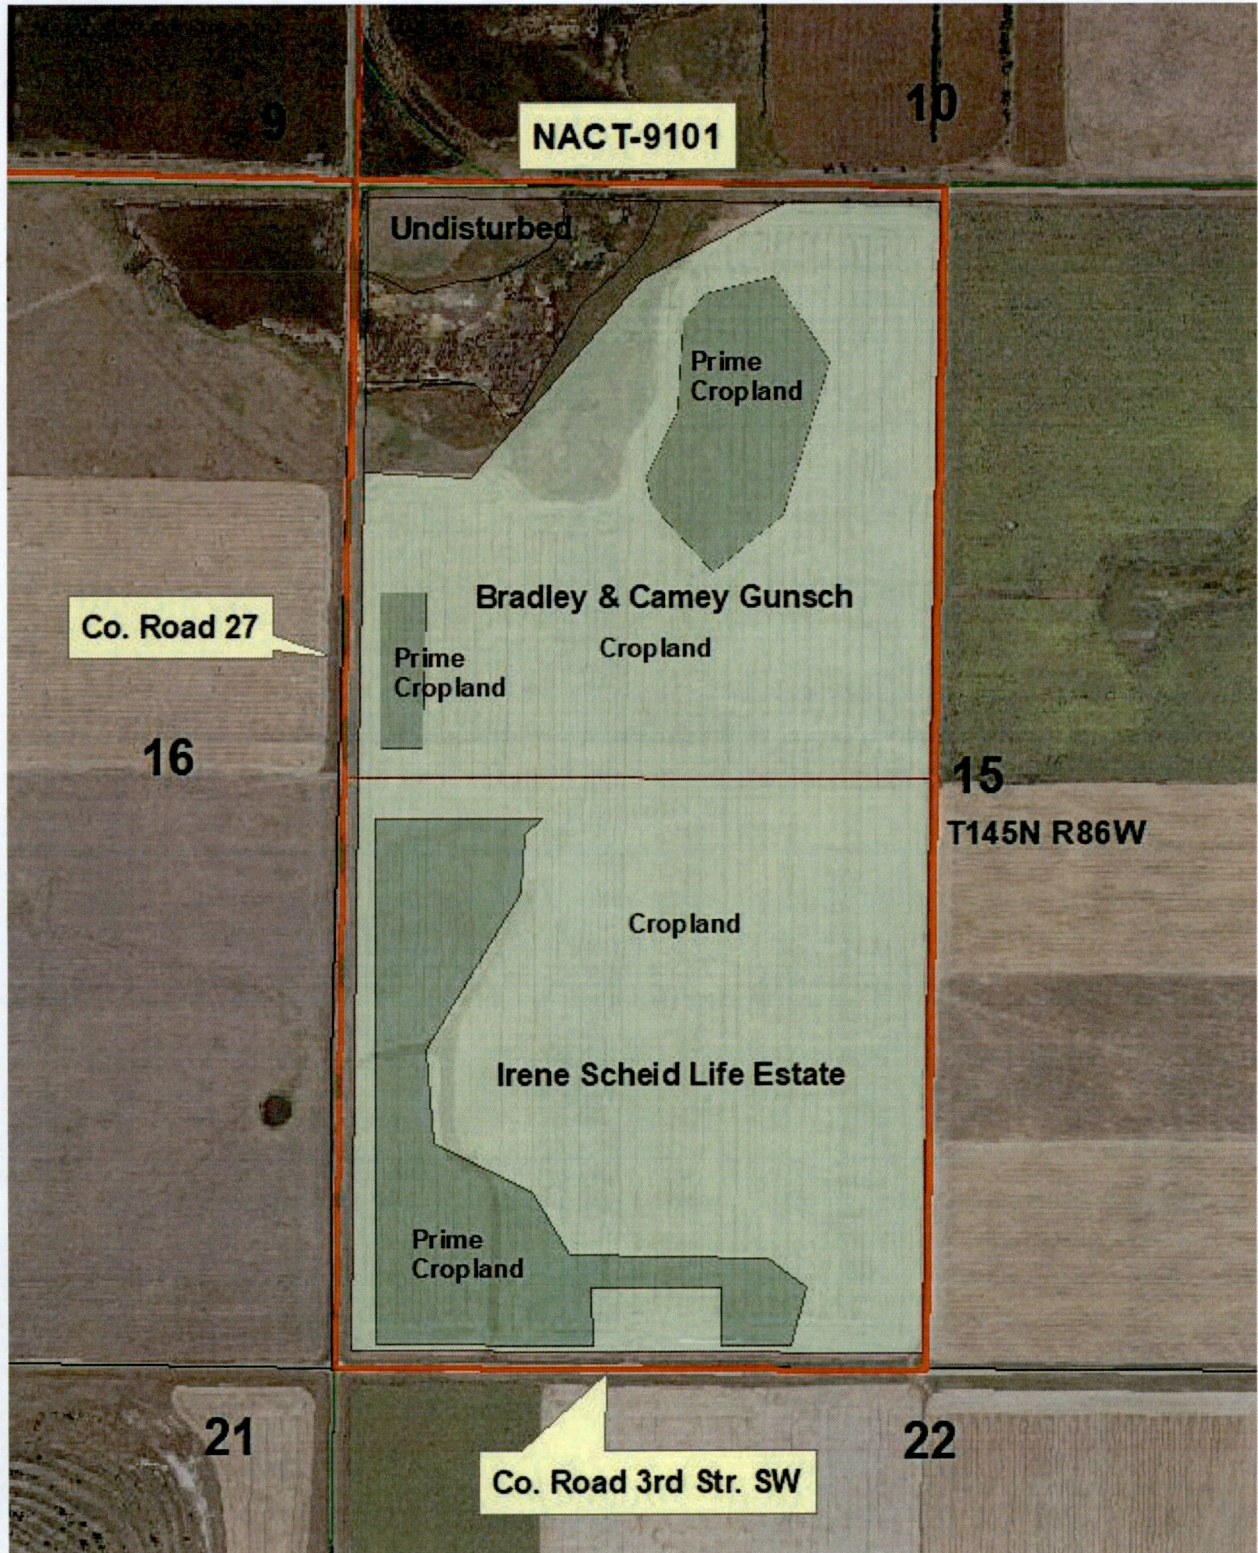
Figure 1: Final Bond Release No. 8 to Permit NACT-9101

The NW¼ of Section 15 is owned by Bradley and Camey Gunsch and the SW¼ of Section 15 is owned by the Irene Scheid Life Estate. Both tracts have been leased to a farmer / cooperater who has managed both tracts as a single unit comprising the W1/2 of Section 15. The bond release tract will be referred to as the W1/2 of Section 15. The bond release tract contains 285.3 acres of cropland, 19.8 acres of wetland and 13.5 acres of road rights-of-way. Approximately 255.5 acres were affected by mining related activities and 63.1 acres were not affected by mining. Lands affected by mining were reclaimed to 247.7 acres of cropland, of which approximately 119.6 acres is prime farmland, and 7.8 acres of county road and adjoining road right-of-way. Approximately 2.6 acres of temporary wetland were replaced in the NW1/4 of Section 15. Figure 1, attached, provides an overview of the bond release tract.
