North Dakota Public Service Commission,

Applicable ND One Call locate ticket number: 19142730

3 **PU-19-356** Filed: 11/21/2019 Pages: 5
Response to North Dakota One-Call Complaint

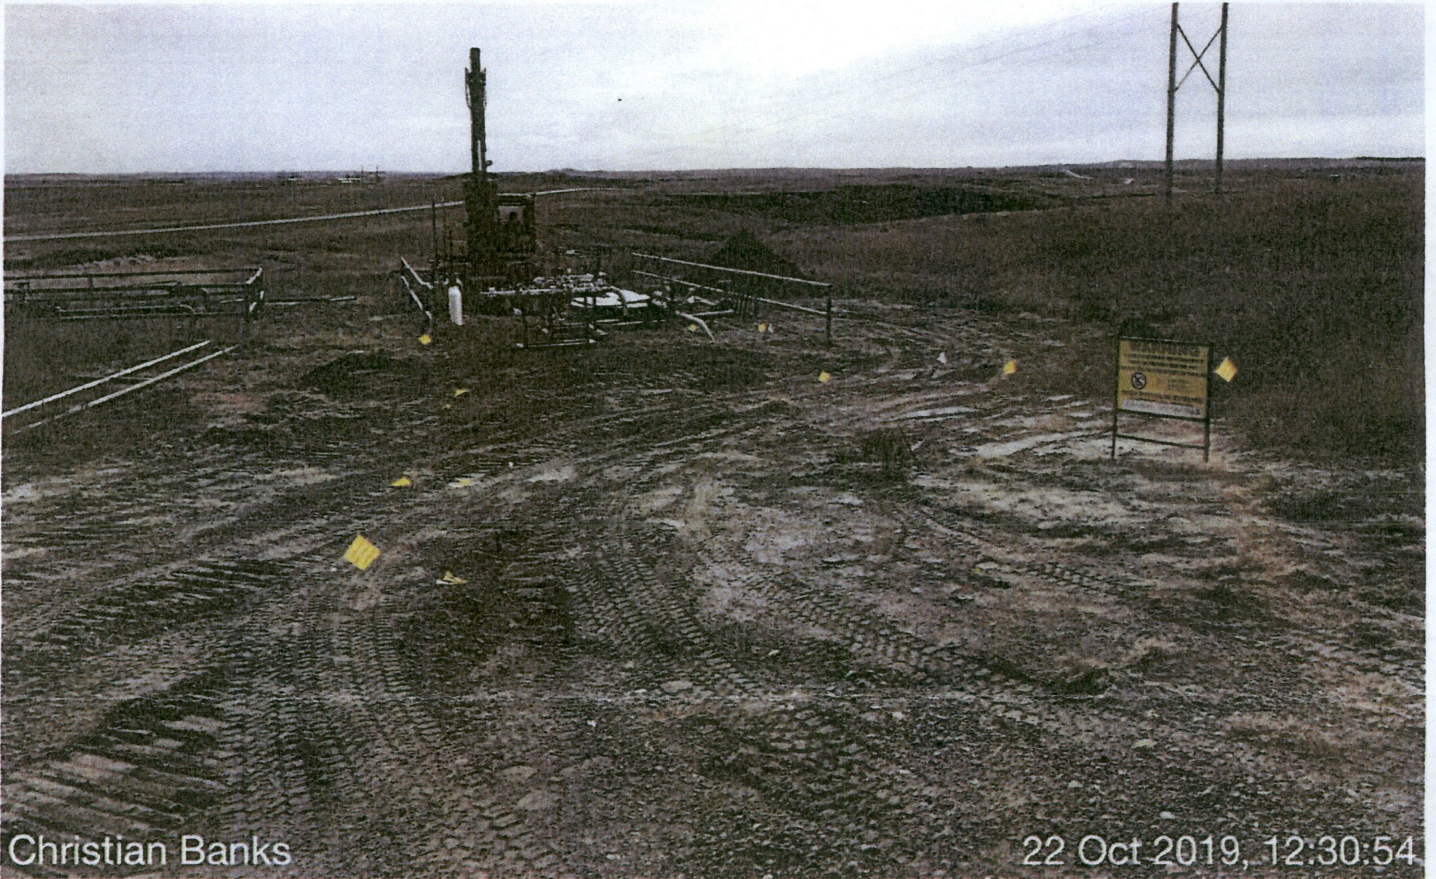
Picture # 1

The picture marked as #1 is a little miss leading to us. It's dated October 22, 2019 at 12:30:54 with no excavation taking place, and the Kinder Morgan rep. supposedly got to location at 1:00 pm.

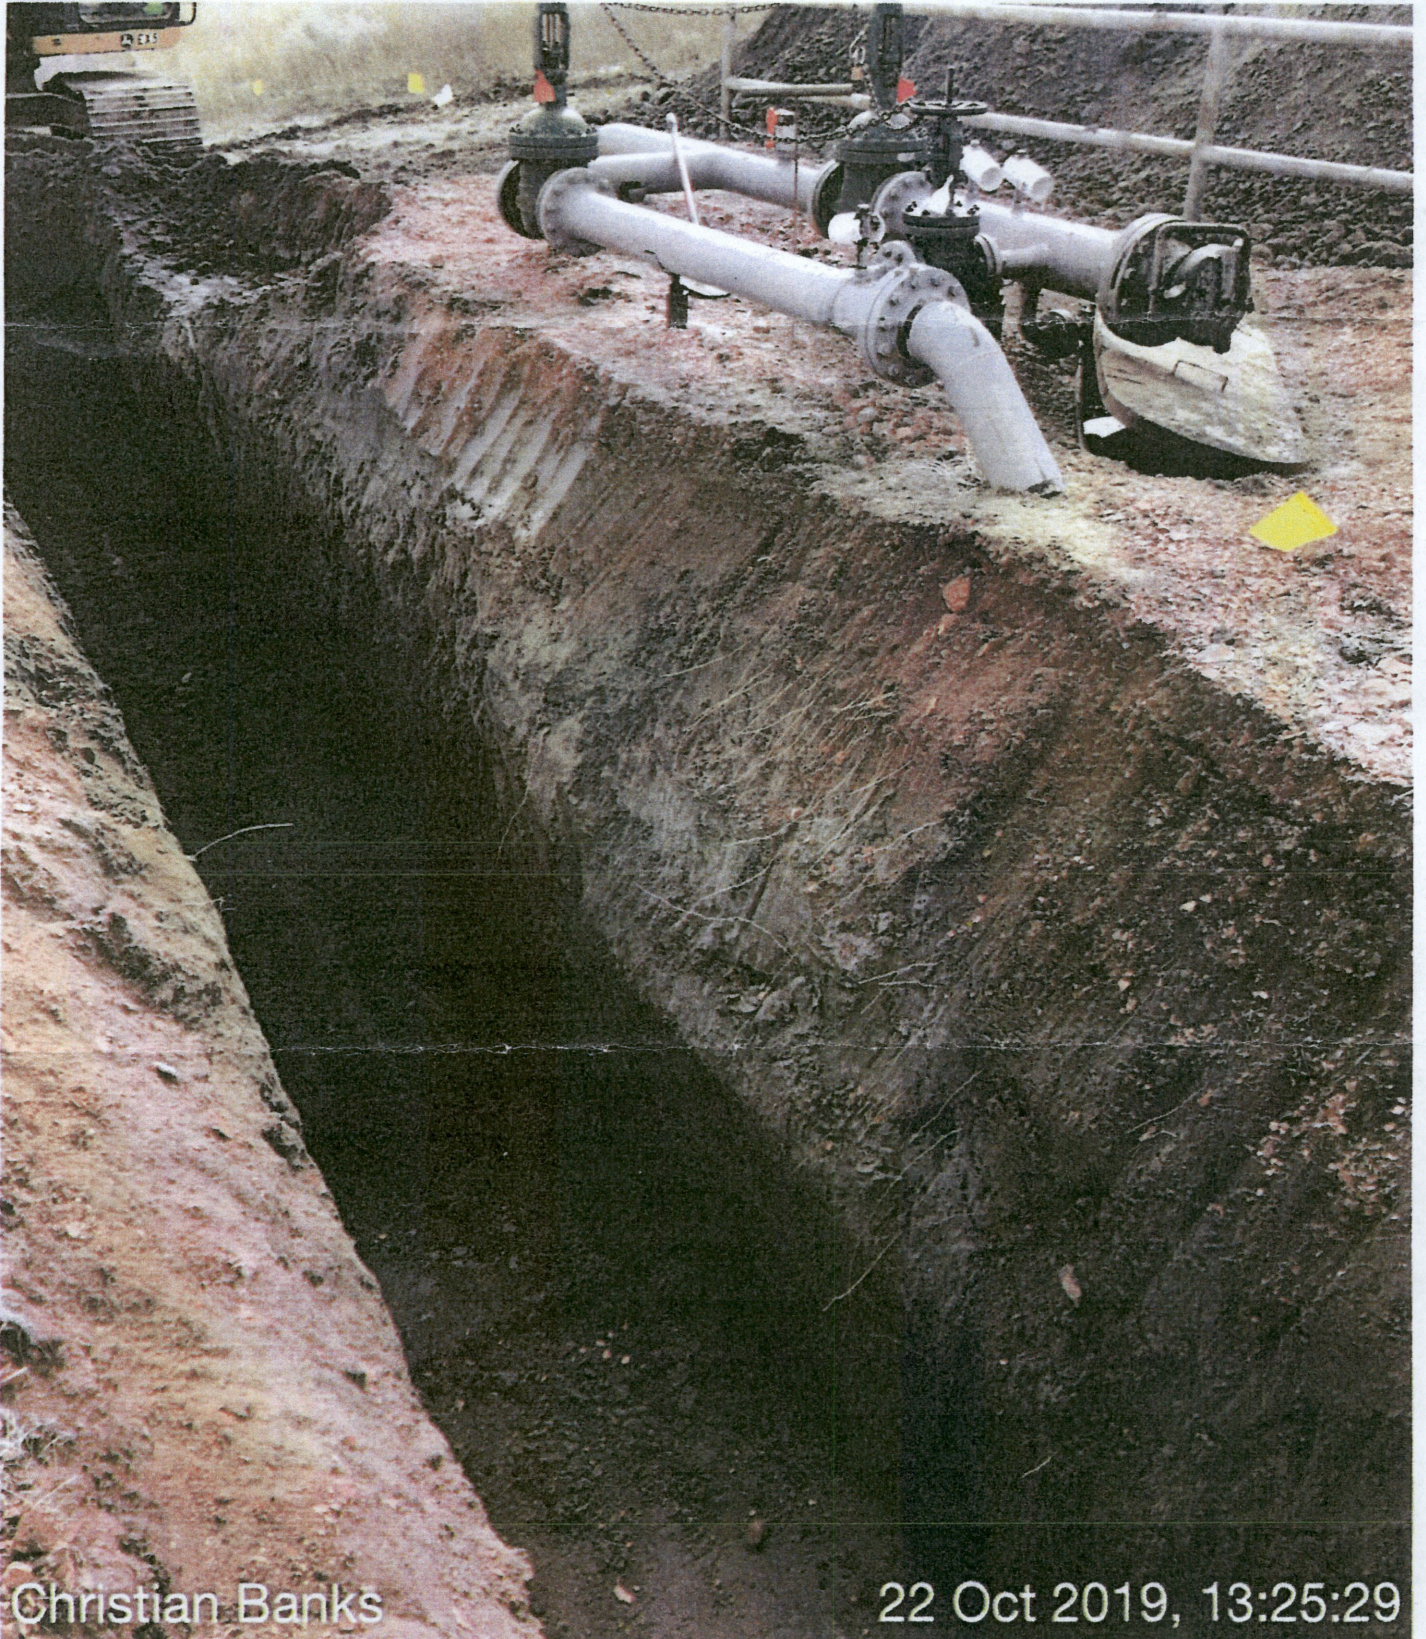
Picture #2

The picture marked as #2 clearly indicates where the operator did the excavation with the bucket of the excavator and where the employees sloped off the remaining 18" with shovels from the trench up to within approximately 10" of Kinder Morgan pipeline. Once the operator got pass the Kinder Morgan piping you can clearly tell that he started benching with the excavator. (Note the shovel marks on the slope midway down the piping.)

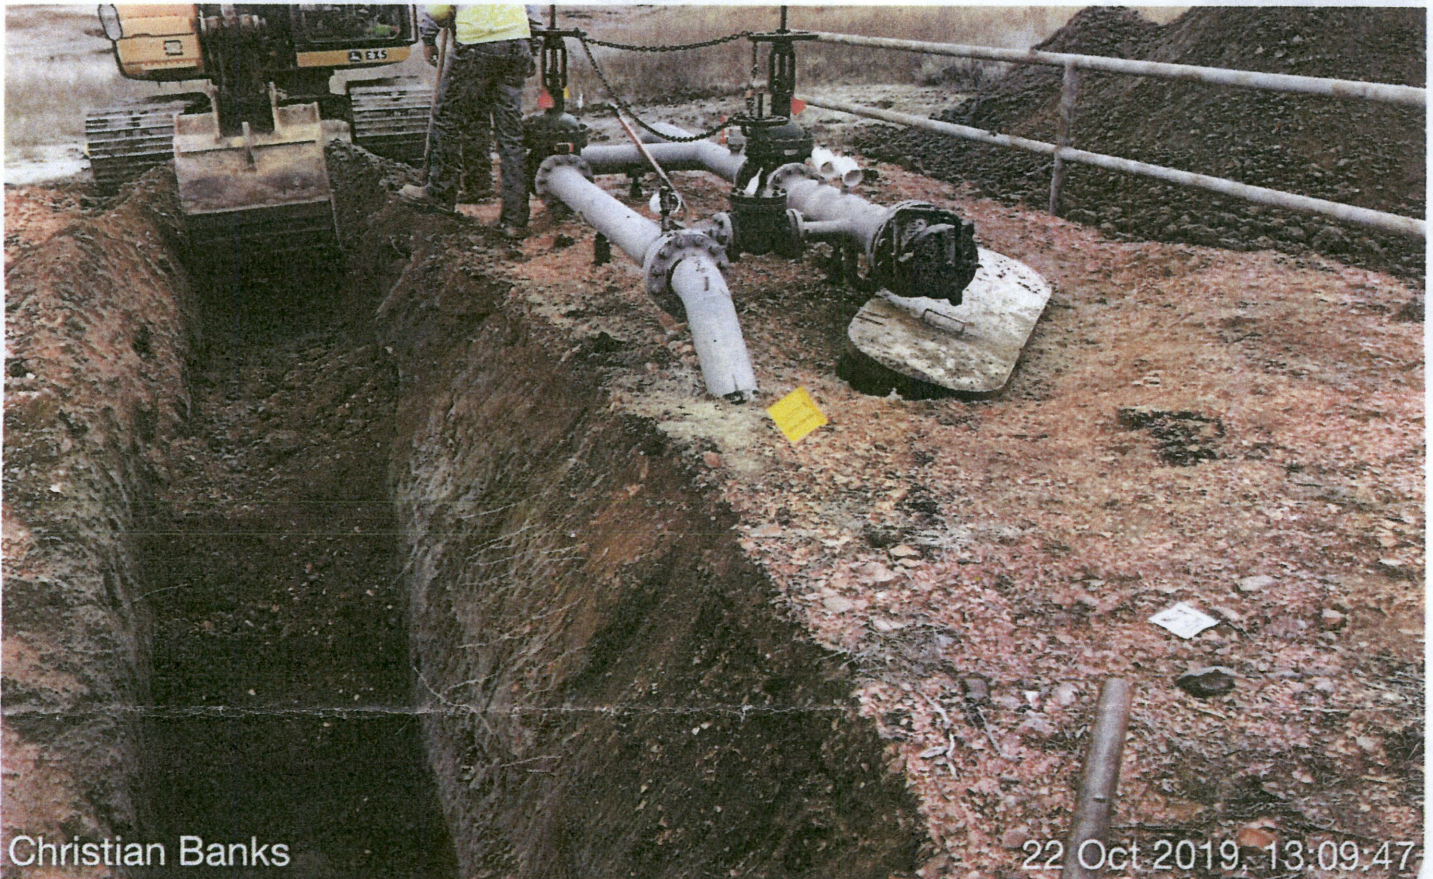
Picture #3

The picture marked as #3 clears up a lot of details:

- 1.) The excavation taking place approximately 2'8" from Kinder Morgan pipeline.
- 2.) The Crawford's Construction, Inc. employees using shovels to slope off the edge of the trench to help prevent cave-ins.
- 3.) The distance between mechanical excavation and pipeline is clearly greater than the 24" ND One Call code.

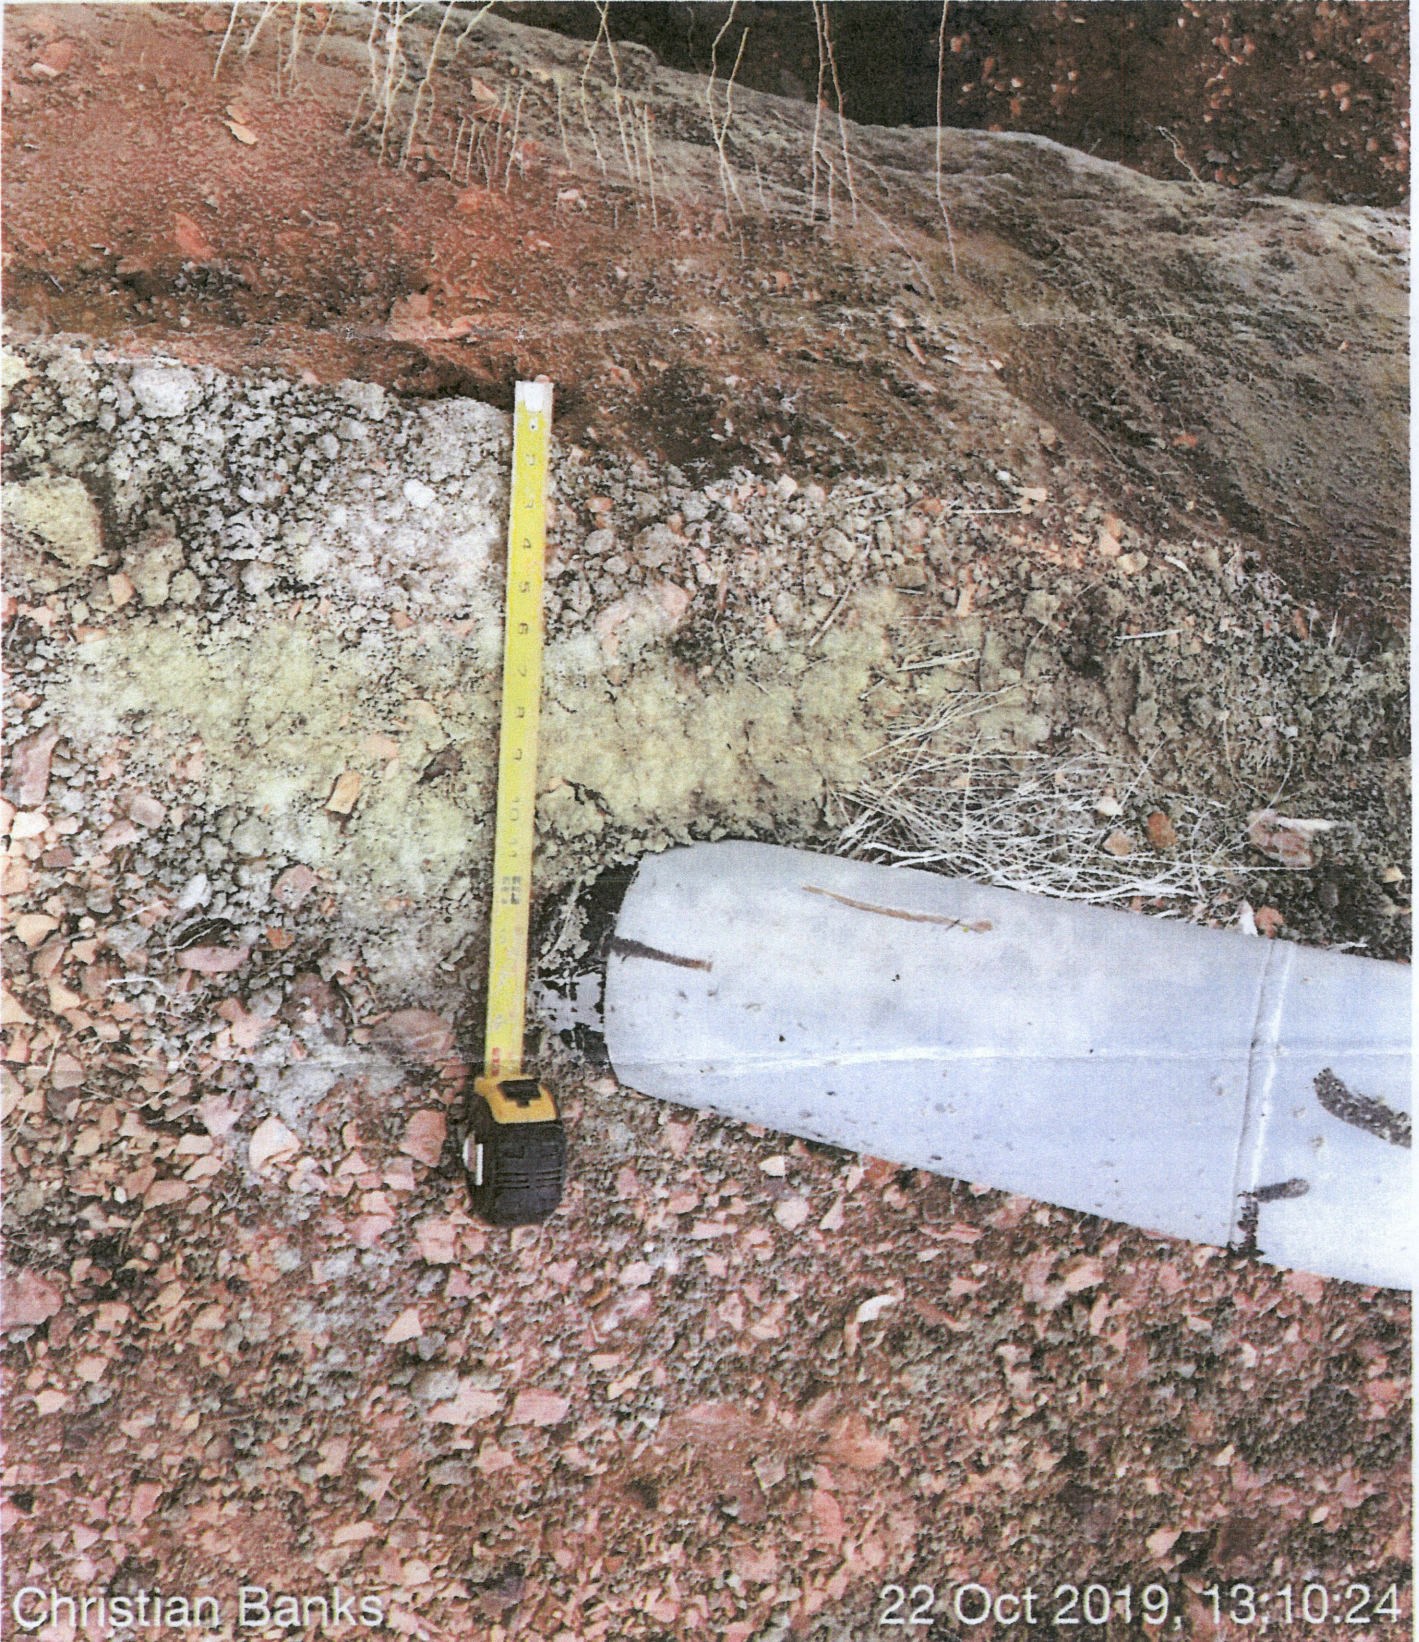
Picture #4

The picture marked #4 is not the measurement from the edge of excavation trench to piping, it is clearly indicating the measurement from top of slope made by shovels, sloping off trench, to edge of piping.
