RE: ND One Call Excavation Notice System: North Dakota Century Code Chapter 49-23

This letter is in response to the One-Call complaint filed by Montana Dakota Utilities, of Minot, ND, Case Number PU-20-423. The locations of the damage identified in the complaint are as follows: 5 31<sup>st</sup> Ave SE, 2 31<sup>st</sup> Ave SE, 100 31<sup>st</sup> Ave SE & 31<sup>st</sup> Ave SE & 2<sup>nd</sup> St in Minot, North Dakota.

Trevor Plasky  
Project Manager/Safety Compliance Officer  
Wagner Construction Inc.

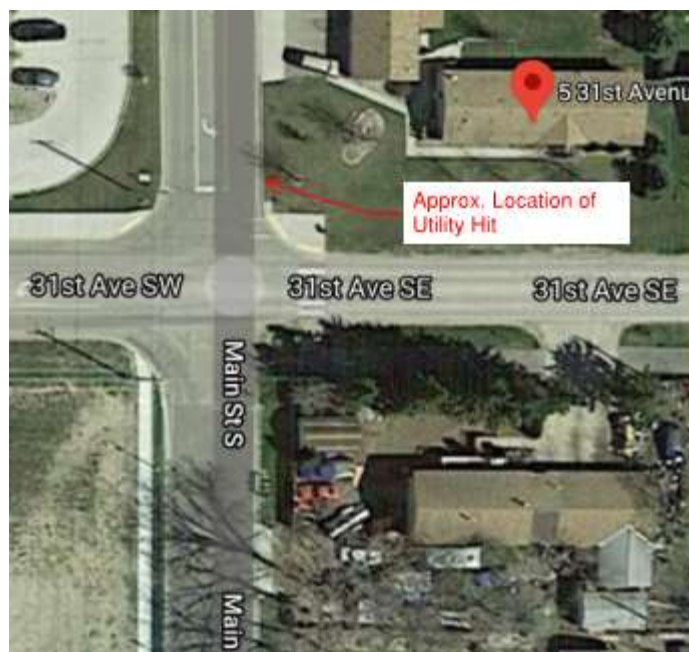
After an internal investigation and conversations with the onsite personnel. Wagner Construction was prepping subgrade for placement of Class 5 prior to concrete pavement. The operator Jess Kindred was using a dozer to prep the area in front of the house at 31<sup>st</sup> and Main St. S when he caught the gas service line for the house with the corner of the dozer blade. Exhibit A shows the approximate location of the gas line hit. Prior to starting work at this location the operator had a laborer dug down and located the

service in the road at the main. They found the service at a depth of approx. 5-6" below the needed level for subgrade prep. However while prepping subgrade they caught the service line at the approximate centerline of where the new concrete curb was to be placed. The service line went from being flat to almost a 90° out of the road into the bank. See photos Exhibit B and Exhibit C. These show that the service line was well above the depth that was needed for the project.

Upon further conversations with the operator and other crew members, it appears that previous discussions were had with MDU explaining that any utilities in this area of the project that were not at the specified grade would need to be lowered due to the contours and elevations of the new road. Jesse McIntosh had asked the MDU worker on site repairing the gas line why the service had not been lowered as previously discussed, to which he was told all utilities in this area had been lowered. This would have been improbable considering that Wagner had just removed the asphalt a few days prior to our work starting.

Wagner Construction took all necessary precautions to locate the gas service line prior to starting their grading work. It was assumed that the service line would have followed the same grade that it was found at when they crew members dug down and located it at the main. There was no way for Wagner to know that the service was going to jump up from the location it was found at below grade. Had this line been relocated to a proper depth prior to our work or had the service line been buried at the same depth across from where it was located at the main, no utility would have been hit.

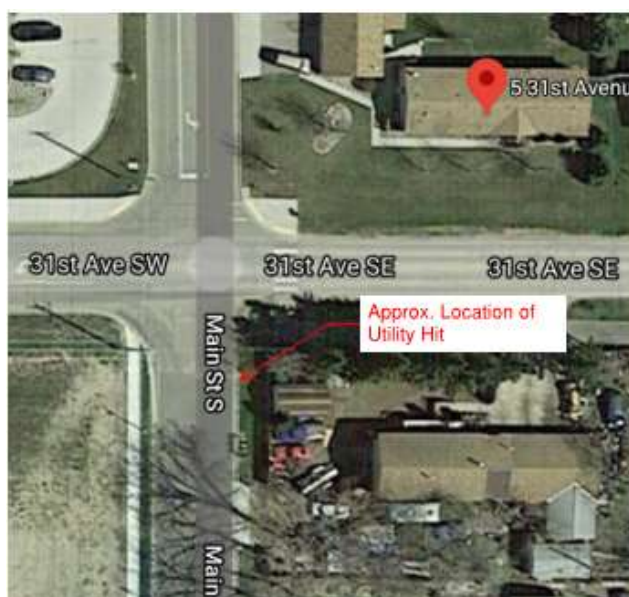
After an internal investigation and conversations with the onsite personnel. Wagner Construction was again prepping subgrade for placement of Class 5 prior to concrete pavement. The operator Jess Kindred was using a dozer to prep the area in front of the house on the south side of 31<sup>st</sup> and Main St. S when he caught the gas service line for the house with the corner of the dozer blade. Exhibit D shows the approximate location of the gas line hit. Prior to starting work at this location the operator had Jesse McIntosh dig down and locate the service in the road at the main. They found the service was again at a depth of approx. 5-6" below the needed level for subgrade prep. However while prepping subgrade they caught the service line at the back of where the new concrete curb was to be placed. Meaning the existing gas service line would have been in the curb and needed to be relocated. The service line went from being flat to almost 45° out of the road into the bank. See photos Exhibit E and Exhibit F. These show that the service line was above the level required for the placement of the new curb and road.

Wagner Construction took all necessary precautions to locate the gas service line prior to starting their grading work. It was assumed that the service line would have followed the same grade that it was found at when the crew members dug down and located it at the main. There is no reasonable expectation that Wagner would have known that the service was going to jump up from the location it was found at below grade. Had this line been relocated to a proper depth prior to our work or had the service line been buried at the same depth across from where it was located at the main, no utility would have been hit.

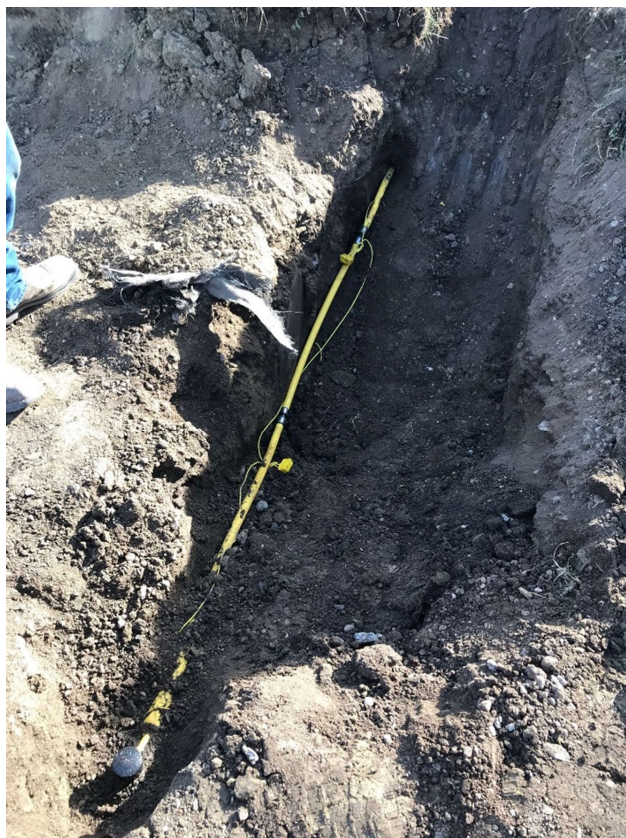
Exhibit G shows the repaired gas line, MDU had to bring in a rubber tired backhoe to dig the line down to the proper depth.

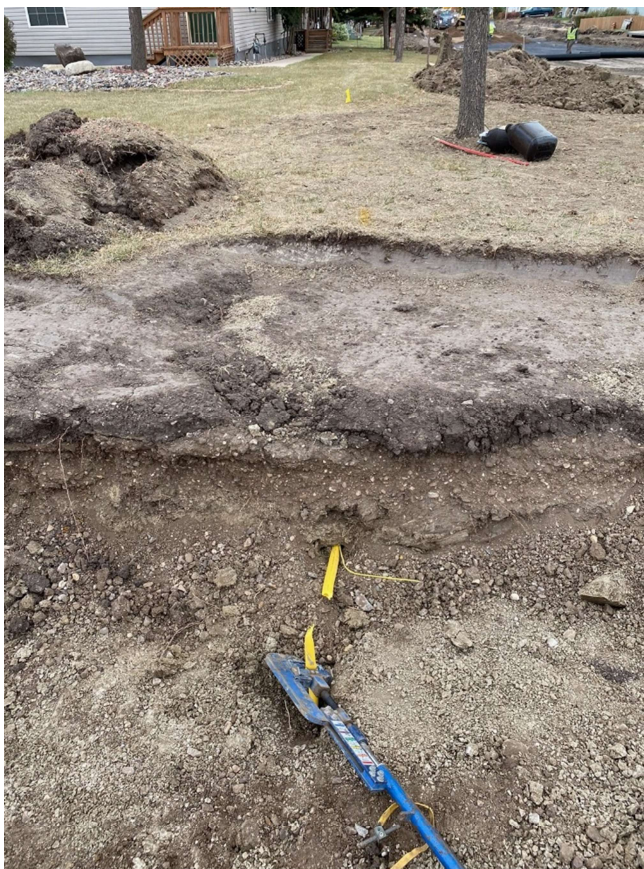
Exhibit C

For the two remaining utility strikes at houses 2 & 5 31<sup>st</sup> Ave SE, Minot, ND these had been refreshed on 9/23/2020 for work to start on 9/26/2020. No work was completed at this area until 9/26/2020 where the grading crew was prepping the subgrade for placement of Class 5. For the gas hit on 9/26, there was only one mark approximately 5-6' from back of curb with no other marks being present in the road way or on the bank showing where the gas line was prior to work starting. In the picture Exhibit C, below there is only one paint line that denotes where the gas line is located.

In Exhibit N this shows an area just east of the paint mark and flag as seen in Exhibit C, earlier in this report. This shows that there are no additional markings or flags after what was is seen in Exhibit C. This area was supposed to have been remarked prior to our start date of 9/26/2020 according to locate #**20140114** and #**20140113**, but not new marks had been placed.

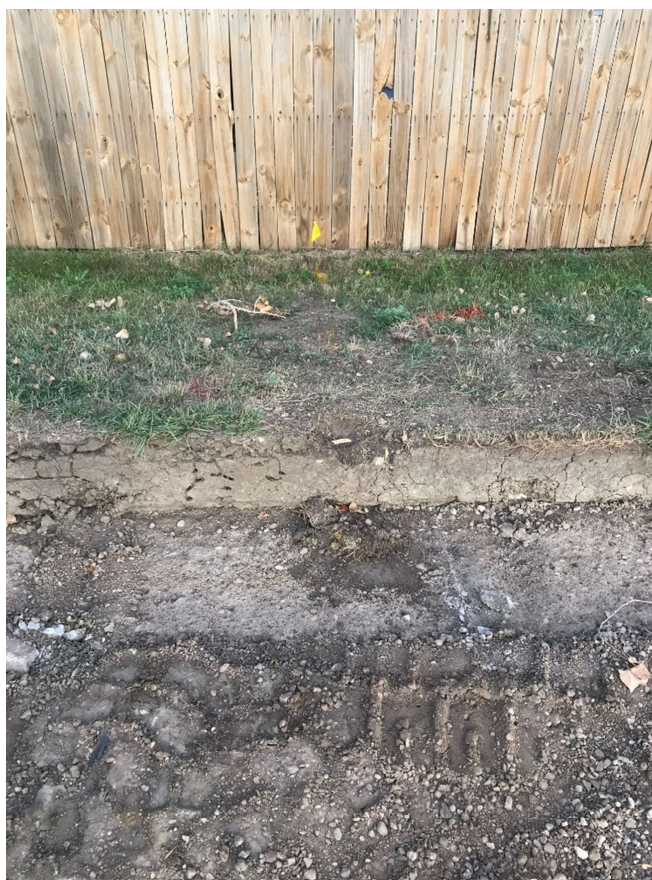
For the gas line hit on 9/29/2020 again there was only one paint mark and flag on the back side of the curb. The marks were still present as no work had been completed in this area until 9/29 and there were no additional paint marks on the roadway or bank marking where the gas line came up at. See Exhibit H below. This was the only mark for MDU in this area. The gas main running in the roadway was never actually marked in the refresh as it ran north back to the intersection of 31<sup>st</sup> and Main. This photo was taken on 9/28, the day prior to any work commencing in this area of the project.

These pictures show that the marks that had been provided in the refresh on 9/23/2020 were still present when we started construction meaning that Wagner had continued to maintain the marks that were provided to us prior to any gas hits. While these gas hits are unfortunate, we feel we have complied with the One-Call Notice System Law as it pertains to acting as a responsible contractor and maintaining the marks that were provided to us.

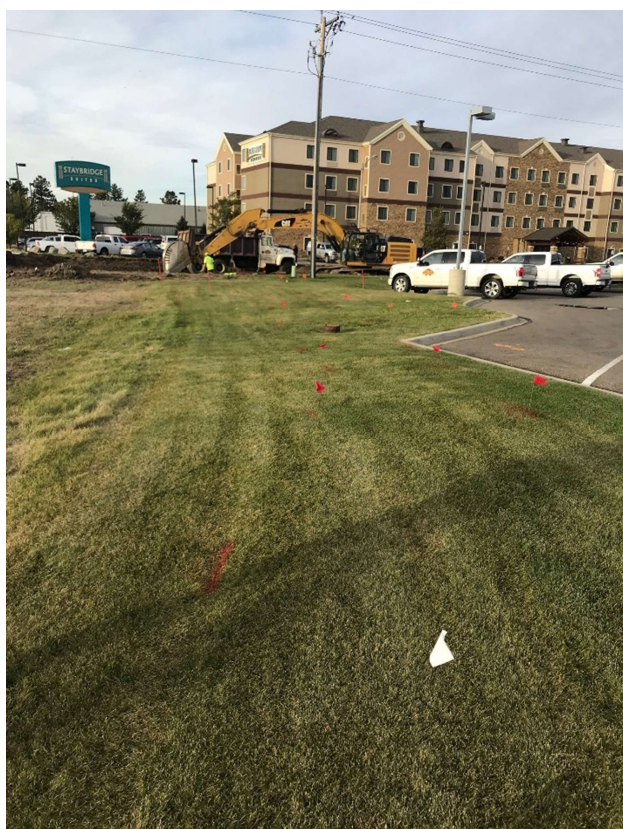
Below are several pictures that I personally took on the afternoon of September 28, 2020, prior to the final gas line being struck by our dozer. In these pictures it show the marks that were provided by ELM, often times there only being one single mark within a 50 to 60 foot area. In pictures Exhibit I and J there is merely 2 flags and 2 paint marks for approximately 100-150 ft. While we were not working in this area these were the only marks that had been refreshed for the 9/23/2020 locates that had been called in. No marks were present in the road way or near the edge of roads we were working in.

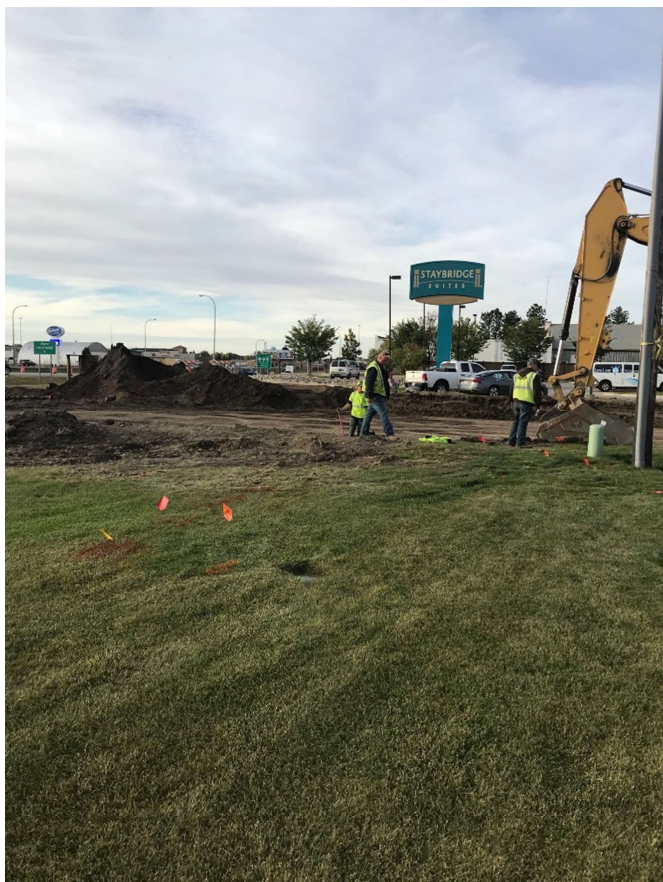
In pictures Exhibit K and L in the page above, the paint mark and flag shown was approximately 30' feet from our work area and no additional marks were present even though we were digging and preparing subgrade in the roadway. This area was supposedly refreshed with the locate #**20140113**, but this was the only mark provided in this refresh. In Exhibit M Wagner can be seen digging down to locate a gas service that crossed the road, but its actual location was only known because we had worked around it weeks earlier. Although we knew of the gas service location, it does not change the fact that no new marks were present across the road prior to the start of our work in this area.
