Reclamation Division

Memorandum

SUBJECT: Hydrology Modeling for Watersheds 14-14 & 14-15 Related to Case No. RC-22-339

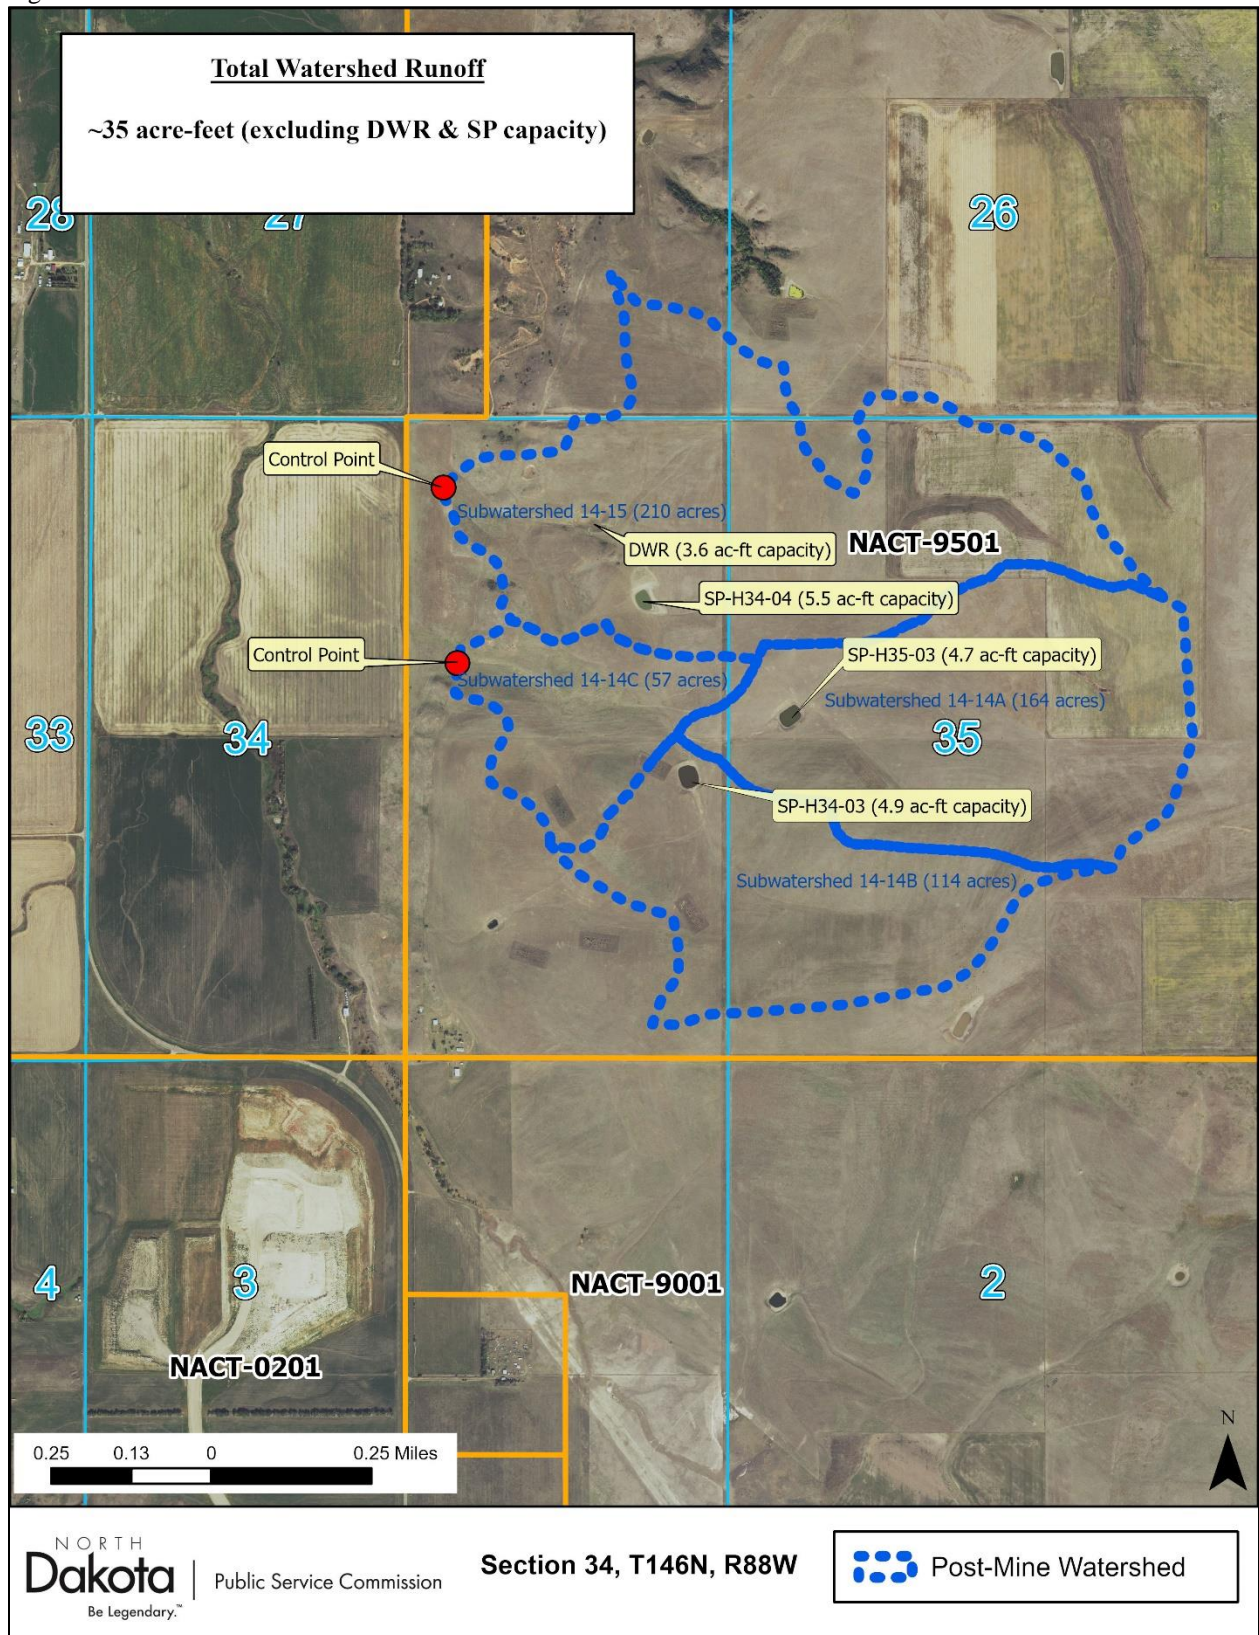
Figure 1 - Post mine watersheds 14-14 and 14-15 in Permit NACT-9501.

Hydrology models were developed and analyzed for watersheds 14-14 and 14-15 at their pre mine and post mine conditions to determine the peak discharge and total volume of runoff at the control point for each watershed. AutoCAD Civil 3D, HEC-HMS, and Autodesk Storm and Sanitary Analysis were used for this analysis. A 10-year, 24-hour design storm event was used for this analysis.

The total volume of surface water runoff from watershed 14-14 decreased by 35% from its pre mine condition. The total volume of surface water runoff from watershed 14-15 increased by 175% from its pre mine condition. Since both of the watersheds outlet to Clyde's land in the NW1/4 of Section 34, T146N, R88W, the total runoff volume from each watershed (14-14 and 14-15) were combined for the pre mine and post mine conditions. The total runoff volume from both watersheds decreased by approximately 8% as compared to the pre mine condition.
