Bauske, Shelly A.

You don't often get email from trimble@trimblelegals.com. [Learn why this is important](#)

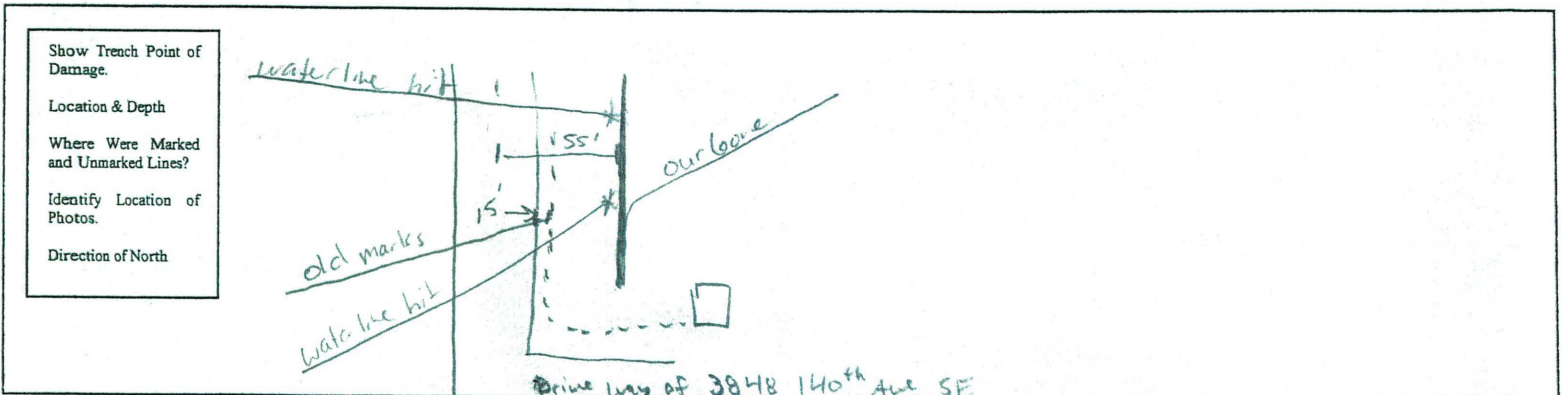
Finley Engineering
Ph: 222-1500 • Fax: 222-1502
101 Basin Avenue
Bismarck, ND 58504-1698

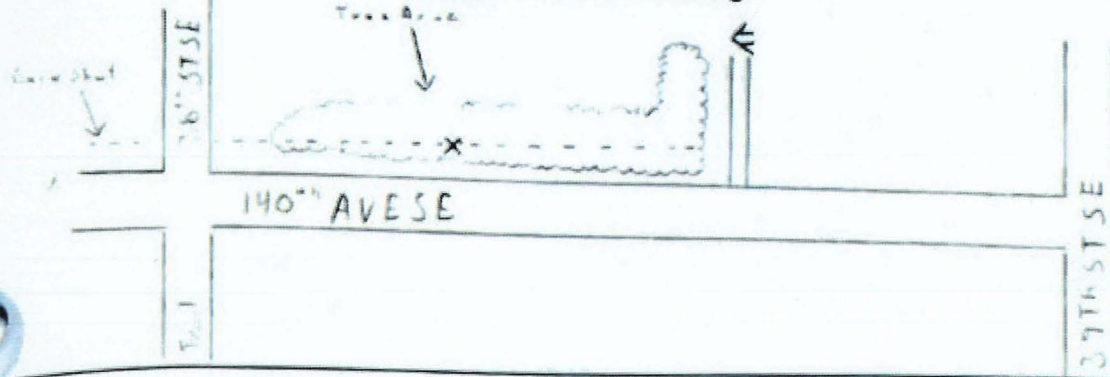
Field Notes and Drawing

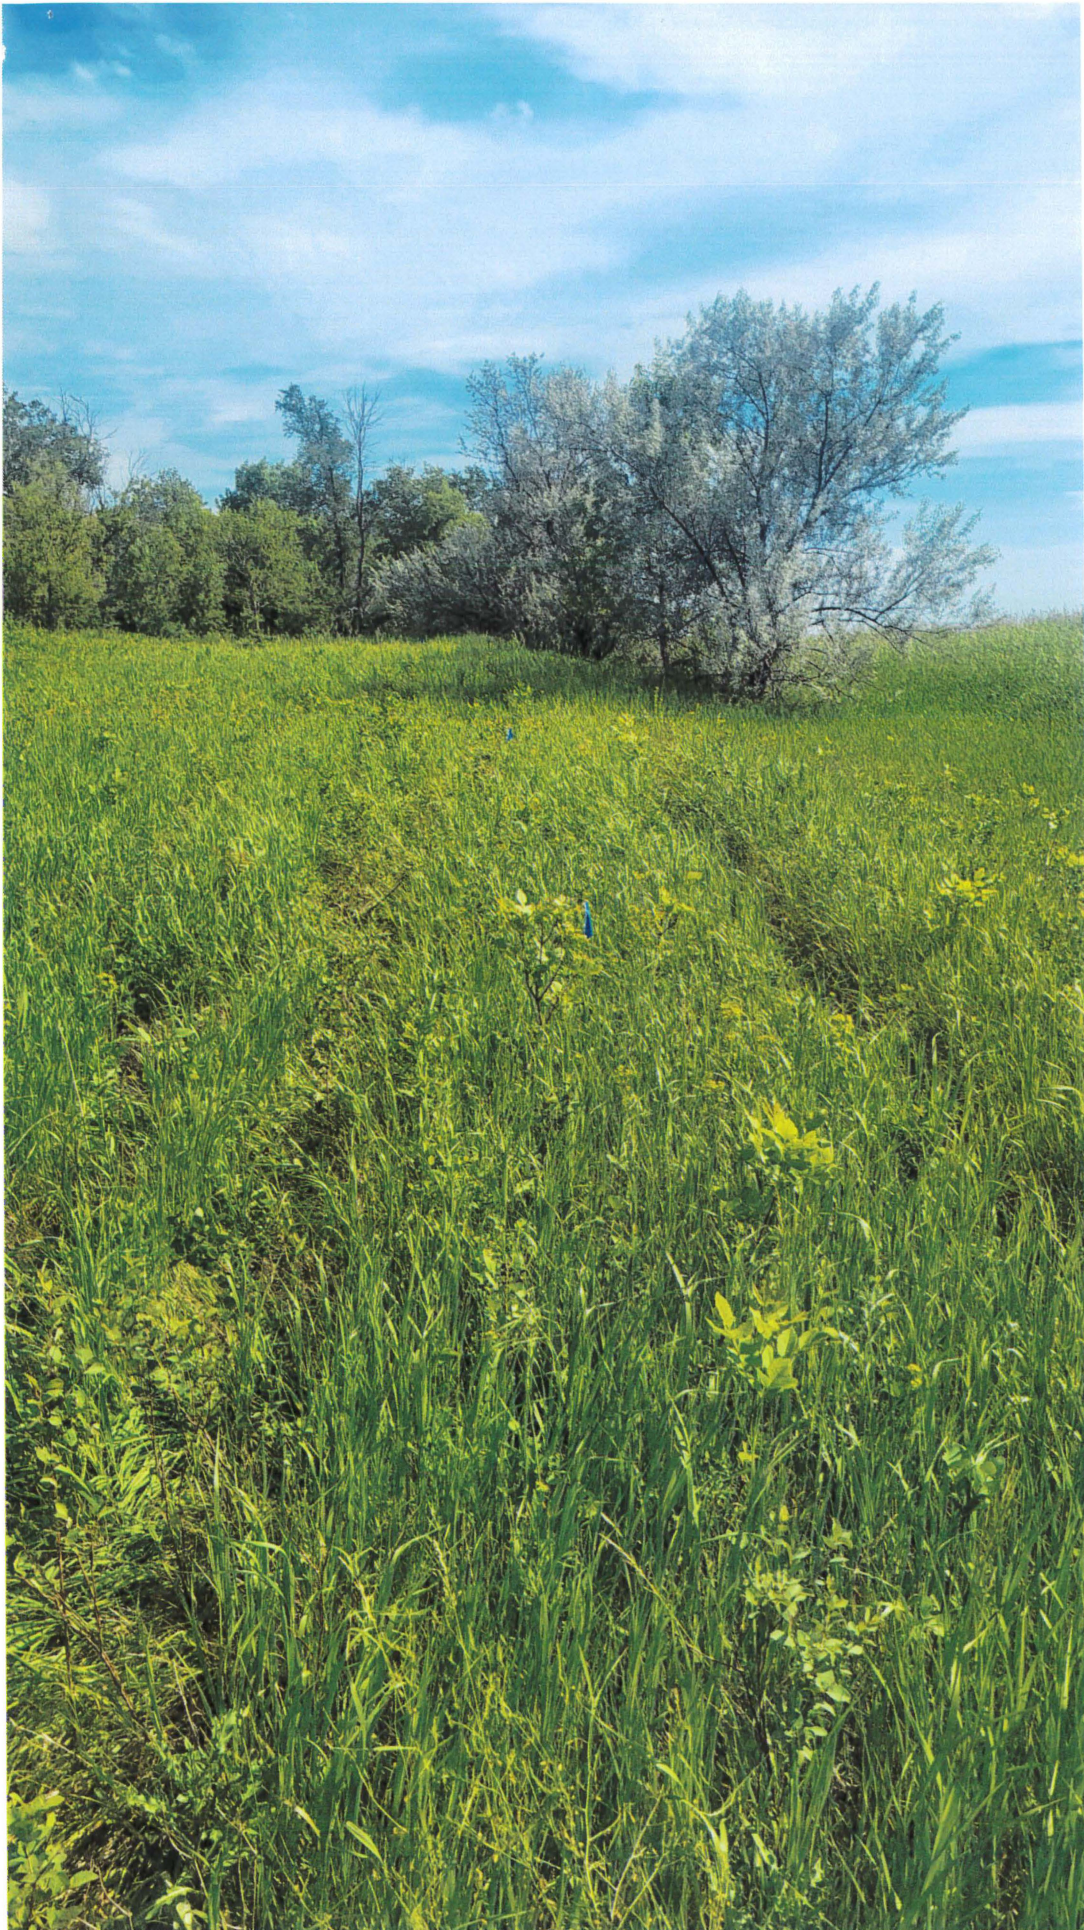
Flags
placed after
repair
