**Bauske, Shelly A.**

You don't often get email from trimble@trimblelegals.com. [Learn why this is important](#)

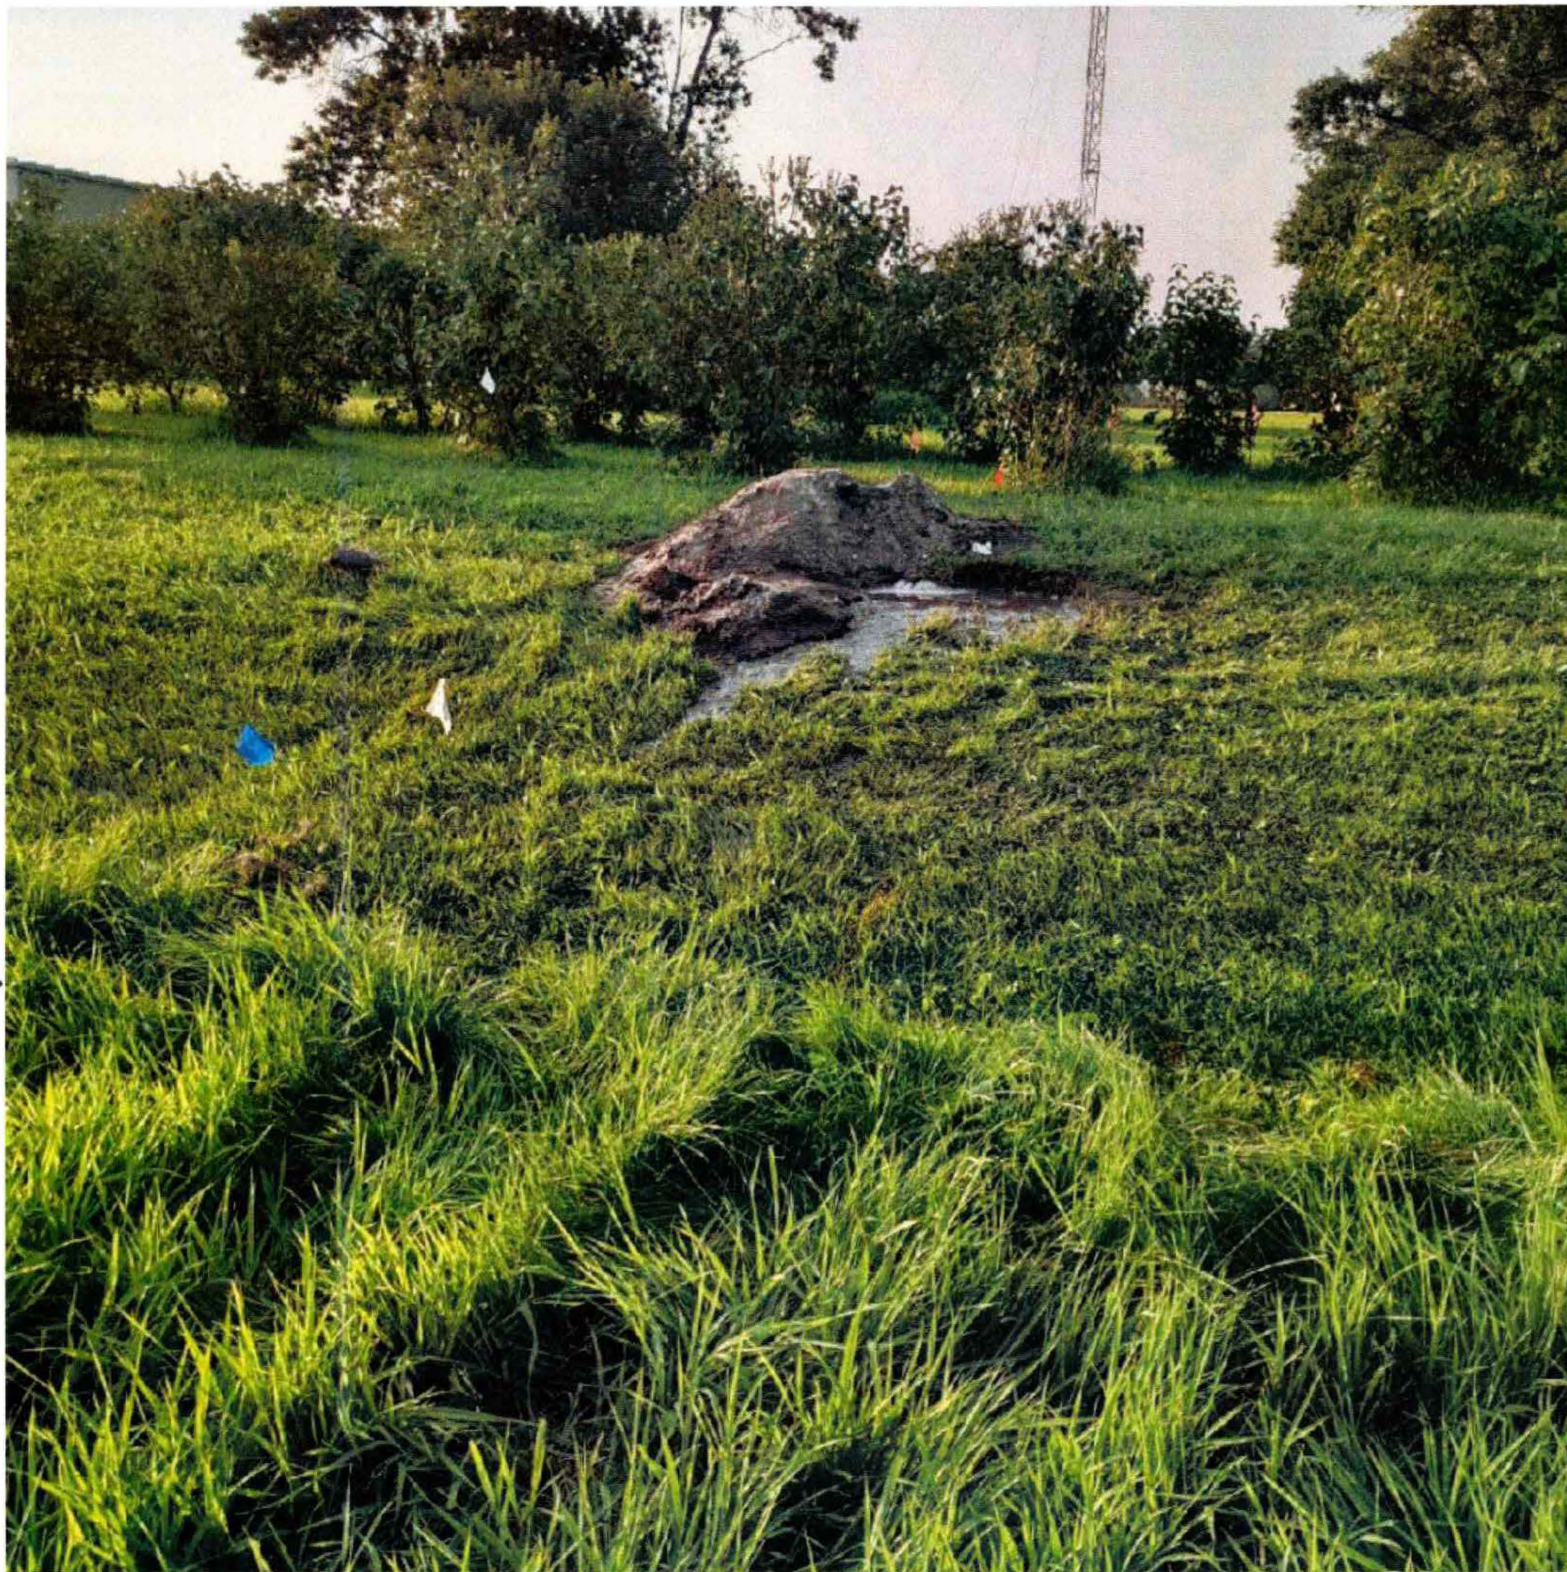
Crew Had Line  
Marked and  
No Evidence  
of potholing  
By NCS

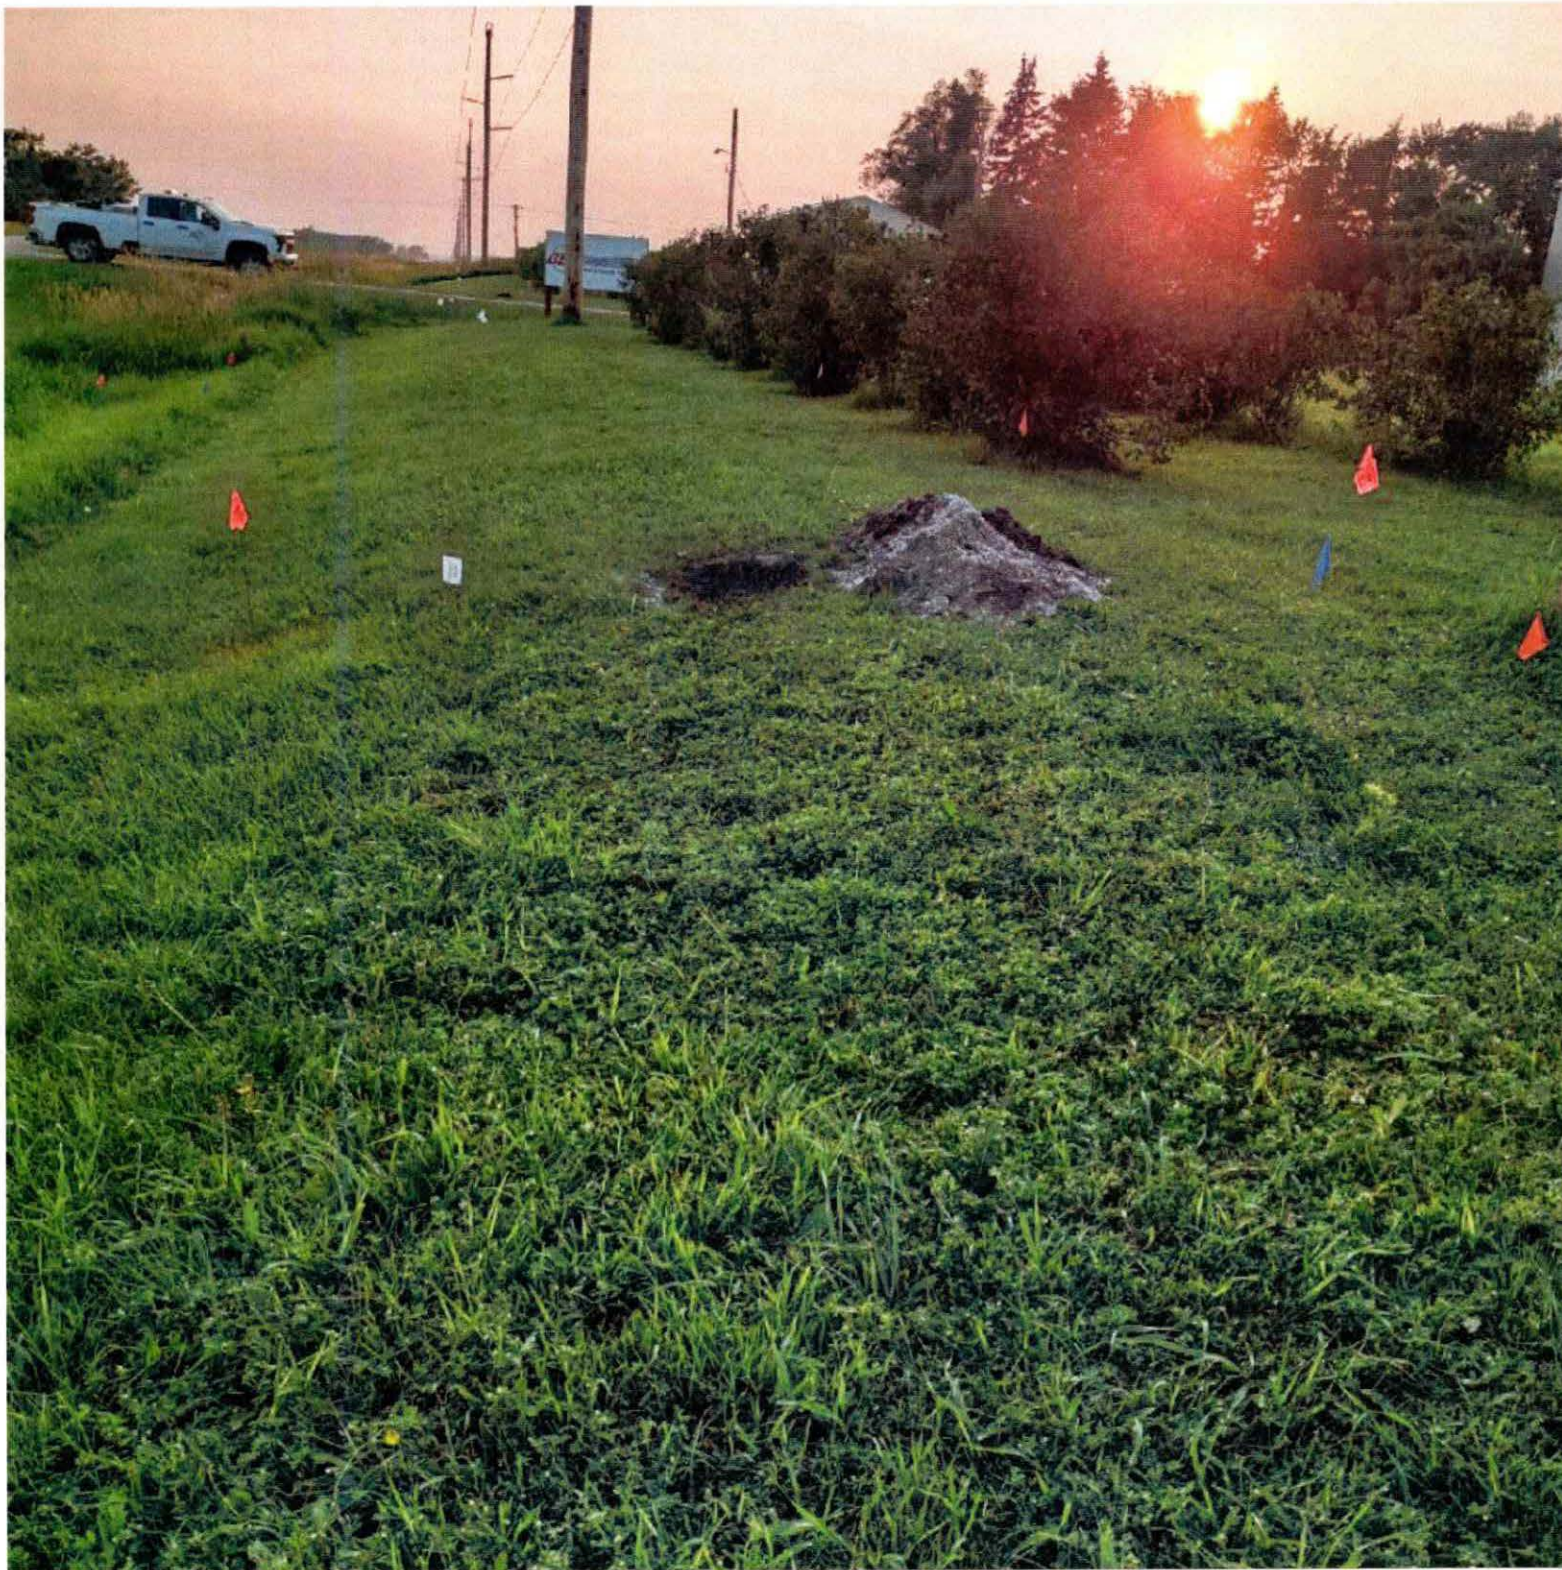
Pothole  
From finding  
other utilities
