Re: Case No. PU-24-361  
Basin Electric Power Cooperative - LOS to Tande 345-kV Transmission Line Project

119 PU-24-361 Filed 06/23/2026 Pages: 9  
Notification of Extraordinary Incident

**RE: Impacted DASK habitat during construction of Leland Olds Station to Tande 345-kV Transmission Project**

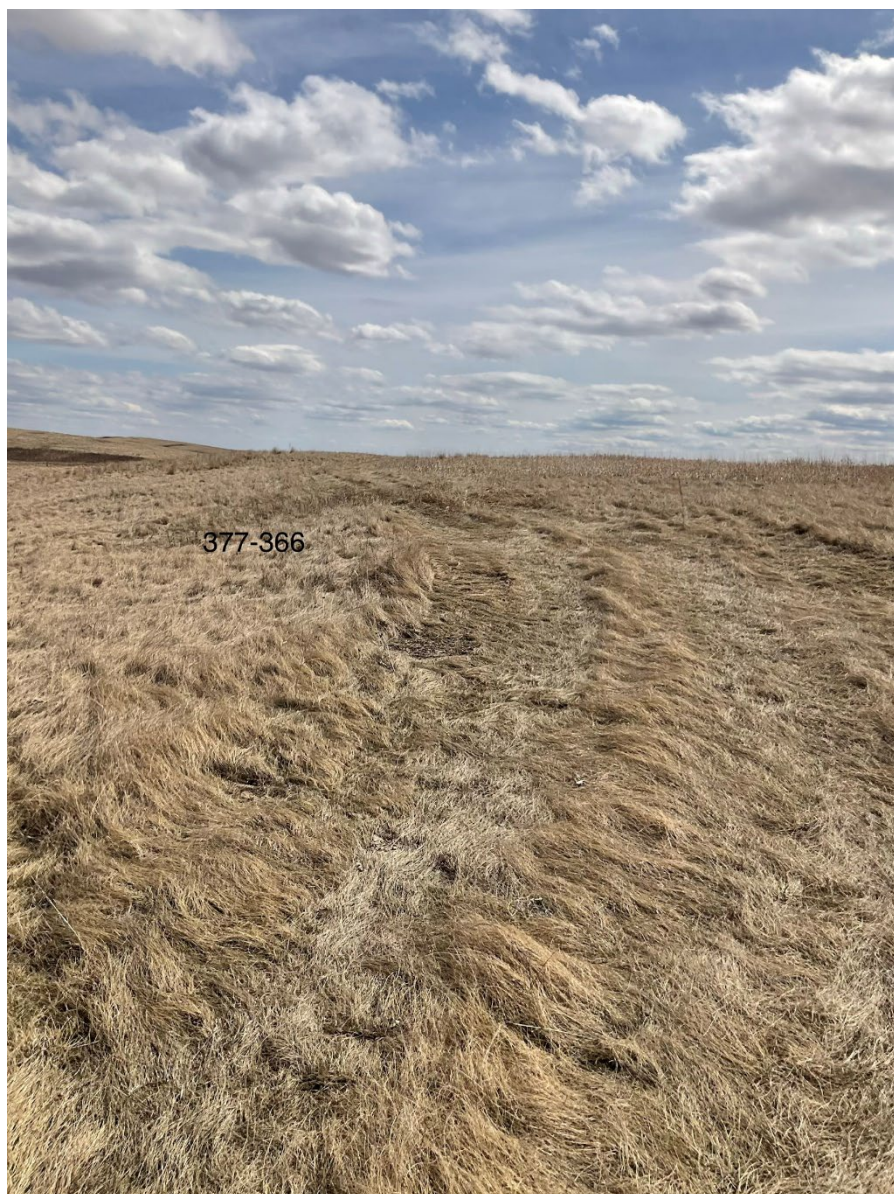
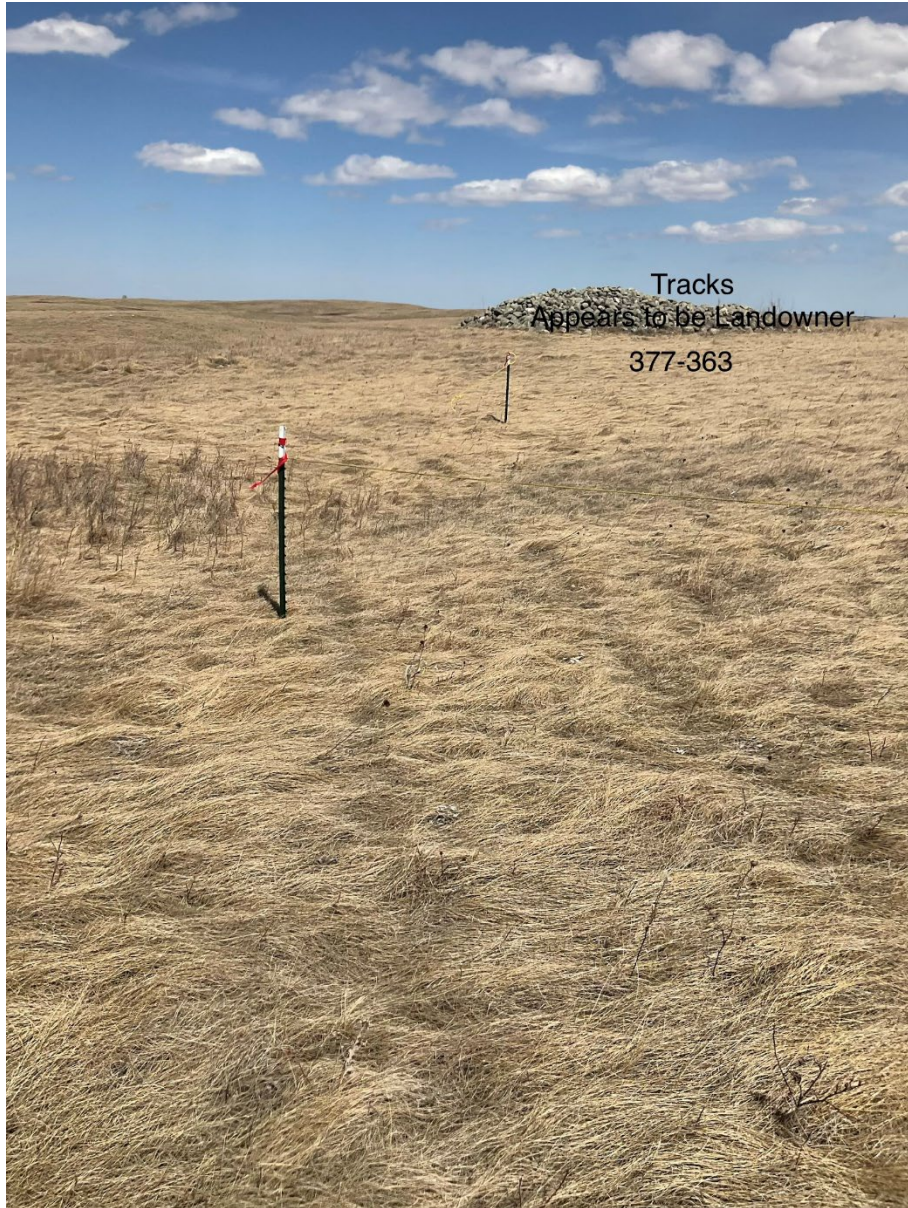
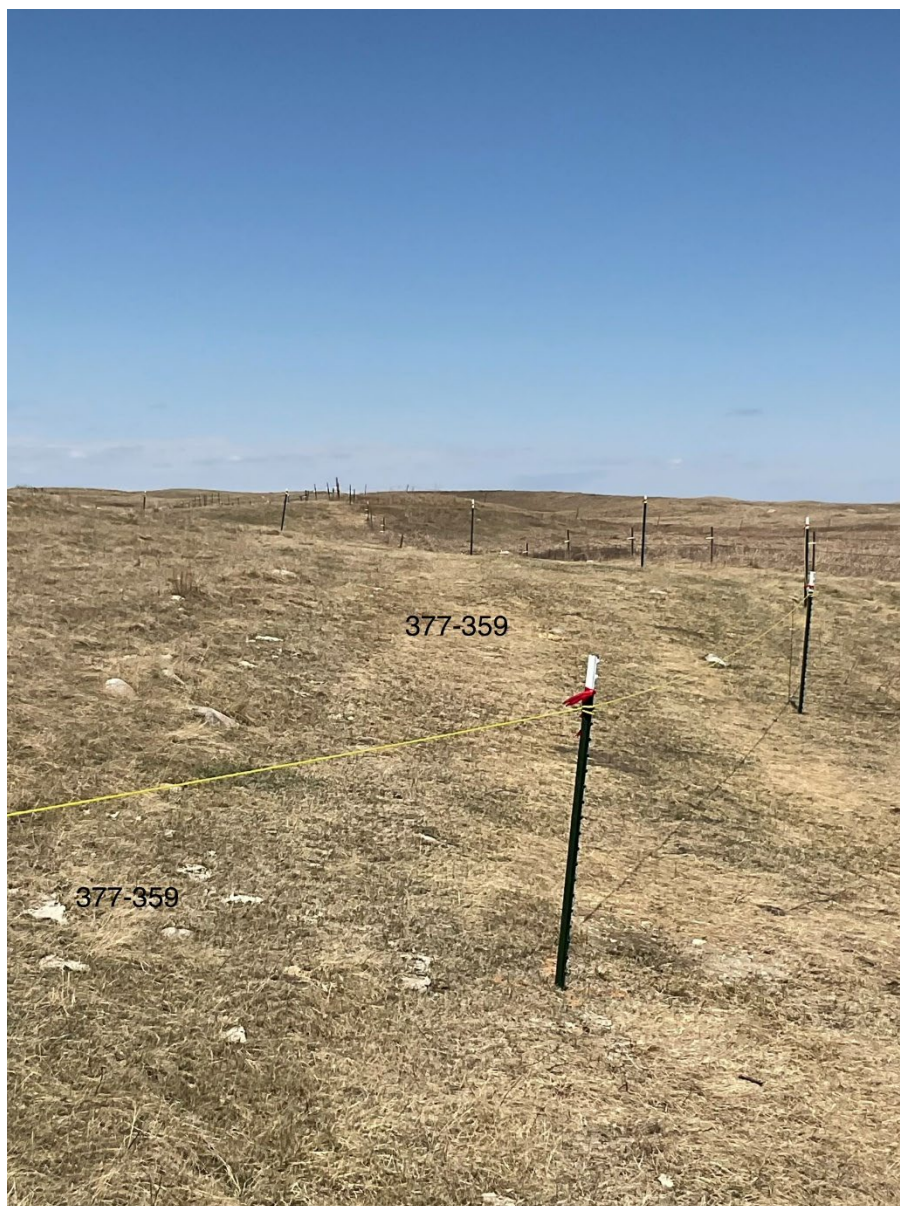
377-366

Photographs of the impacted DASK habitat were reviewed by a WEST biologist. The impacts appeared to be consistent with vehicles making a pass through the potential DASK habitat locations, resulting in compressed vegetation and disturbed topsoil. The impacts were documented at seven potential DASK habitat locations, however only a small amount of disturbance occurred at each location. Example photos are attached.

The impacts are temporary, short-term disturbances to the surface of the grasslands. No long-term effects are expected, and the vegetation will recover without reclamation. Furthermore, the events occurred in early spring when the DASK is below the soil surface in larval form.
