# Assessment of Potential Impacts of Fires at BESS Facilities

LITERATURE REVIEW | August 21, 2025

Prepared by Fire & Risk Alliance, LLC. for:  
The American Clean Power Association

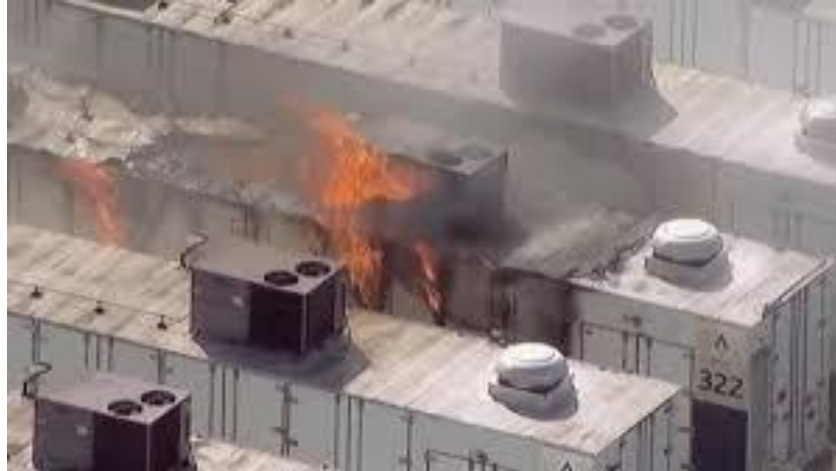
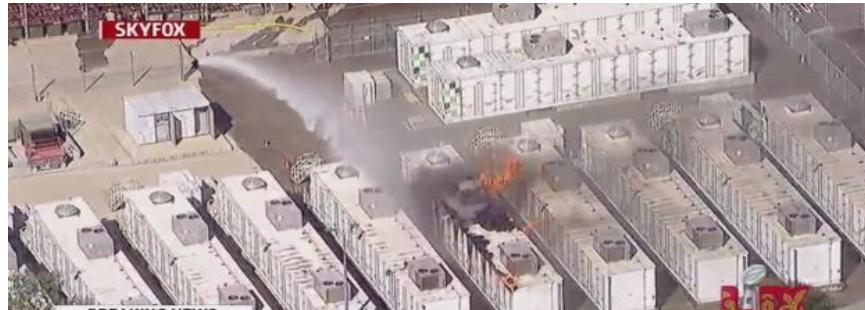
Figure 9: Images of the Escondido BESS Container Fire

Figure 9a shows a clear image of the burning container, including dark smoke and flames [15]. Figure 9b shows a clear image of the burning container as part of the larger BESS facility [16]. It can be seen that firefighters are applying water from a distance to surrounding containers to avoid fire spread and are letting the involved container burn out [16].

The Escondido incident was similar to that of Surprise in that both only impacted one container (see Figure 10). Both installations were at a substation, and both units were multiple years old, with the unit at Escondido being 7.6 years old [5, 13, 14]. Both incidents had air monitoring during the event performed by the responding firefighters, and resulted in evacuation orders for surrounding areas [5, 13, 14]. Escondido was a larger system at 120 MWh with 24 total containers on site. Surrounding unaffected containers were sprayed with water to avoid propagation instead of directly applying water to the affected container, which could have made the situation worse [5, 13, 14]. The affected container was left to burn itself out, taking about 13 hours total, and did not have a reported cause or failed element [5, 13, 14].

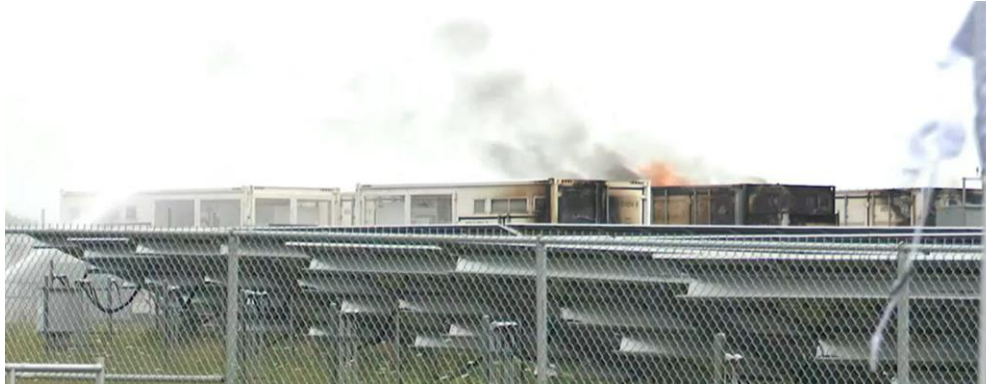
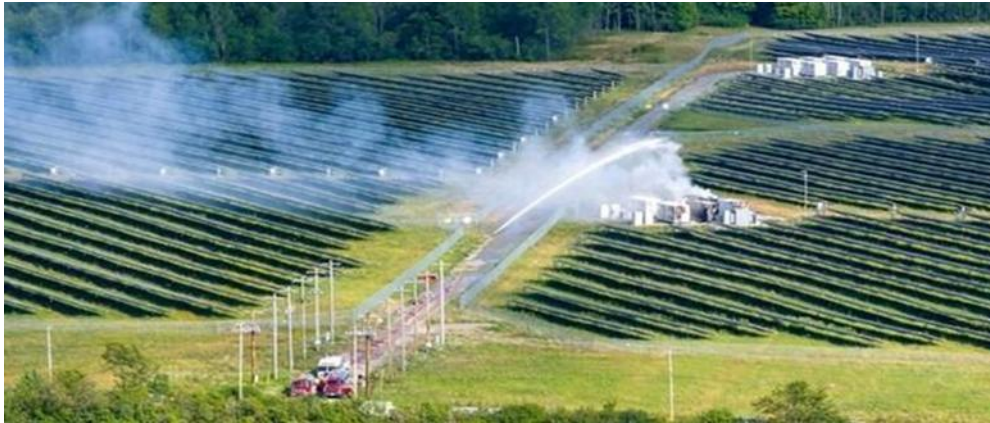
Figure 10: Images of the Chaumont (Lyme) BESS Fire Incident

- (a) An image showing burned containers emitting smoke and flames. The solar panels can also be seen in front of the BESS [19].
- (b) A remote image showing the smoking BESS containers in the context of the whole site. Firefighters can be seen spraying water onto the adjacent containers from a great distance. [20]

On July 27, 2023, a multi container fire occurred at a utility-scale facility in Lyme, New York (see Figure 10). The system was 4-5 months old and was operational and in use during the incident. An investigative report showed that the cause of the incident had to do with “the controls” [17, 18, 19]. There is minimal information regarding the specific design impairments and controls issue that led to this incident.

The system was 15 MWh and was collocated with a solar farm in a rural area [5]. During the event, four LIB storage containers and two transformers were damaged and produced large amounts of smoke [17, 18, 19]. A shelter-in-place order was issued for the surrounding community within one mile of the facility out of caution. The local fire chief intentionally chose not to put water on the flames due to knowledge that it would not put the fire out, and chose to let the battery burn itself out with full knowledge that it could take hours if not days to do so [17, 18, 19].

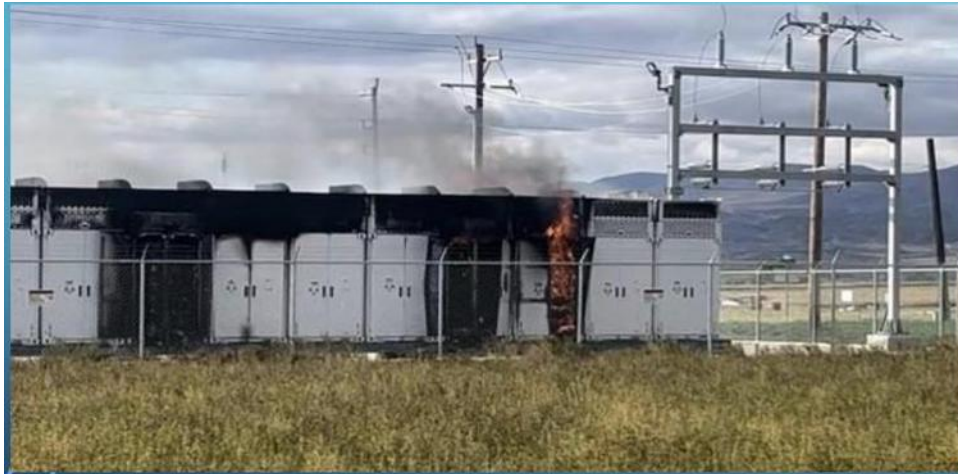
Figure 12: Images of the Melba, ID BESS Fire

- (a) An image showing one side of the burning enclosure at the substation [24].
- (b) Another angle of the burning BESS enclosure showing the other side burning [24]

A fire at a BESS unit installed at a substation for distribution report occurred in Melba, Idaho on October 2, 2023. At the time of the incident, the system was in the pre-commissioning stage (not yet operational) [5]. The unit capacity was 8 MWh [5]. It was suspected that water intrusion led to a short-circuit, which caused excess heat production that eventually lead to ignition of the battery cells, with the fire spreading among battery segments until burning out [23]. 48 hours after the event, the temperature of the batteries was reported to be approximately 650 °F [24]. The fire burned out after three days, and the substation remained operational through the fire event with external road closures [23, 24]. Images of this incident may be found in Figure 12.
