Assessment of Potential Impacts of Fires at BESS Facilities

LITERATURE REVIEW | August 21, 2025

Prepared by Fire & Risk Alliance, LLC. for:
The American Clean Power Association

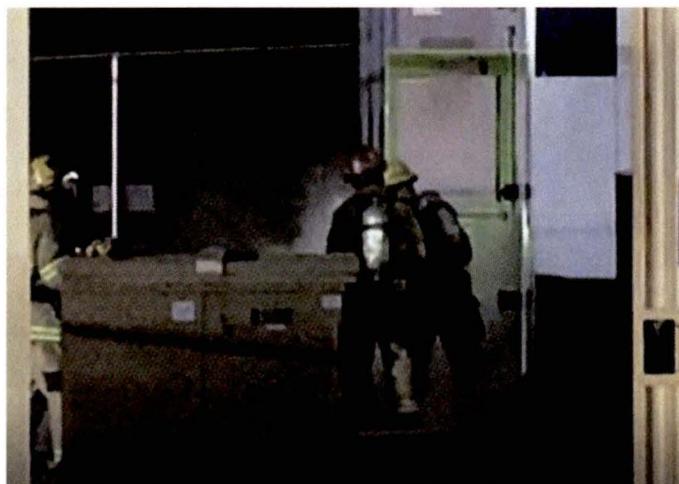
Figure 8: Images of the Surprise, AZ Fire.

Neither UL or APS's investigative reports provide pictures of the singular container on fire. Rather, both reports include photos of the damage after the incident, and UL's report features images of the incident upon arrival and just after firefighters opened the door to the unit during battery venting, which may be seen in Figure 8.

- (a) Conditions of the BESS site upon the firefighters' arrival. Venting can clearly be seen coming from the unit [11]
- (b) Approximately 5 seconds after the responding firefighters opened the door to the BESS unit. As noted by UL in the report, high-density gases and vapors can clearly be seen in the photograph [11]

This BESS unit was slightly more than two years old at the time of the incident and was operational. It was installed at a substation to help with power supply and voltage regulation. The 2 MWh unit had NMC batteries, and the failure was traced to an internal manufacturing defect in a cell/module that caused a short circuit [5, 11, 12].

During the incident, fire alarms and the clean agent fire suppression system activated, but were unable to prevent or stop the cascading thermal runaway (TR) reaction in the BESS unit. Upon arrival on-scene, firefighters monitored temperatures and gas release from the venting batteries. Three hours after TR was initiated, firefighters opened a door to the battery container, allowing oxygen to enter. Within minutes, a powerful deflagration occurred, seriously injuring several firefighters [5, 11, 12].

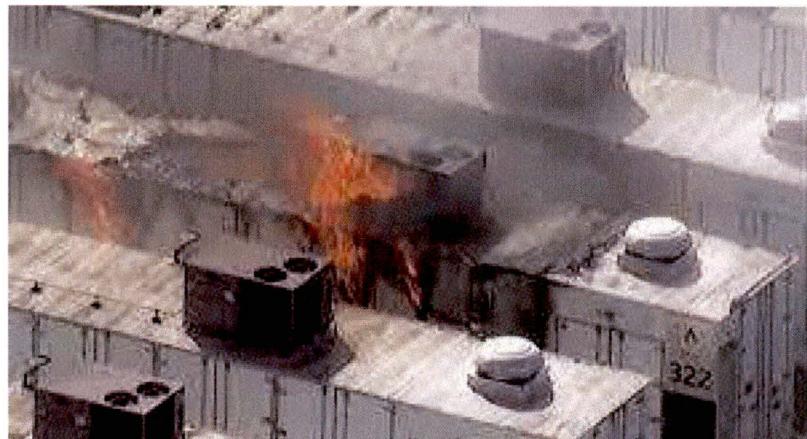
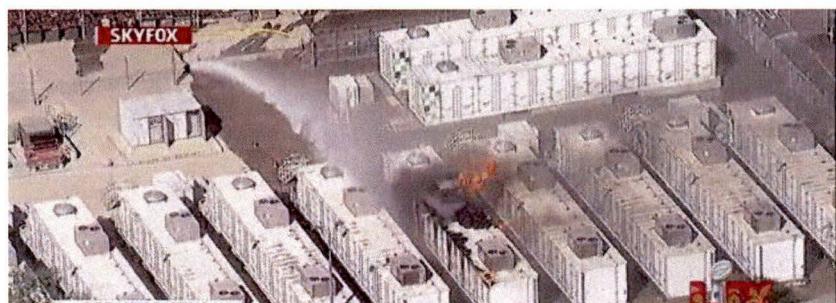
Figure 9: Images of the Escondido BESS Container Fire

Figure 9a shows a clear image of the burning container, including dark smoke and flames [15]. Figure 9b shows a clear image of the burning container as part of the larger BESS facility [16]. It can be seen that firefighters are applying water from a distance to surrounding containers to avoid fire spread and are letting the involved container burn out [16].

The Escondido incident was similar to that of Surprise in that both only impacted one container (see Figure 10). Both installations were at a substation, and both units were multiple years old, with the unit at Escondido being 7.6 years old [5, 13, 14]. Both incidents had air monitoring during the event performed by the responding firefighters, and resulted in evacuation orders for surrounding areas [5, 13, 14]. Escondido was a larger system at 120 MWh with 24 total containers on site. Surrounding unaffected containers were sprayed with water to avoid propagation instead of directly applying water to the affected container, which could have made the situation worse [5, 13, 14]. The affected container was left to burn itself out, taking about 13 hours total, and did not have a reported cause or failed element [5, 13, 14].

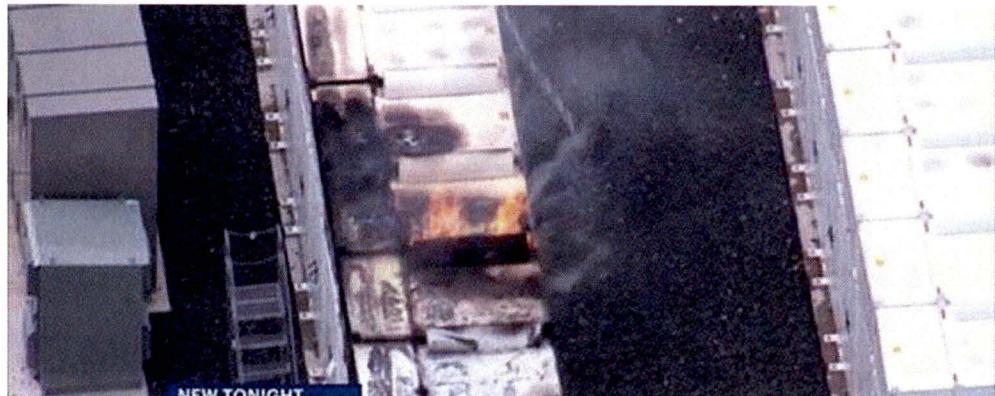
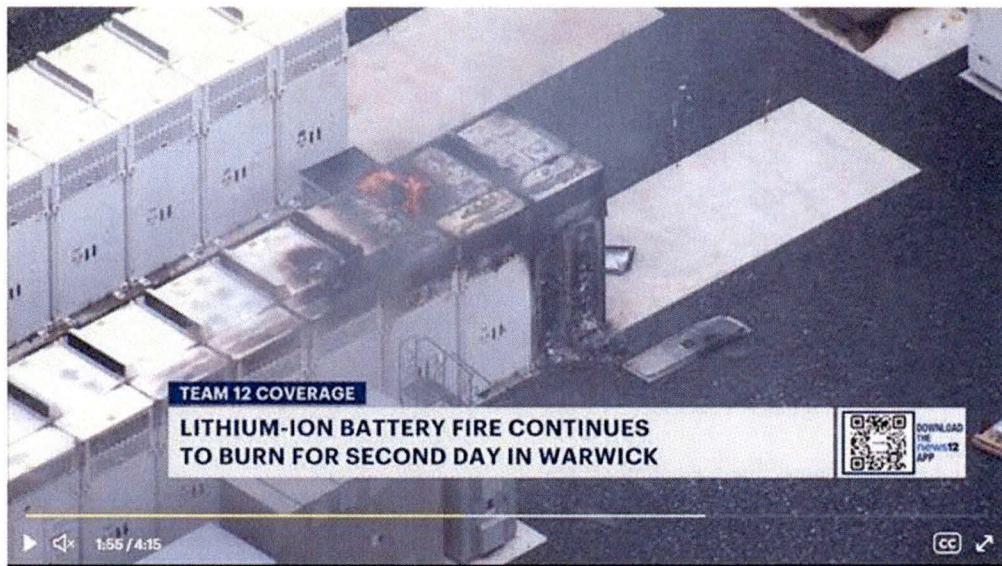
Figure 11: Images of the Warwick, NY BESS Fires

Two independent fire events occurred on June 26 and June 27, 2023 in Warwick, New York (see Figure 11). On June 26, a fire alarm went off at a BESS site, activating the suppression system within the affected enclosures. A second incident on June 27 also resulted in the activation of the fire alarm at another BESS site [21]. The fire department responded and provided support for the battery fires [5]. The fire department allowed the fire to burn itself out and monitored air quality. The fires were believed to have been caused by damage to the batteries from a storm the previous night, though that was not confirmed [22]. Both were installed at substations for grid stability and were only several months old and in use/operational at the time of incident [5, 21].

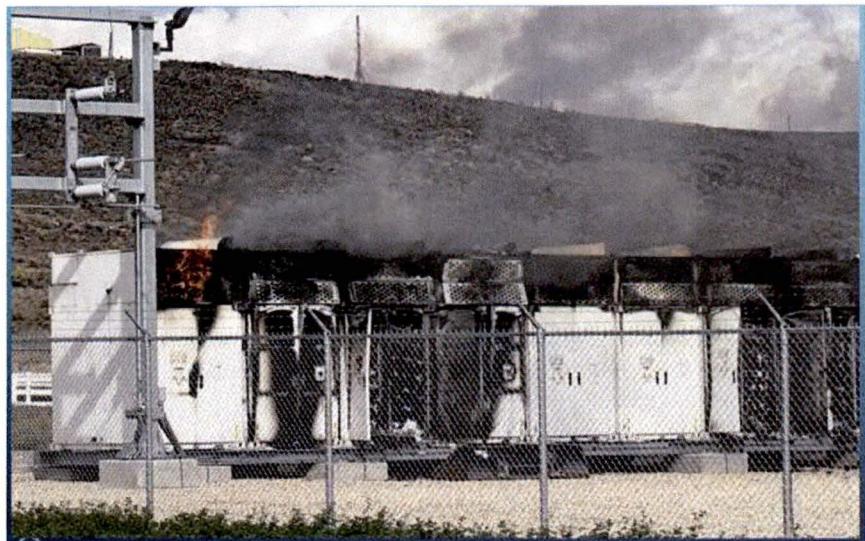
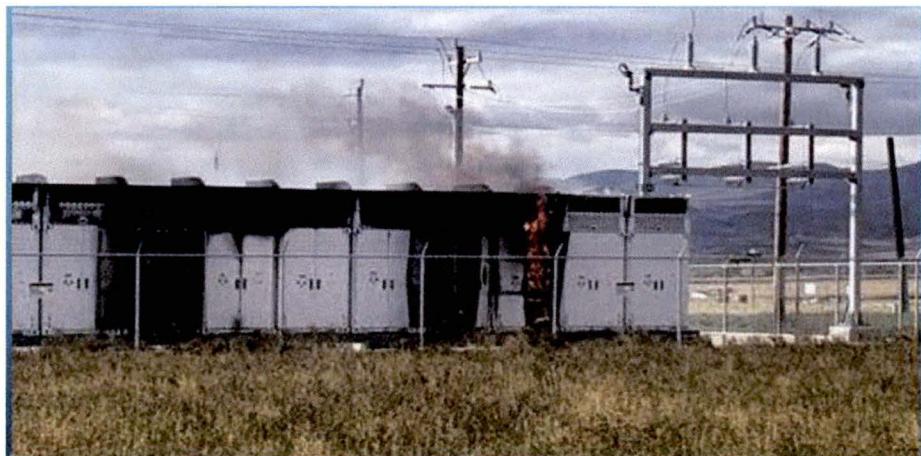
Figure 12: Images of the Melba, ID BESS Fire

A fire at a BESS unit installed at a substation for distribution report occurred in Melba, Idaho on October 2, 2023. At the time of the incident, the system was in the pre-commissioning stage (not yet operational) [5]. The unit capacity was 8 MWh [5]. It was suspected that water intrusion led to a short-circuit, which caused excess heat production that eventually lead to ignition of the battery cells, with the fire spreading among battery segments until burning out [23]. 48 hours after the event, the temperature of the batteries was reported to be approximately 650 °F [24]. The fire burned out after three days, and the substation remained operational through the fire event with external road closures [23, 24]. Images of this incident may be found in Figure 12.

- (a) An image showing one side of the burning enclosure at the substation [24].
- (b) Another angle of the burning BESS enclosure showing the other side burning [24]
