**Emmons-Logan Energy Storage, LLC  
140-MW Battery Energy Storage System – Emmons County  
Siting Application**

Case No. PU-25-209

# Assessment of Potential Impacts of Fires at BESS Facilities

LITERATURE REVIEW | August 21, 2025

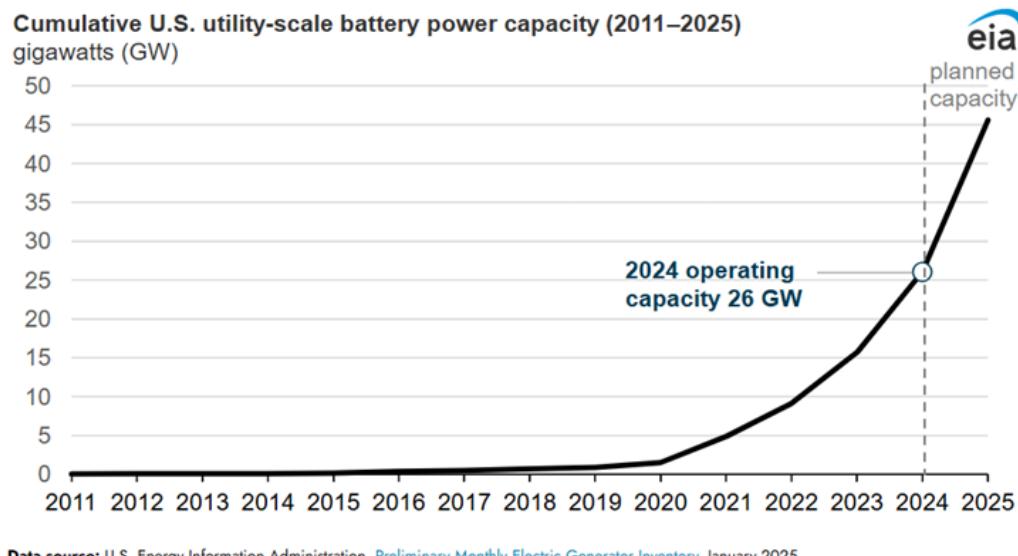
According to the US Energy Information Administration (EIA), BESS capacity has increased drastically since 2021 and total installed US battery capacity exceeded 26 GW in 2024 [1]. Figure 1 shows the current and projected BESS storage capacity, in terms of total gigawatts.

Figure 1: Cumulative Installed Battery Capacity in the US [1]

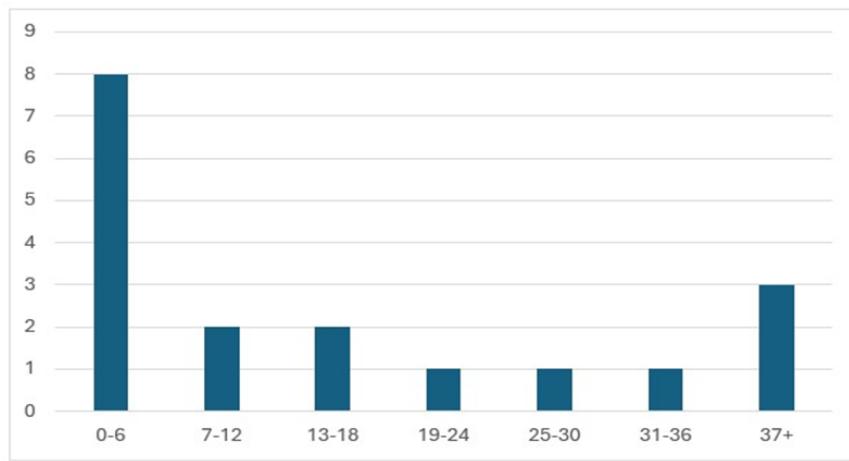
- Of the 35 incidents analyzed, 51% included data on the age of the BESS unit at the time of the fire (Figure 4). There were significantly more fires in BESS units that were early in the life cycle as compared to aged systems.
- Nearly half (44%) of the incidents with reported age occurred within the first six months of operation, suggesting that early-stage issues during assembly, installation, or pre-commissioning may play a significant role in BESS fire risk.
- The oldest system with a recorded fire was 7.6 years old (Escondido, CA, 2024) [5].
- This trend underscores the importance of improved quality control during manufacturing, commissioning, and initial operational phases.

Figure 4: The Number of Fire Incidents by Age (Months) in Six-Month Increments<sup>4</sup>

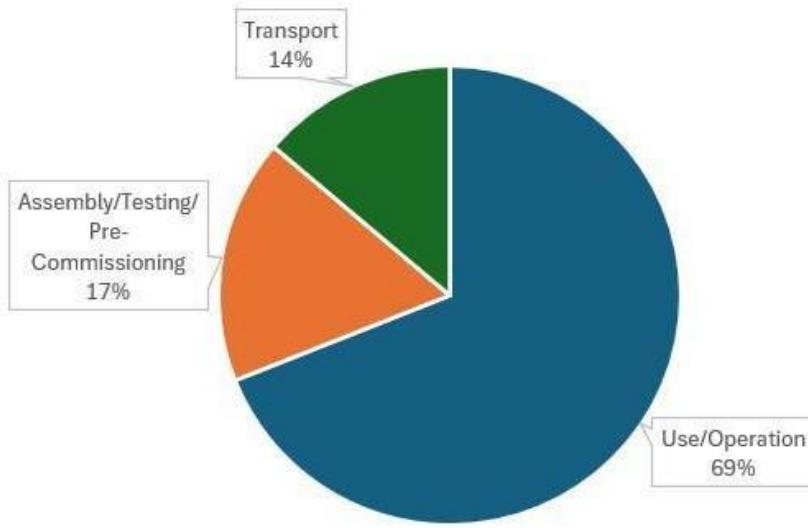
- 69% of fires occurred while the BESS was operational and in use.
- 17% of fires occurred during the assembly, testing, or pre-commissioning phase.
- Early-stage incidents highlight potential vulnerabilities in integration and commissioning procedures, necessitating improved testing, monitoring, and safety checks before systems are put into full operation [7].

Figure 5: The Number of Incidents by the State of the BESS During the Fire Event<sup>5</sup>

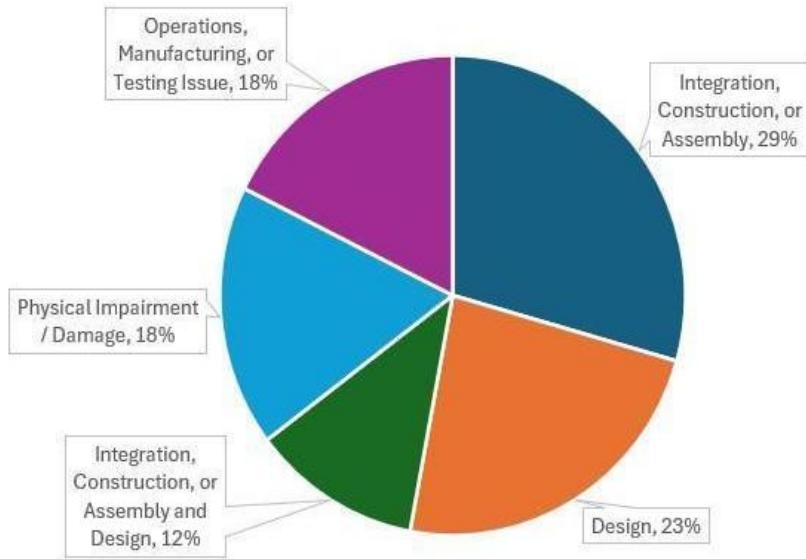
- 49% had a reported cause, with the most common being integration, assembly, or construction failures, followed by design-related failures (Figure 6).

Figure 6: Number of Incidents by Cause<sup>6</sup> <sup>7</sup>

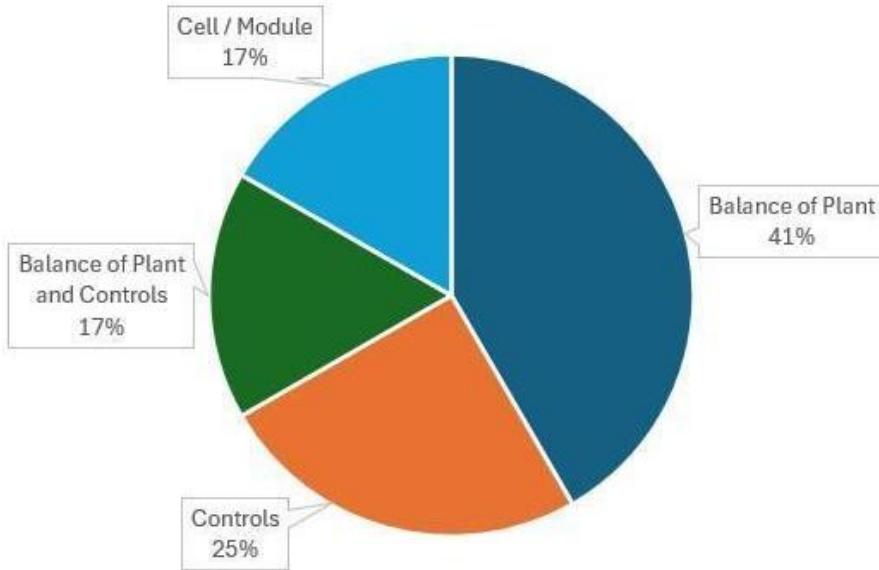
Among the 35 incidents, 34% reported data on failed elements (Figure 7). The most commonly affected components were:

- Balance of Plant (BOP) Failures: These include wiring, busbars, enclosures, power conversion systems, fire suppression systems, HVAC, or liquid cooling systems.
- Control System Failures: Issues related to battery management systems (BMS), energy management systems (EMS), or communication/control circuit failures [7].
- Cell/Module: Failure in the LIB cell or module, usually beginning with short circuits that lead to thermal runaway. Failures can originate from poor cell design or incorrect installation.

Figure 7: Number of Incidents by Failed Element<sup>8</sup>

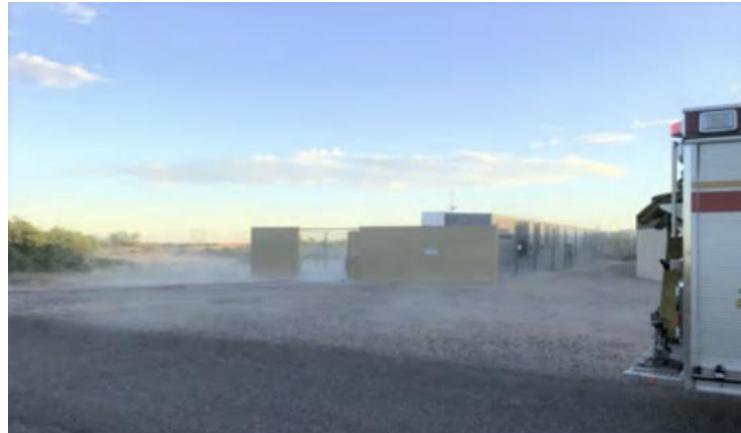
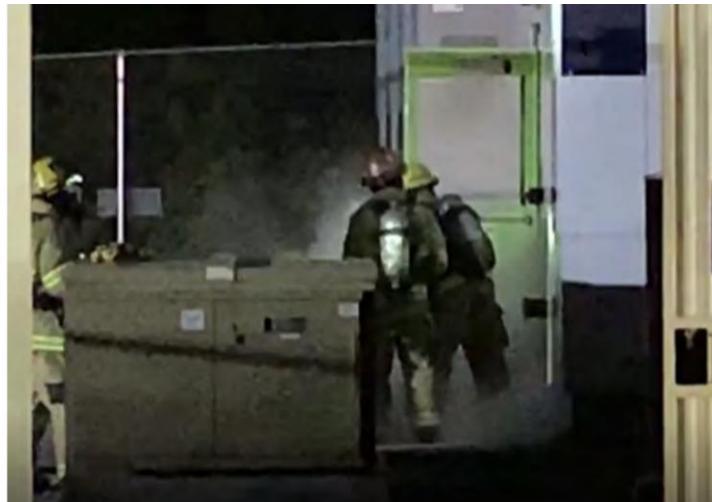
Figure 8: Images of the Surprise, AZ Fire.

Neither UL or APS's investigative reports provide pictures of the singular container on fire. Rather, both reports include photos of the damage after the incident, and UL's report features images of the incident upon arrival and just after firefighters opened the door to the unit during battery venting, which may be seen in Figure 8.

(a) Conditions of the BESS site upon the firefighters' arrival. Venting can clearly be seen coming from the unit [11]

(b) Approximately 5 seconds after the responding firefighters opened the door to the BESS unit. As noted by UL in the report, high-density gases and vapors can clearly be seen in the photograph [11]

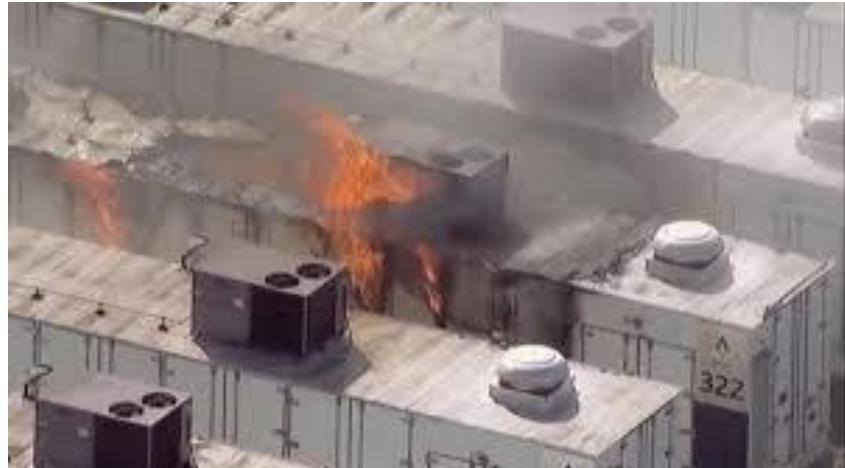
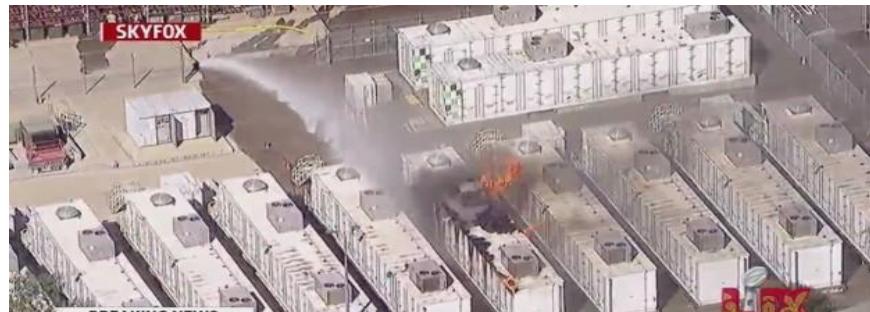
Figure 9: Images of the Escondido BESS Container Fire

Figure 9a shows a clear image of the burning container, including dark smoke and flames [15]. Figure 9b shows a clear image of the burning container as part of the larger BESS facility [16]. It can be seen that firefighters are applying water from a distance to surrounding containers to avoid fire spread and are letting the involved container burn out [16].

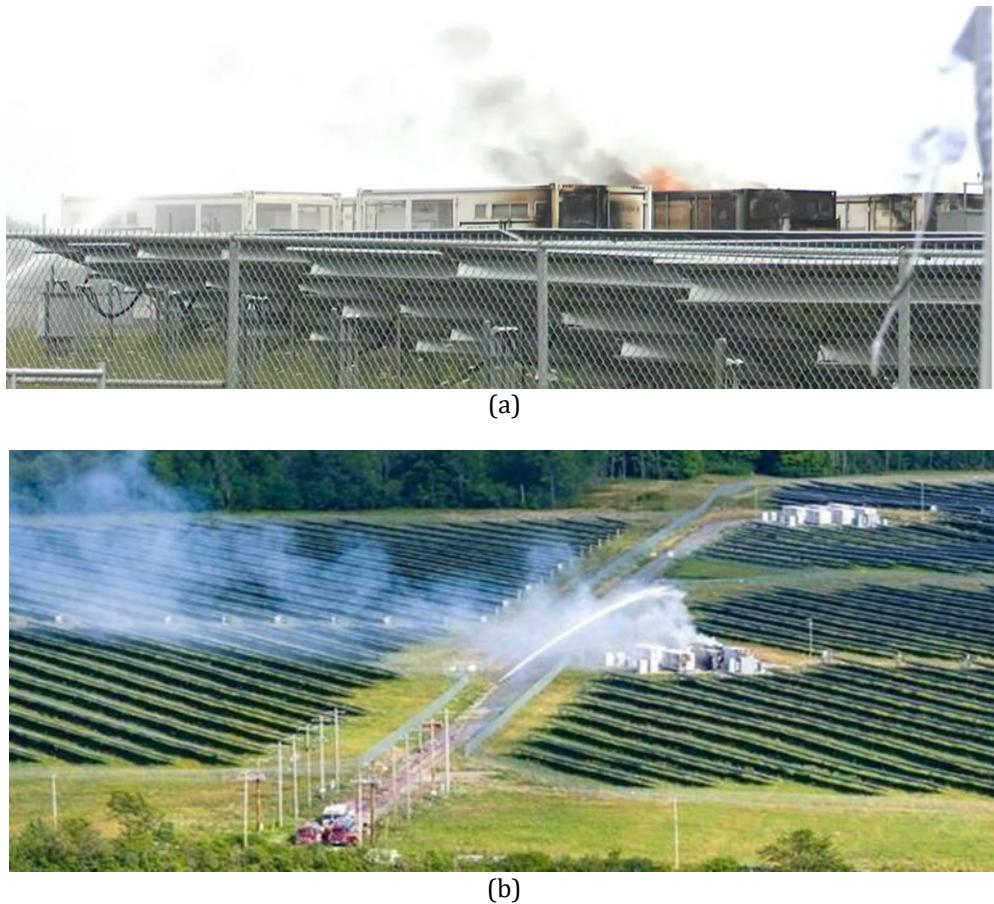
Figure 10: Images of the Chaumont (Lyme) BESS Fire Incident

On July 27, 2023, a multi container fire occurred at a utility-scale facility in Lyme, New York (see Figure 10). The system was 4-5 months old and was operational and in use during the incident. An investigative report showed that the cause of the incident had to do with “the controls” [17, 18, 19]. There is minimal information regarding the specific design impairments and controls issue that led to this incident.

- (a) An image showing burned containers emitting smoke and flames. The solar panels can also be seen in front of the BESS [19].
- (b) A remote image showing the smoking BESS containers in the context of the whole site. Firefighters can be seen spraying water onto the adjacent containers from a great distance. [20]

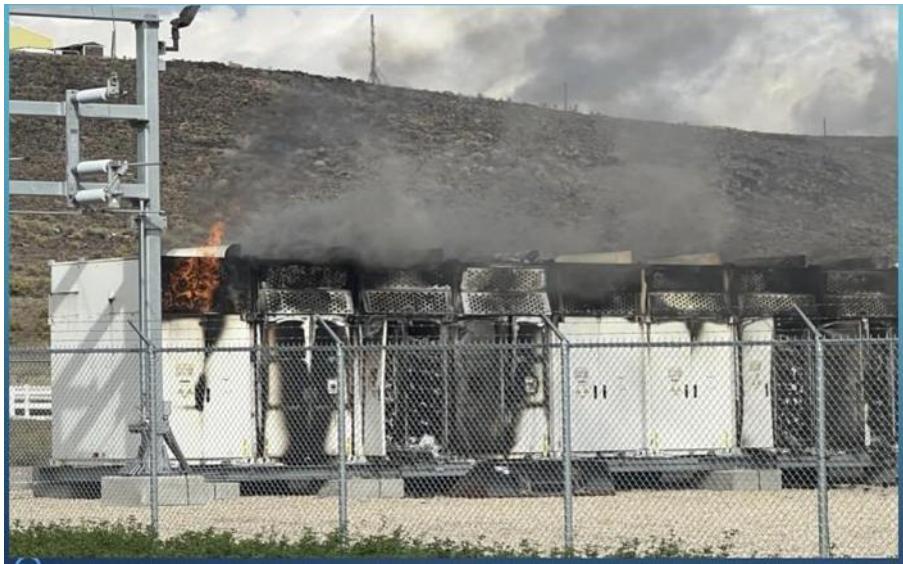
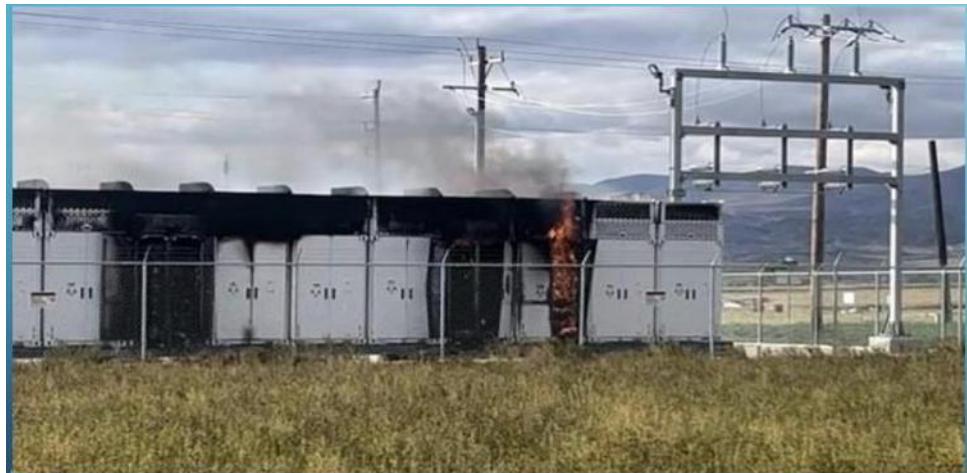
Figure 12: Images of the Melba, ID BESS Fire

A fire at a BESS unit installed at a substation for distribution report occurred in Melba, Idaho on October 2, 2023. At the time of the incident, the system was in the pre-commissioning stage (not yet operational) [5]. The unit capacity was 8 MWh [5]. It was suspected that water intrusion led to a short-circuit, which caused excess heat production that eventually lead to ignition of the battery cells, with the fire spreading among battery segments until burning out [23]. 48 hours after the event, the temperature of the batteries was reported to be approximately 650 °F [24]. The fire burned out after three days, and the substation remained operational through the fire event with external road closures [23, 24]. Images of this incident may be found in Figure 12.

- (a) An image showing one side of the burning enclosure at the substation [24].
- (b) Another angle of the burning BESS enclosure showing the other side burning [24]

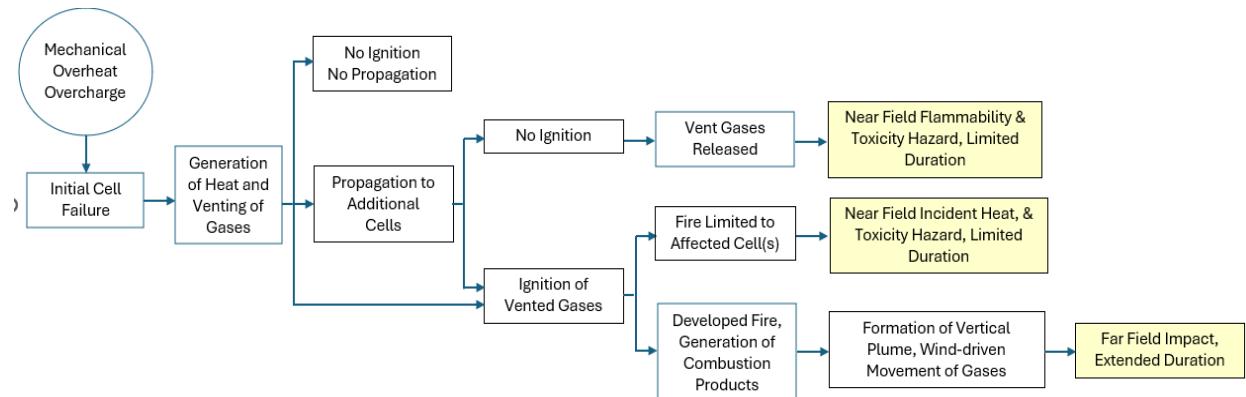
A review of toxic gas hazards and the potential for soil and water contamination requires an understanding of the gaseous and particulate emissions that are associated with BESS fire-related events. These events are associated with malfunctioning of a battery. These events may be limited to overheating of a battery with some venting of gases, while others may continue to TR and flaming combustion. The progression of these events and their consequences are depicted in Figure 13.

Figure 13: Event Pathways for Battery Malfunctions

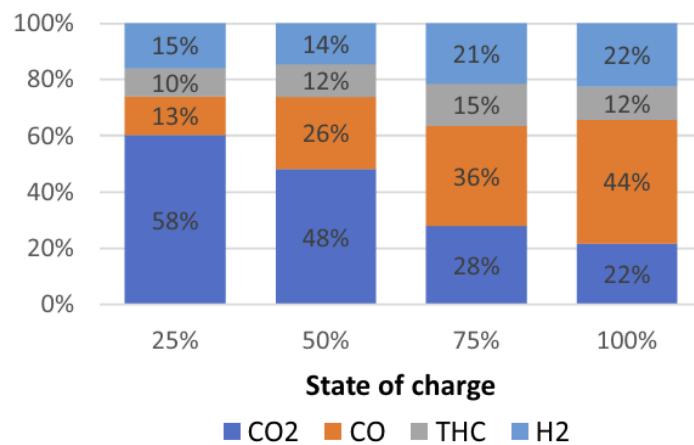
The list and proportions of gases generated from batteries undergoing TR is influenced by the State of Charge (SOC). At 0% SOC, more CO<sub>2</sub> is produced than CO, and only a few solvents are produced. The impact of SOC on the production of CO<sub>2</sub>, CO, total hydrocarbons (THC) and H<sub>2</sub> on a prismatic NMC cell experiencing TR is presented in Figure 14 [36].

Figure 14: Impact of SOC on Proportion of CO<sub>2</sub>, CO, Total Hydrocarbons (THC) and H<sub>2</sub> [36]

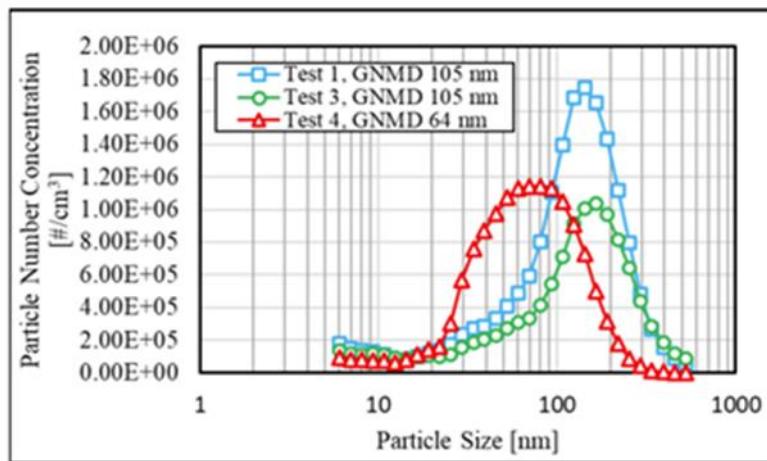
A distribution of airborne particle sizes as a function of particle count in repeated tests of NMC battery cells is presented in Figure 16 [47]. The mean particle size ranges from about 70 to 130 nm, which is also the size range noted for the greatest mass. These are smaller than those shown in Figure 16 as the data reported in Figure 15 was done downstream of the source and hence had settled out of the airstream.

Figure 16: Airborne Particle Sizes [47]

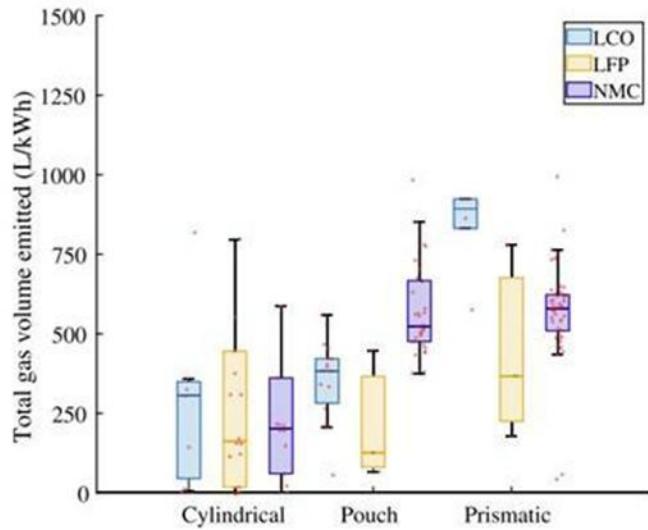
The gas volume produced normalized by the cell capacity is presented in Figure 17 and Figure 18. As indicated in Figure 18, NMC pouch and NMC and LFP prismatic cells generate similar volumes of gas production and more volume than cylindrical cells of either chemistry.

Figure 17: Influence of Cell Type on Gas Volume Produced [32]

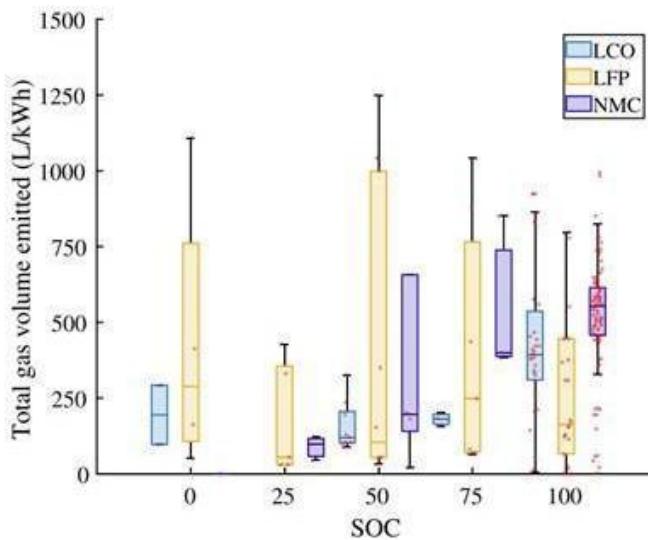
Figure 18: Influence of SOC on Gas Volume Produced [32]

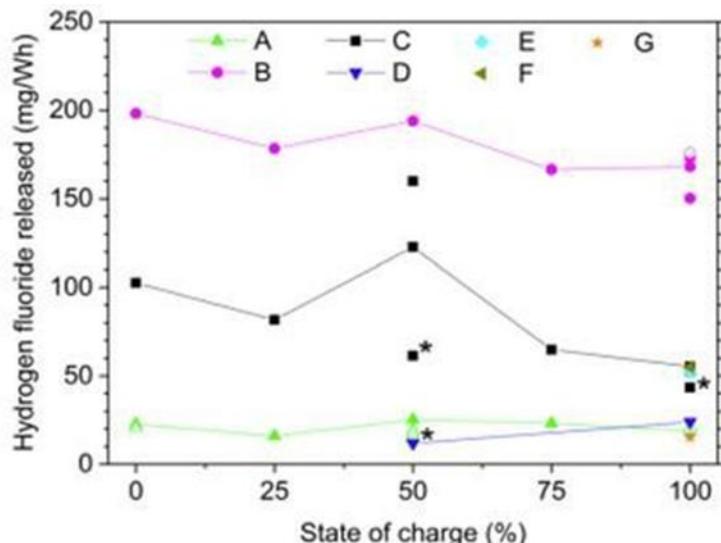
According to EPRI [34], the emissions of battery cells of LFP chemistry contain fluorine compounds, which is produced as a result of the  $\text{LiPF}_6$  electrolyte. The total volume of HF generated appears to be independent of the SOC as indicated in Figure 20. While the concentration of fluorine compounds can be appreciable in close proximity to the cell, given the reactivity of fluorine compounds, they will tend to react with other substances (including water vapor) or be absorbed into particulate matter. The rate of production of HF is presented in Figure 21 for a range of SOC's. As with other gases, the rate of production is dependent on the SOC, with greater release rates observed with increasing SOC.

Figure 20: Influence of SOC on HF Production (Battery Types B-E have LFP Chemistry) [34].<sup>12</sup>

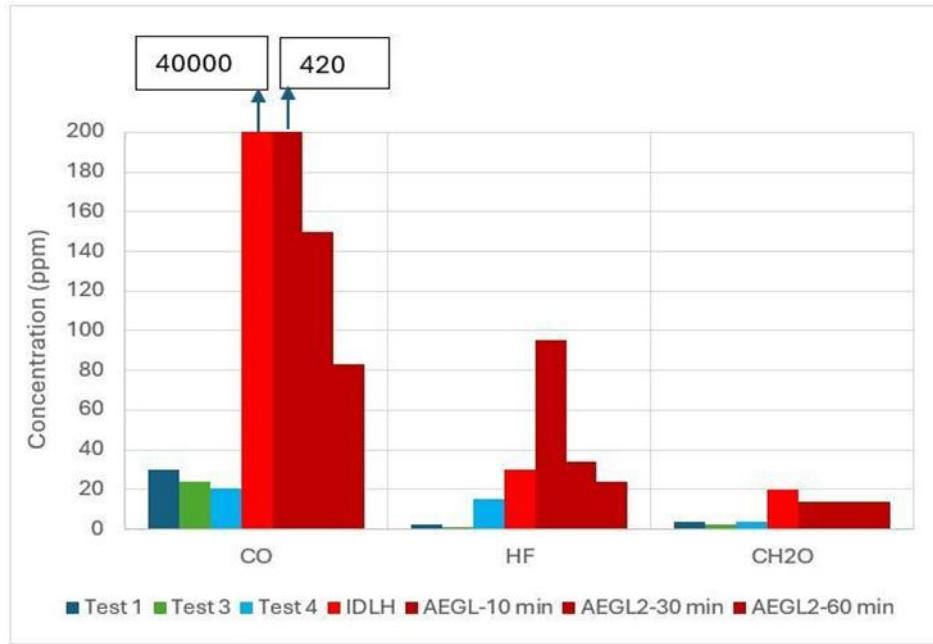
Average concentrations of the gases over the noted time period are utilized in this review, being that these are more indicative of the sustained levels of gas concentrations. The AEGL-2 criteria are selected because these are the lowest AEGL thresholds that relate to significant health consequences, some of which may be irreversible. As indicated in Figure 21, all of the average concentrations are appreciably less than the IDLH levels. Relative to the AEGL-2 thresholds, none of the average gas concentrations exceed any of the respective AEGL thresholds.

Figure 21: Example of Toxicity Assessment of Selected Gas Emissions from TR of NMC Battery

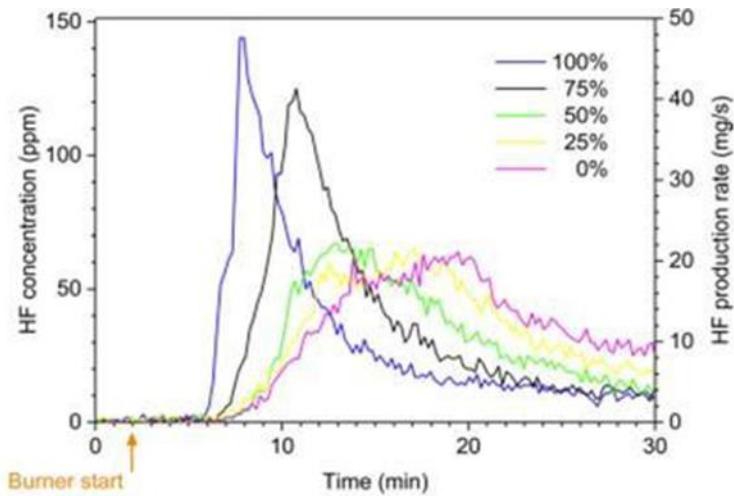
From most sources, the peak rate of overall gas production, as well as that for CO, CO<sub>2</sub>, and HF, has been shown to be proportional to the SOC [38, 55]. Results from experiments a pouch LFP cell are presented in Figure 22 [43]. The peak concentrations of HF occur simultaneously with flaming being observed. In that figure, the peak gas concentration for HF is relatively constant for SOCs of 50% or less but increases appreciably at SOCs of 75% and 100%. While there is a rapid increase in the concentration or rate of HF emissions at an early stage, the concentration of HF emissions decreases exponentially thereafter. A substantial amount of HF may be generated, ranging between 20 and 200mg/Wh of nominal battery energy capacity. In addition, cells with a capacity of 15–22 mg/Wh produced substantial quantities of phosphoryl fluoride (POF3), another potentially toxic gas, in some of the fire tests.

Figure 22: Transient Hydrogen Fluoride Production for Different SOCs [43]

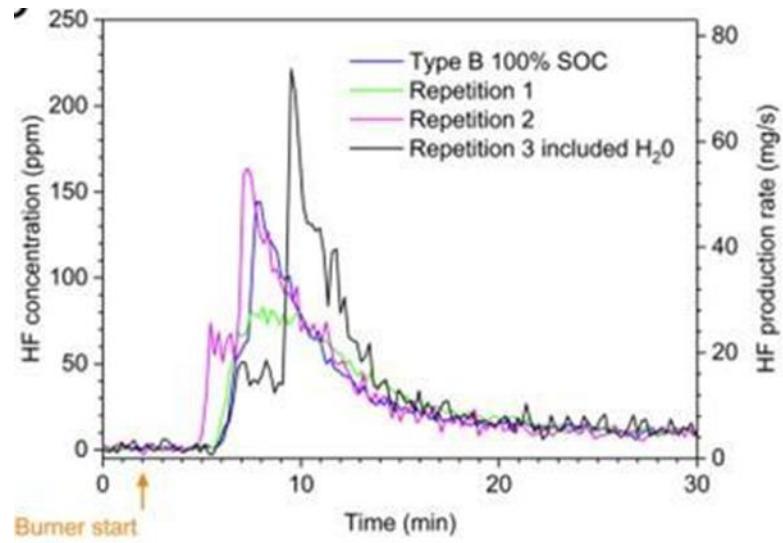
In Figure 23, results of three replicate experiments (identified as “Type B,” repetition 1 and 2) (plus one additional experiment conducted with water mist, “repetition 3”) are presented. HF production varied significantly for LFP batteries with a 100% SOC, indicating the variability in outcomes from TR events, even when controls are in place to attempt repetition. While the production rate of HF is much less in repetition 1 than in the other two tests, the total volume of HF produced is reported to be similar in all three tests.

Figure 23: Transient Hydrogen Fluoride Production in Repetitive Experiments [43]

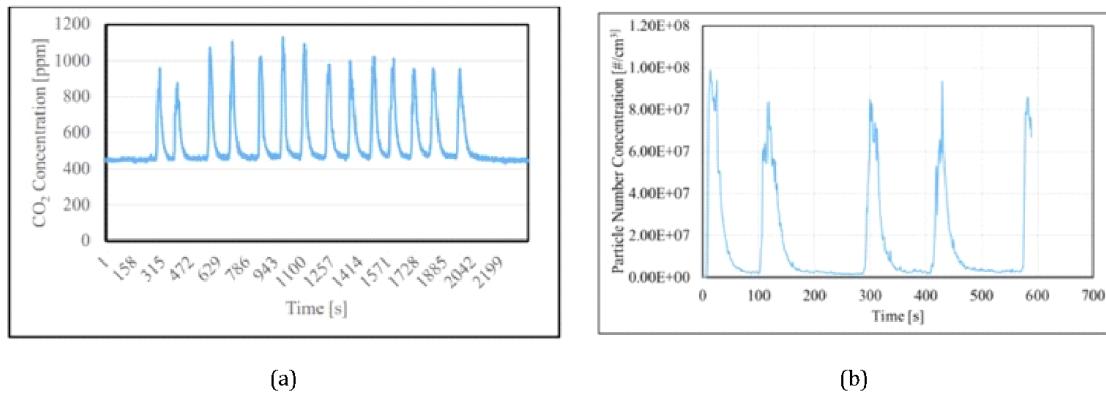
The time variation in the concentration of CO<sub>2</sub> (as an example of gaseous emissions) and particles from experiments by Larsson [43] is presented in Figure 24. The repeating peaks are evidence of a “puffing” type of response from the battery. The highly transient nature of such an event will be impractical to capture via computer simulations given the capabilities of currently used software.

Figure 24: Transient Emissions of CO<sub>2</sub> and Particles [43]

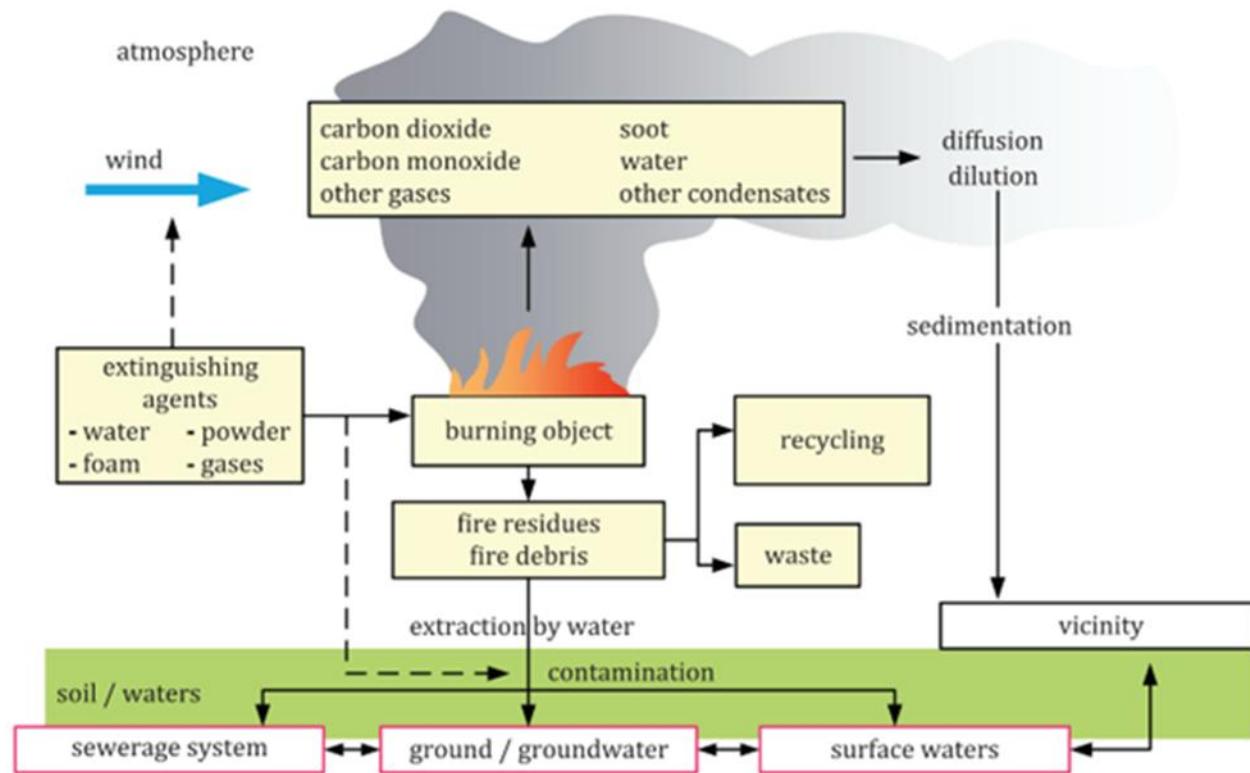
The comprehensive nature of an environmental impact analysis for a fire involving a BESS unit is depicted in Figure 25 [66]. Smoke produced from a fire involving any commodity, including a BESS unit, will rise in a plume and include combustion gases such as carbon dioxide (CO<sub>2</sub>), carbon monoxide (CO), water vapor, other gases, particulate matter (i.e. soot) and other condensed chemical species. The plume will continue to rise as long as it remains buoyant (i.e. is warmer than the surrounding air).

Figure 25: Pathways to Contamination from a Fire [66]
