# Construction Inspection Report Cenex 10" Refined Fuels Pipeline PU-17-97

Prepared for:  
**North Dakota  
Public Service Commission**

**WENCK Associates, Inc.**  
301 1st Street NE, Suite 202  
Mandan, ND 58554  
Phone: 701-751-3370  
Fax: 763-479-4242

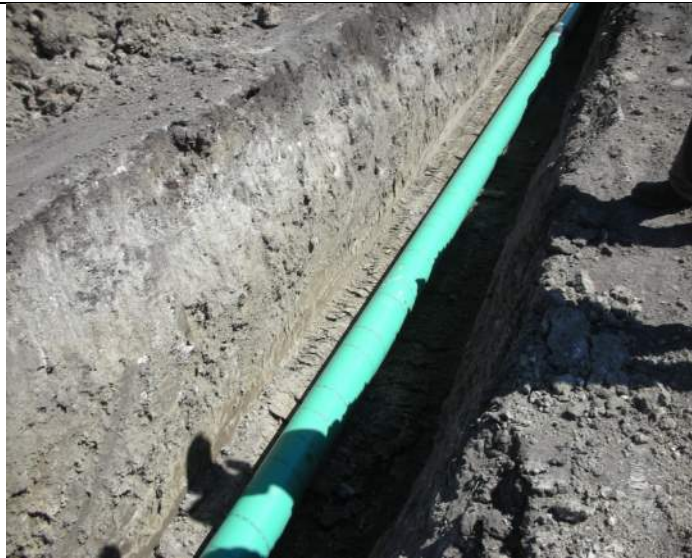
**Observation Point: 2734**

Date Taken: August 20, 2019  
Direction Photo is Taken:  
Station 6107+00 Spread 2
