+NuStar 10" Pipeline Relocation Project

As-Built Inspection Report

Docket Number: PU-20-381

Prepared for North Dakota Public Service Commission

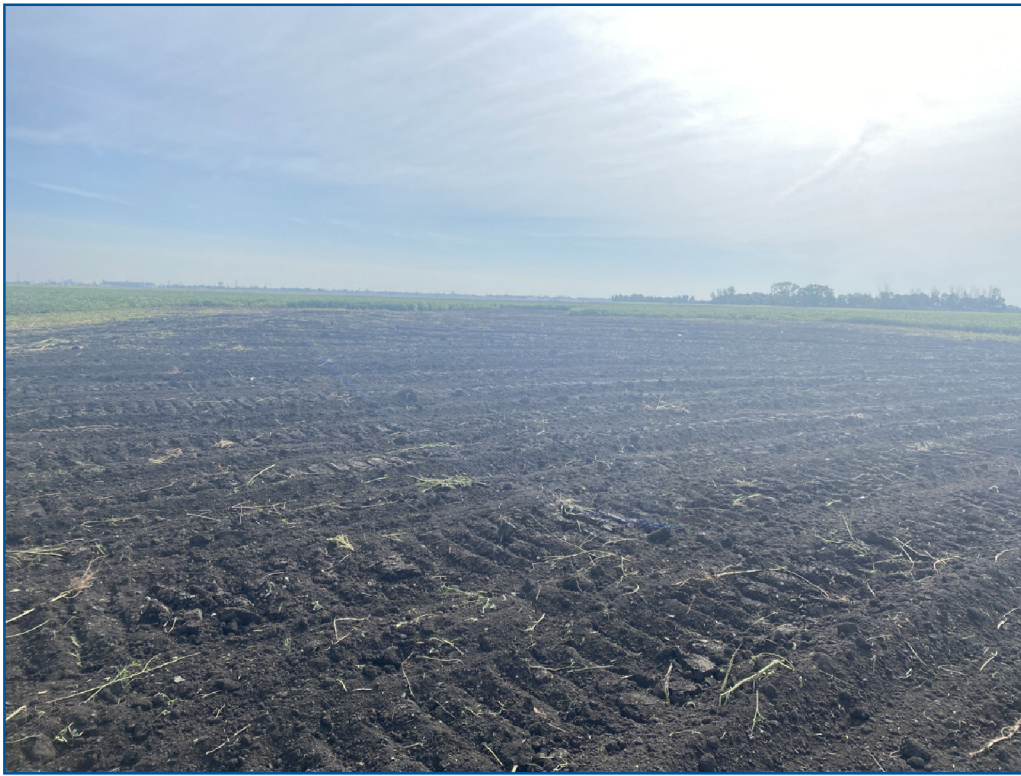
Map 1 of 24
**NUSTAR 10" PIPELINE RELOCATION
 AS-BUILT INSPECTION**
PU-20-381
 North Dakota Public Service Commission
 Cass County, North Dakota

Date: 8/26/2022
 Photo Direction: East
 Comment: Tie in location

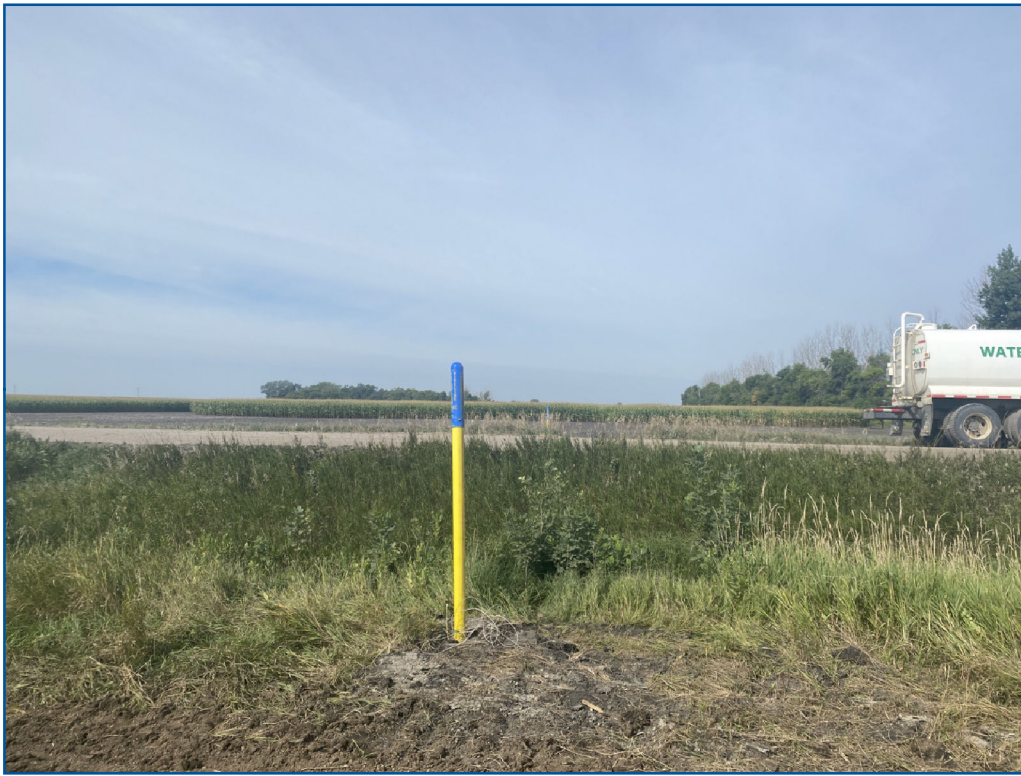
Map 2 of 24

Date: 8/26/2022
 Photo Direction: West
 Comment: No visible issues

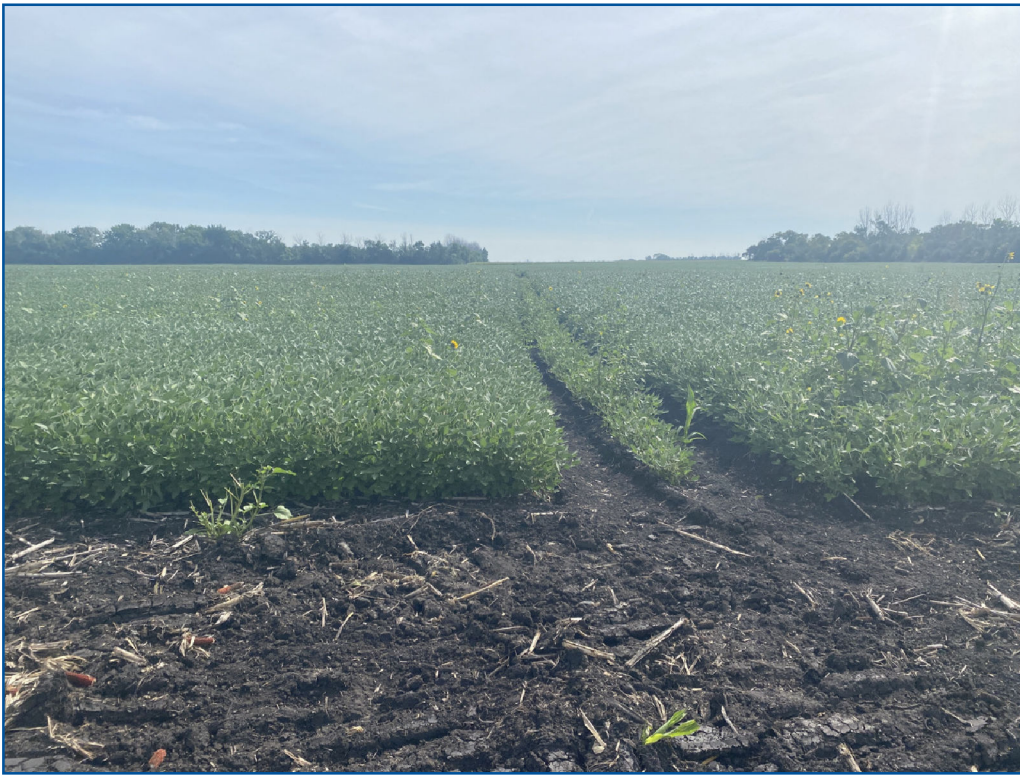
Map 3 of 24

Date: 8/26/2022
 Photo Direction: East
 Comment: No visible issues, corn planted over pipeline

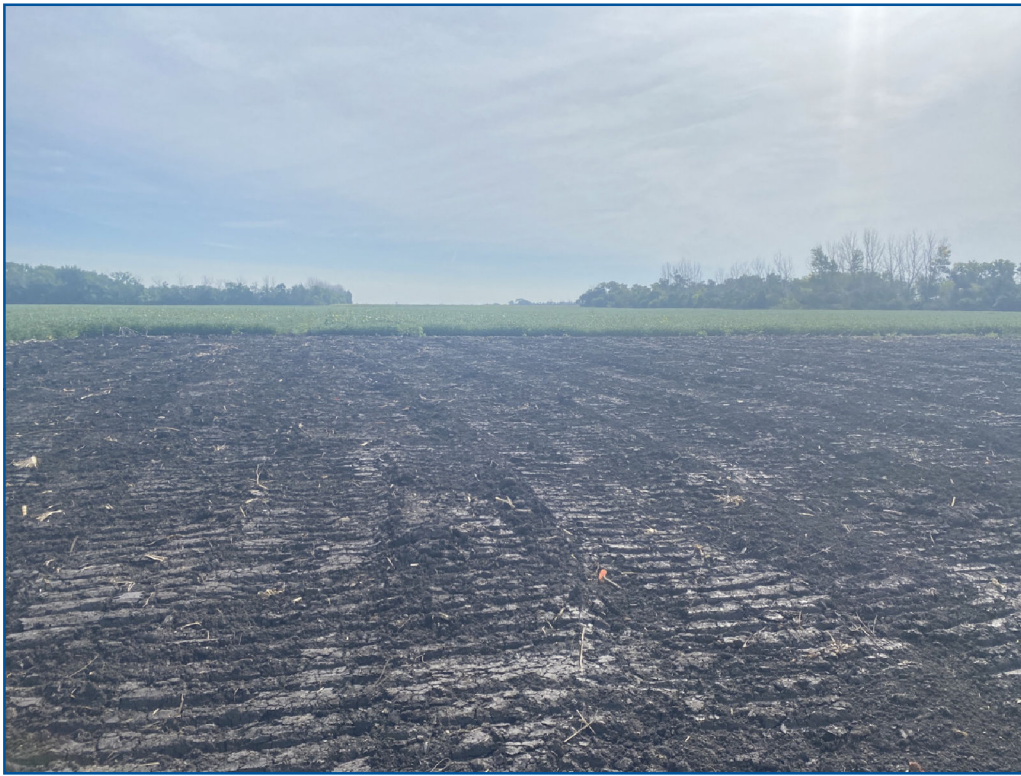
Map 4 of 24

Date: 8/26/2022
 Photo Direction: East
 Comment: No visible issues

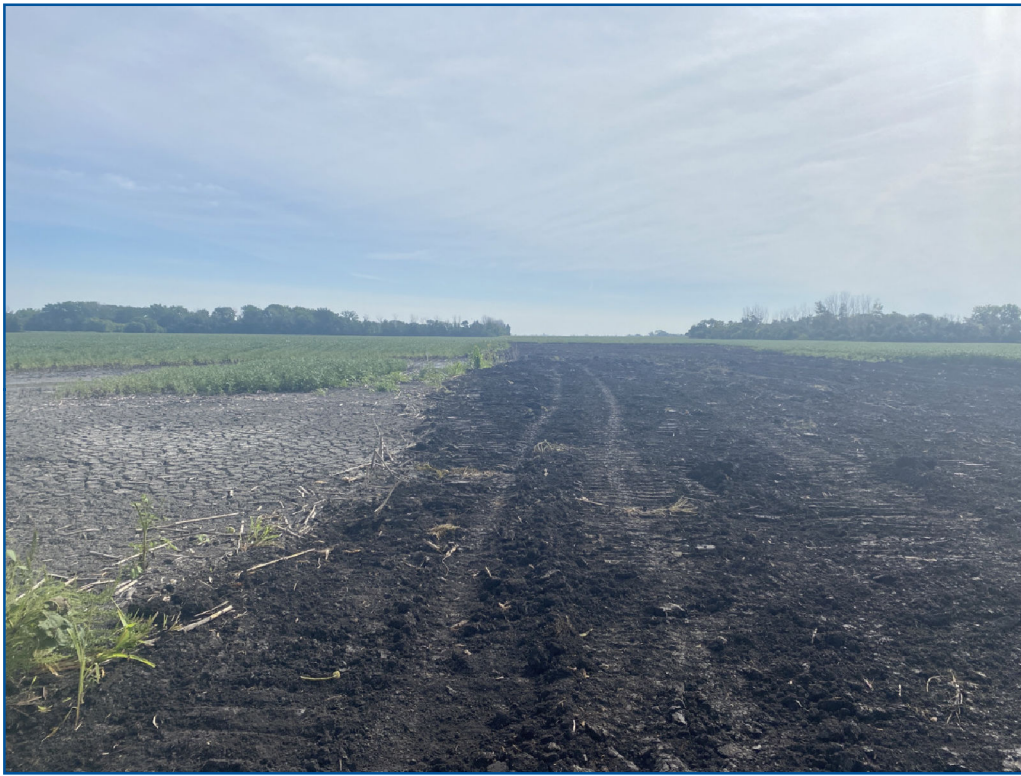
Map 5 of 24

Date: 8/26/2022
 Photo Direction: East
 Comment: No visible issues, cropland adjacent was flooded

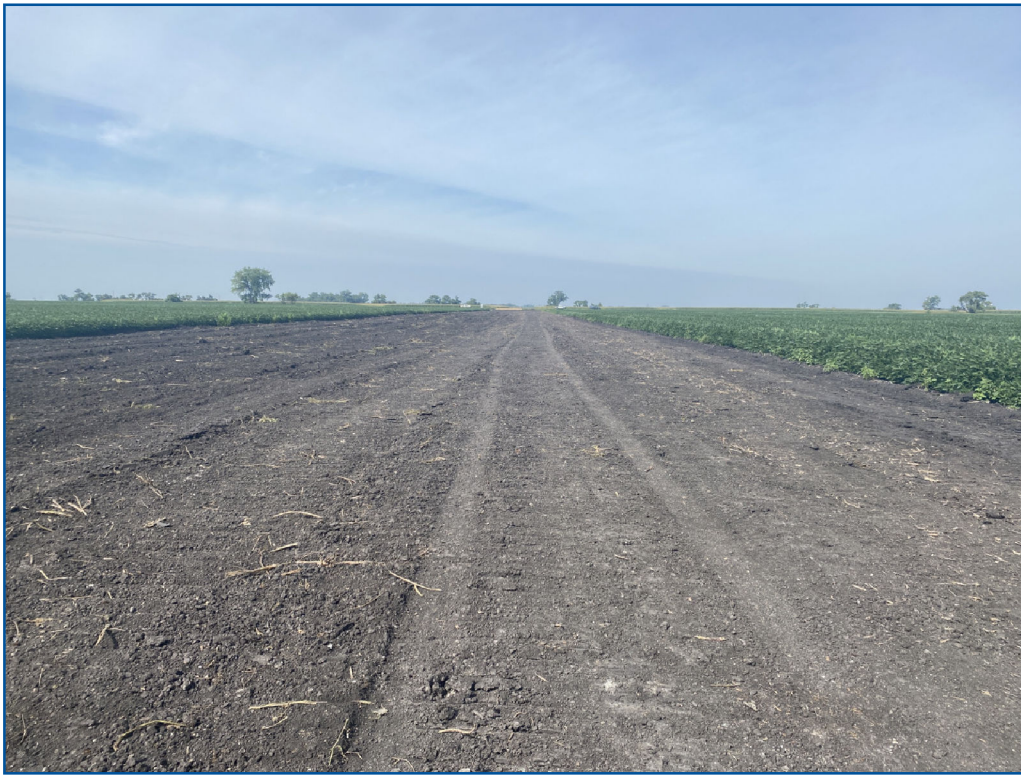
Map 6 of 24

Date: 8/26/2022
 Photo Direction: West
 Comment: No visible issues

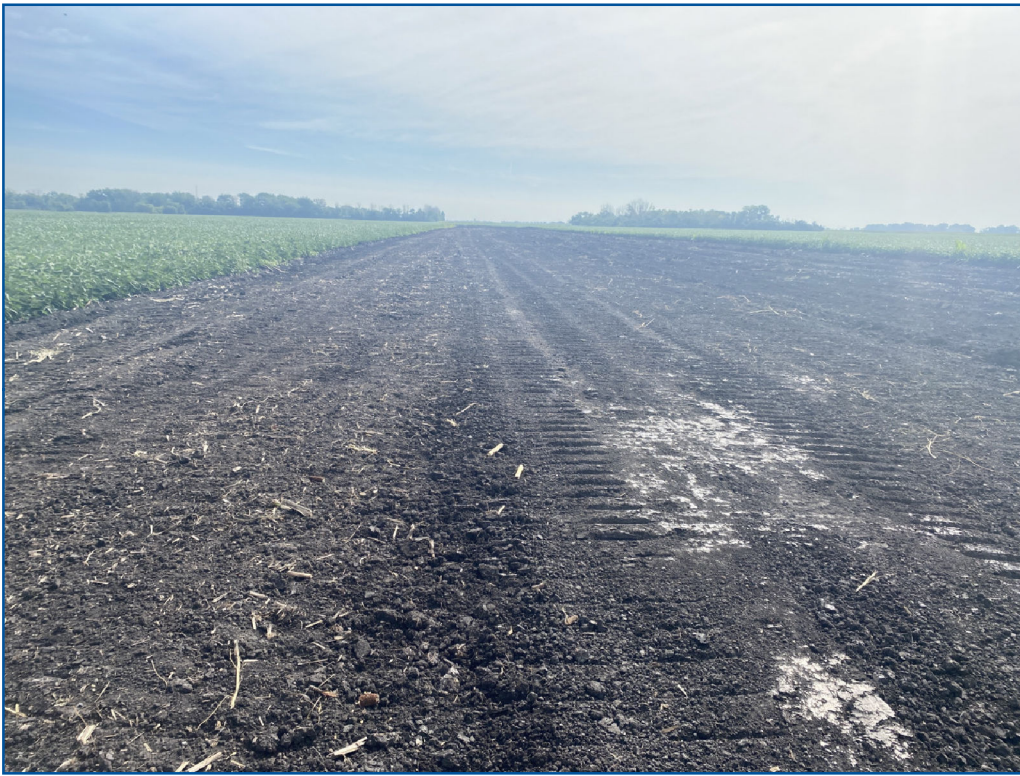
Map 7 of 24
**NUSTAR 10" PIPELINE RELOCATION
 AS-BUILT INSPECTION**
PU-20-381
 North Dakota Public Service Commission
 Cass County, North Dakota

Date: 8/26/2022
 Photo Direction: East
 Comment: No visible issues

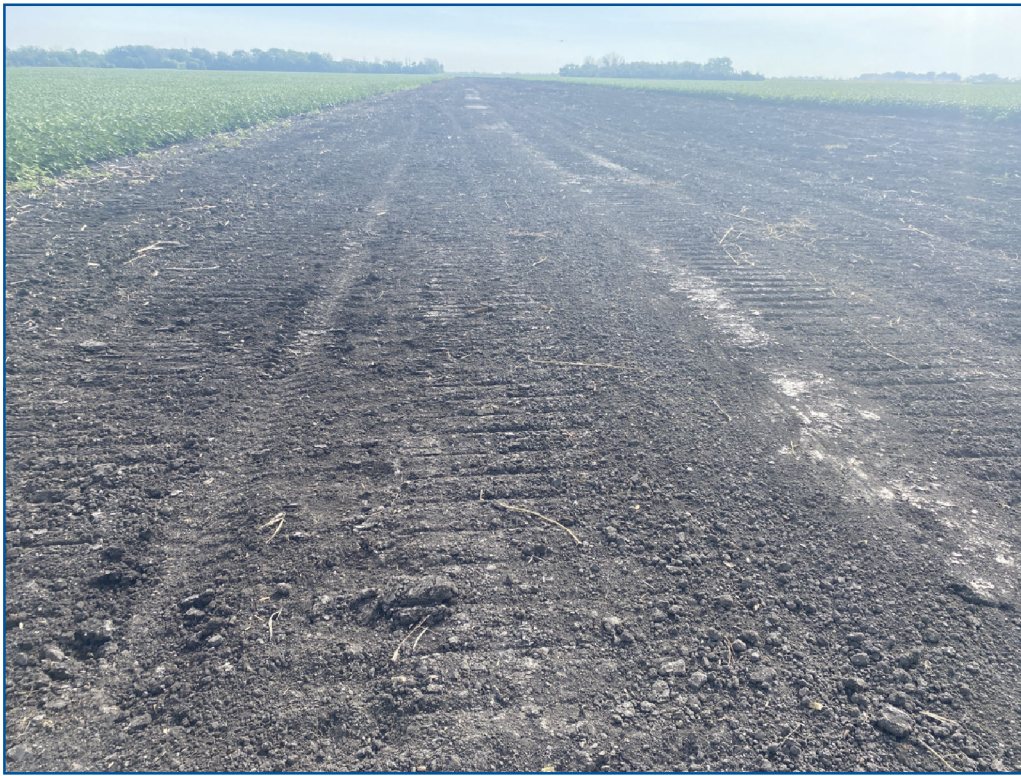
Map 8 of 24

Date: 8/26/2022
 Photo Direction: East
 Comment: No visible issues

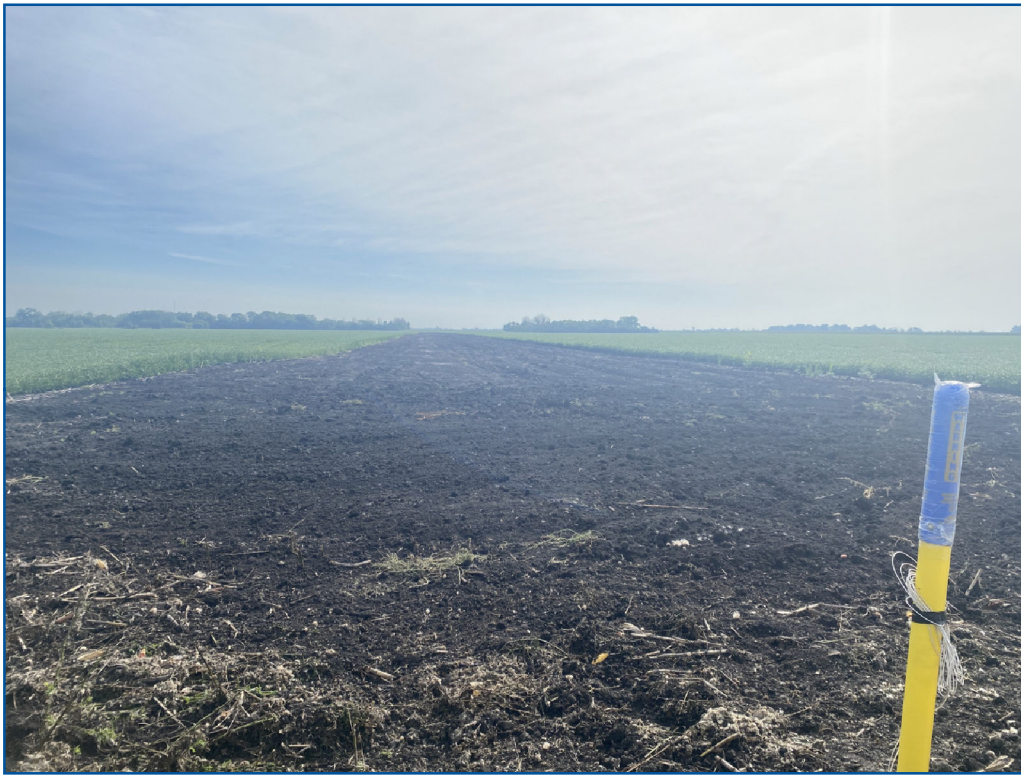
Map 9 of 24

Date: 8/26/2022
Photo Direction: East
Comment: No visible issues

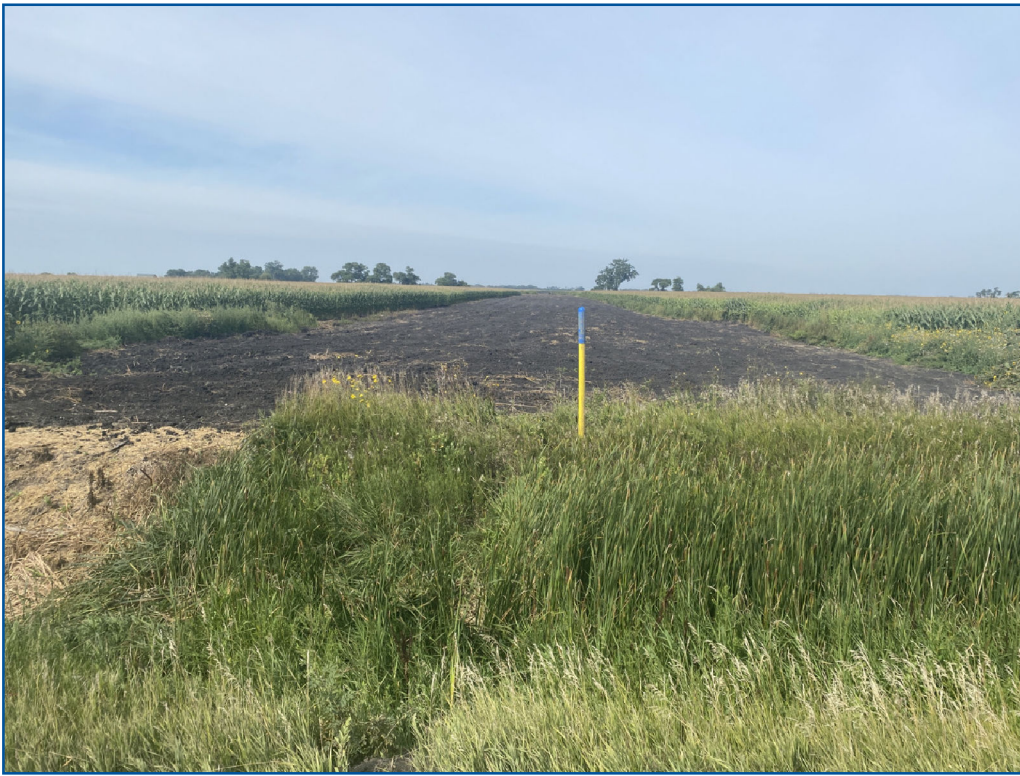
Map 10 of 24
**NUSTAR 10" PIPELINE RELOCATION
 AS-BUILT INSPECTION**
PU-20-381
 North Dakota Public Service Commission
 Cass County, North Dakota

Date: 8/26/2022
 Photo Direction: West
 Comment: No visible issues

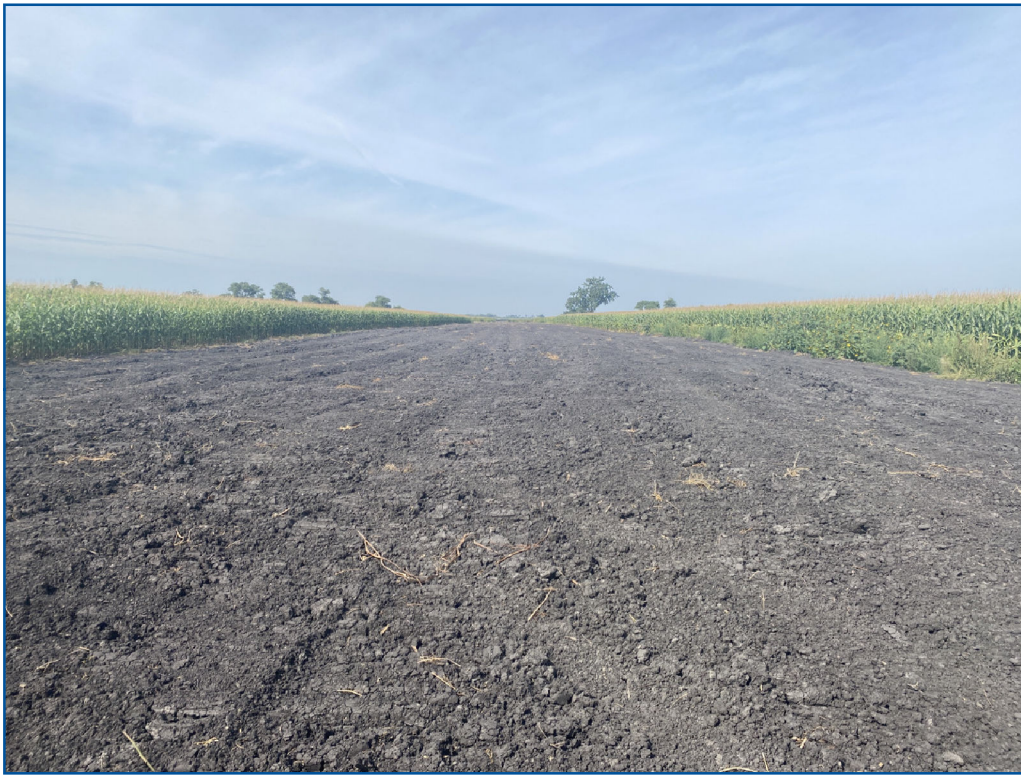
Date: 8/26/2022
 Photo Direction: West
 Comment: No visible issues

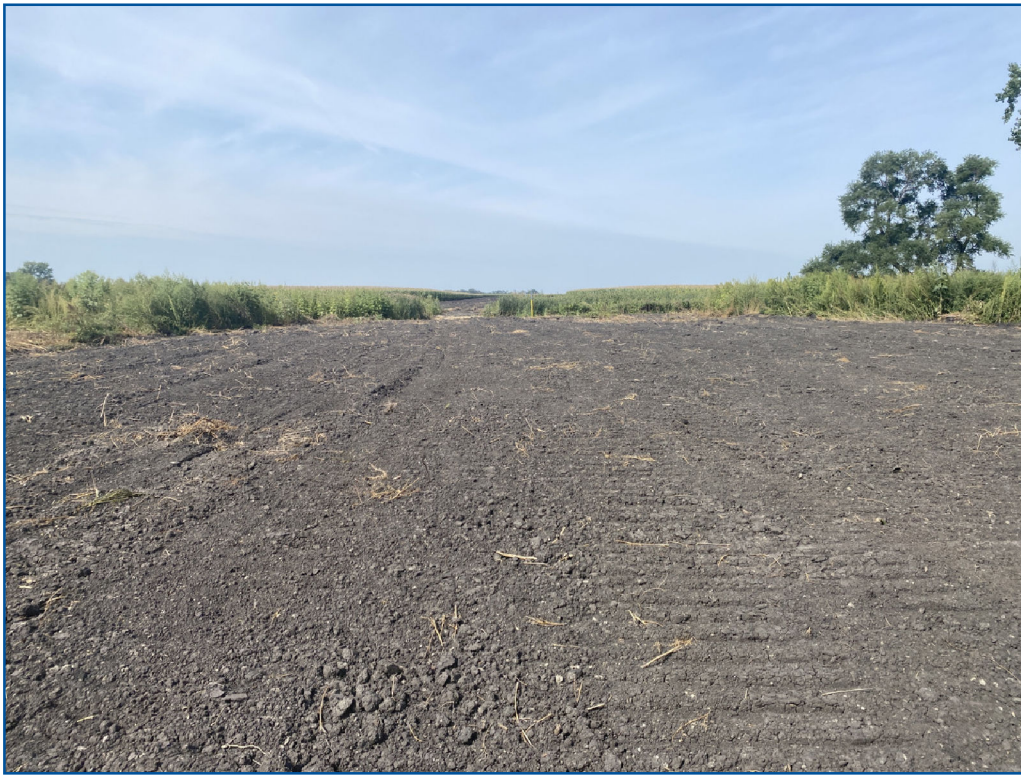
Map 13 of 24

Date: 8/26/2022
 Photo Direction: West
 Comment: No visible issues

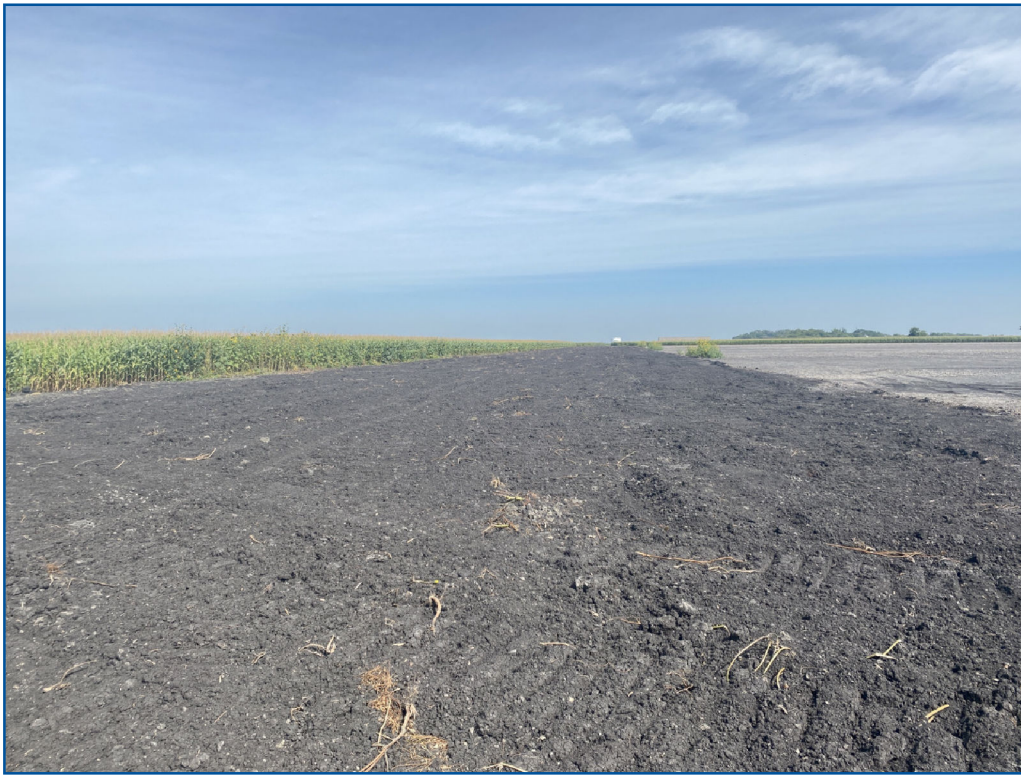
Map 17 of 24

Date: 8/26/2022
 Photo Direction: North
 Comment: No visible issues

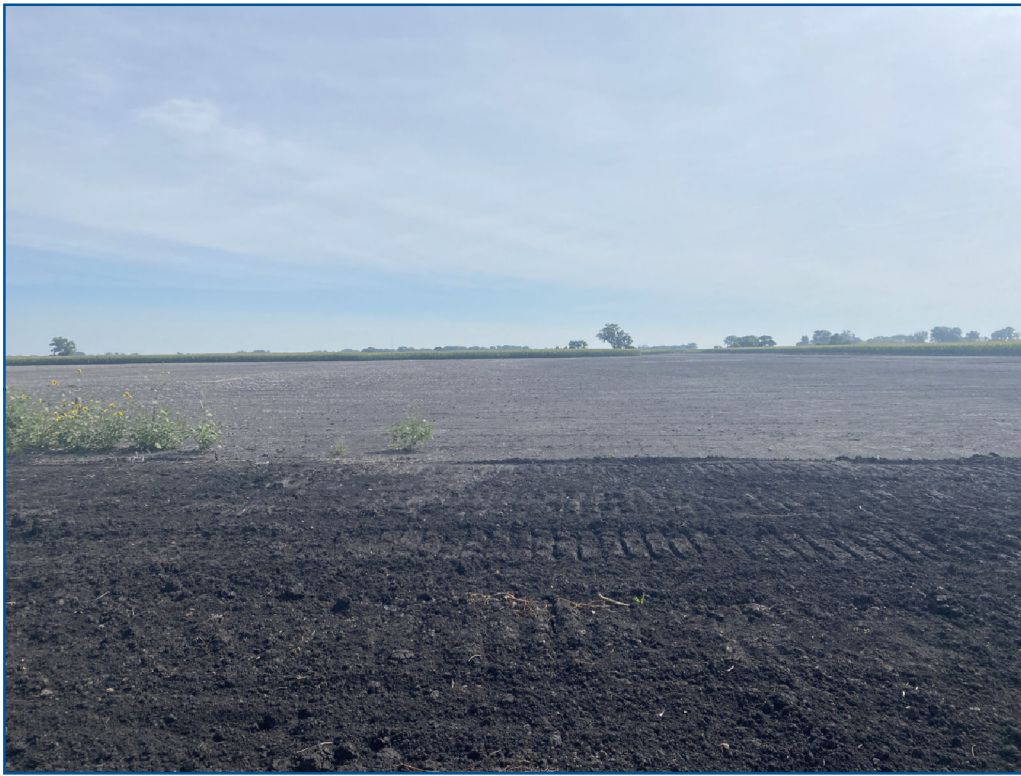
Map 18 of 24

Date: 8/26/2022
 Photo Direction: East
 Comment: 20 acres farmland flooded out due to project

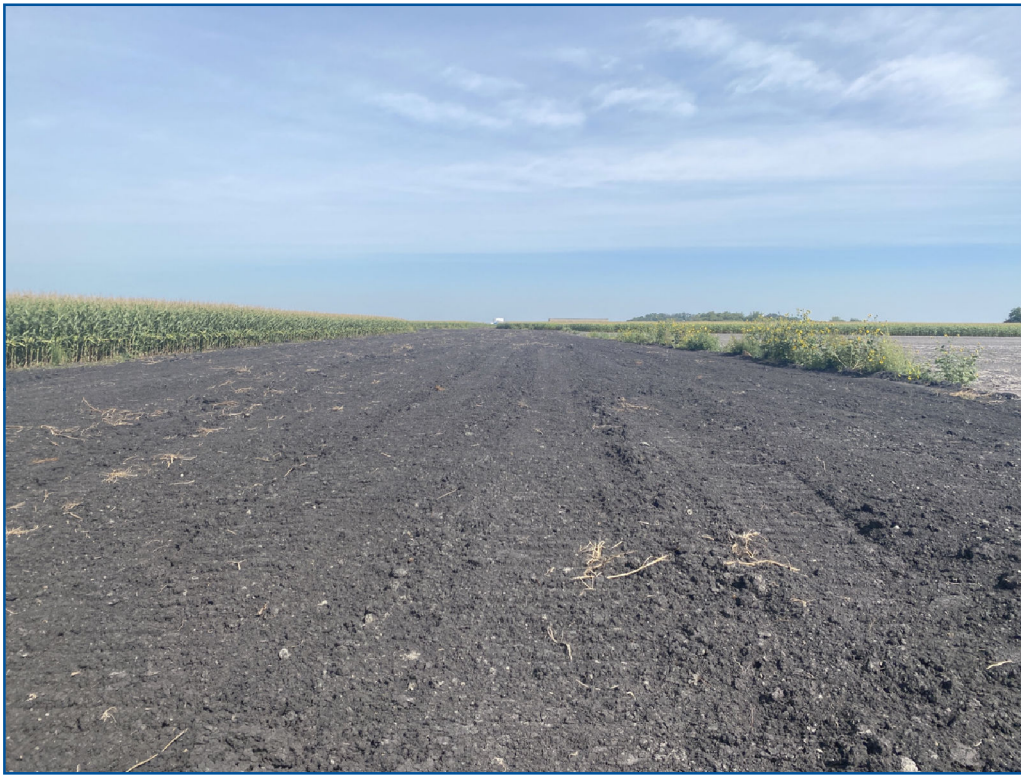
Map 19 of 24

Date: 8/26/2022
 Photo Direction: North
 Comment: No visible issues

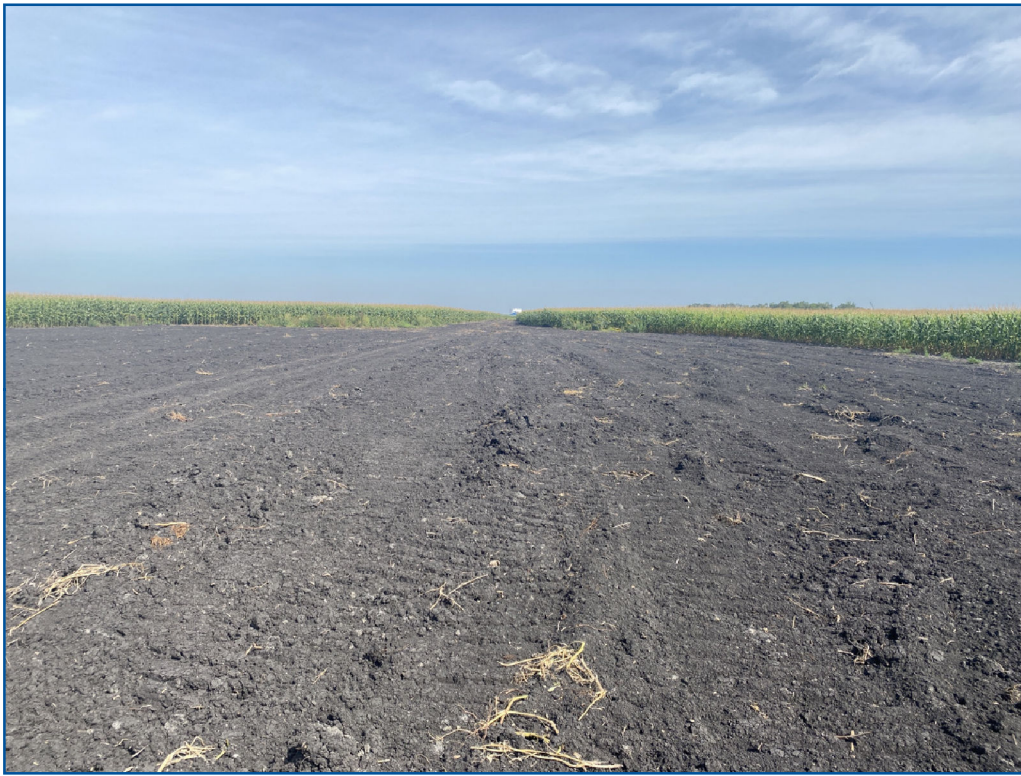
Date: 8/26/2022
 Photo Direction: North
 Comment: No visible issues
