Subject: Depth of Cover for the Thunder Butte Pipeline

Geohazard Investigation  
Thunder Butte Pipeline Project

Thunder Butte Petroleum Services Clean Fuels Refinery  
Geological Hazard Investigation

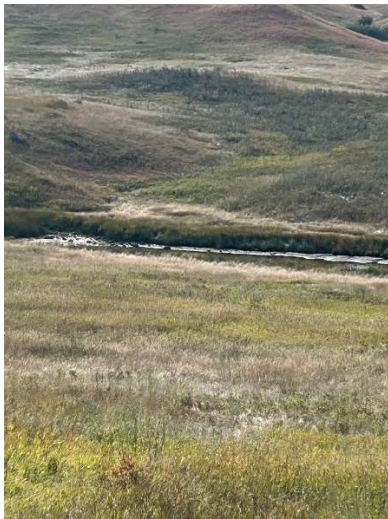
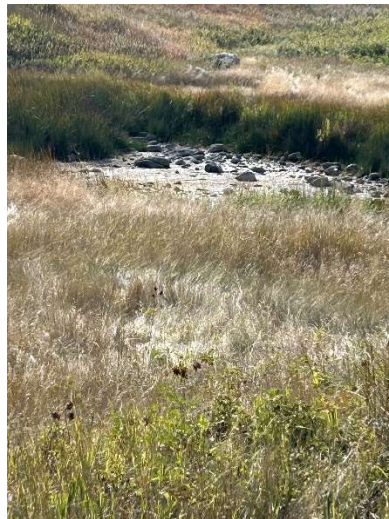
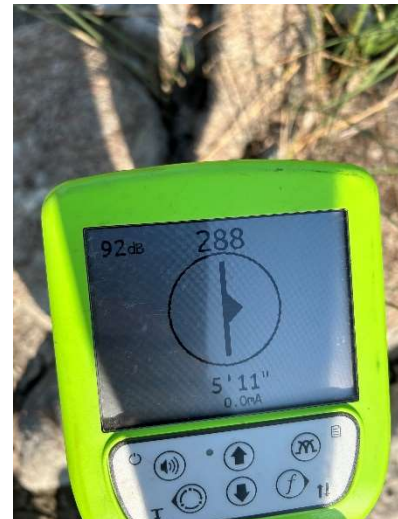
The results can be found on the attached pages to this memo. All of the depths checked meet the requirement of 48" or 72" minimum DOC except for 2 spots that are of potential concern. Both locations were found by the geologist, and one is at a spot where there is a pond in a farmers field the other is at a possible washed-out area at the top of a slope to a creek crossing. The pond location in the farmer's field was at 3'11" and the spot at the potential wash out location was shot at 3'0". We had our operations guy go out and check the potential washed out area as it was unclear from the geologist report if this wash out was on our pipeline or to side of our pipeline by 15' (see report from geologist provided in the submittal package). Our operations guy searched the whole area and the minimum depth of cover that he found was 5'11" as shown below in the pictures.

During construction of the new pipeline, this area will be checked again and if found to be less than 48", then proper repair of the area will be done to ensure 48" minimum DOC is obtained over the existing pipe. The farmer's pond location will be checked further once crops are cleared, and

access is easy to obtain and if depth of cover is less than 48" then proper repairs will be made to obtain the proper DOC. If we continue to get bad readings on the depth at either of these locations, then potholing will occur to expose the top of pipe, and a hard tape measurement reading will be conducted to determine the DOC.

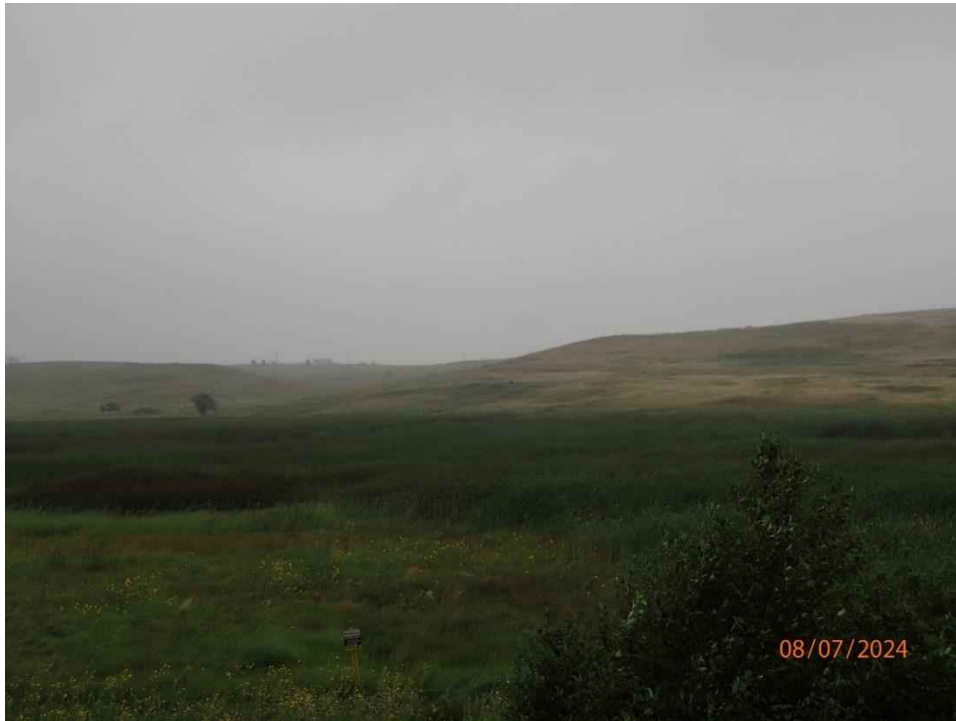
**Photograph: 1**

**Location ID:** W1

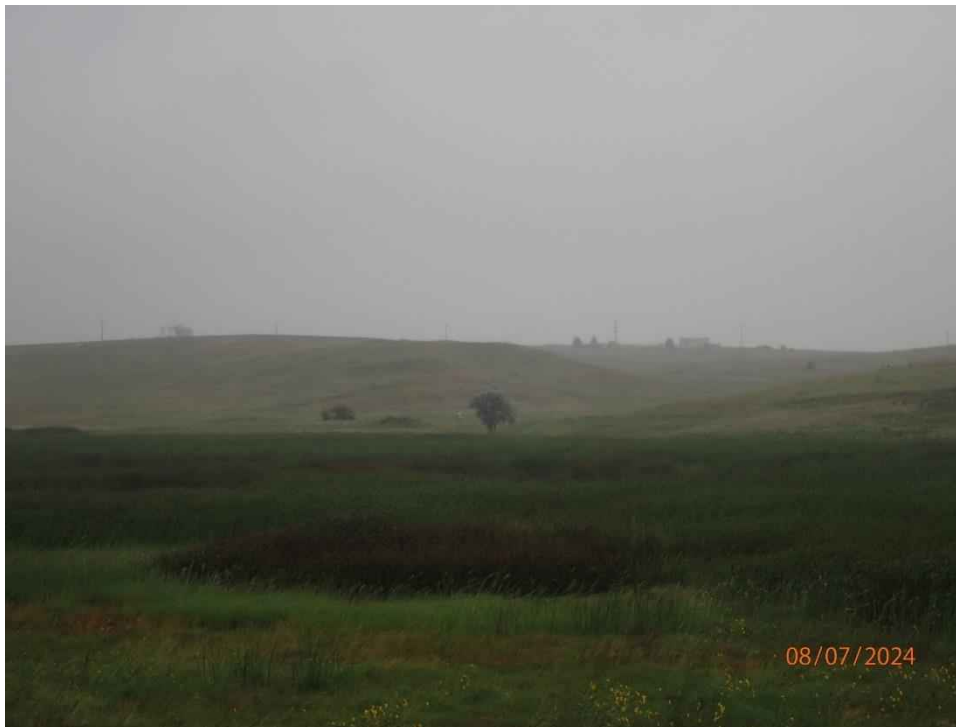
**Photograph: 2**

**Location ID:** W1

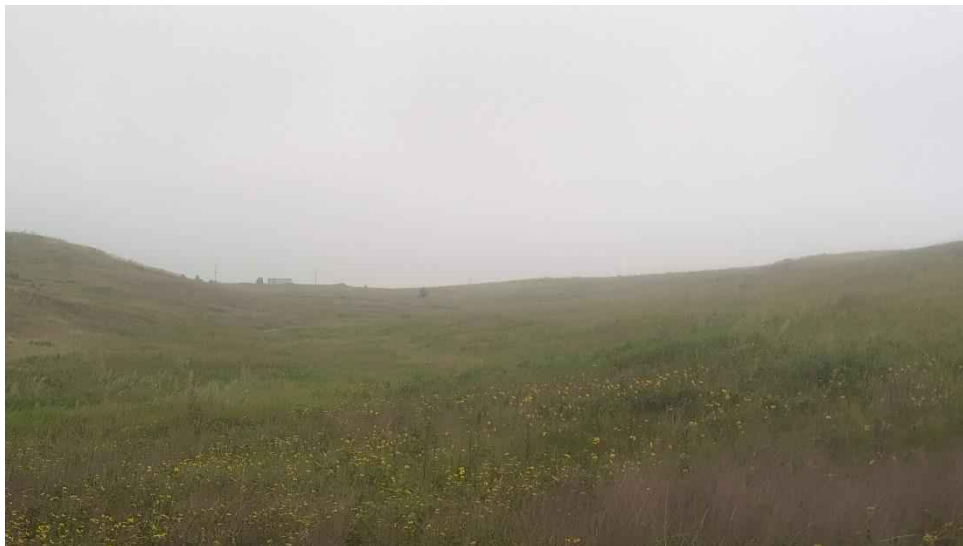
**Photograph: 3**

**Location ID:** W1

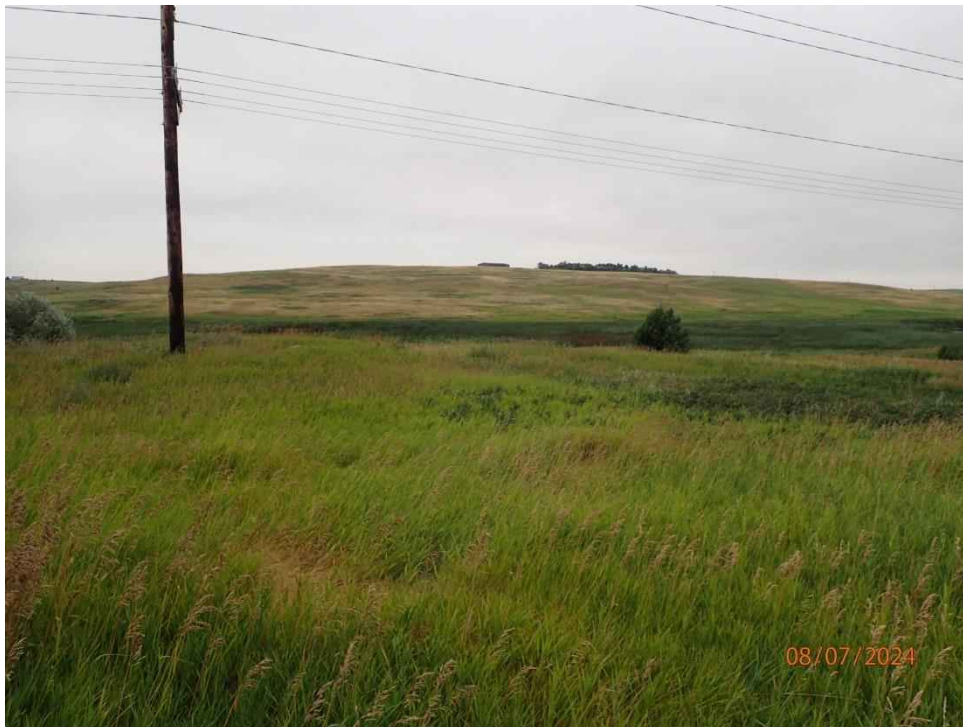
**Photograph: 4**

**Location ID:** W2

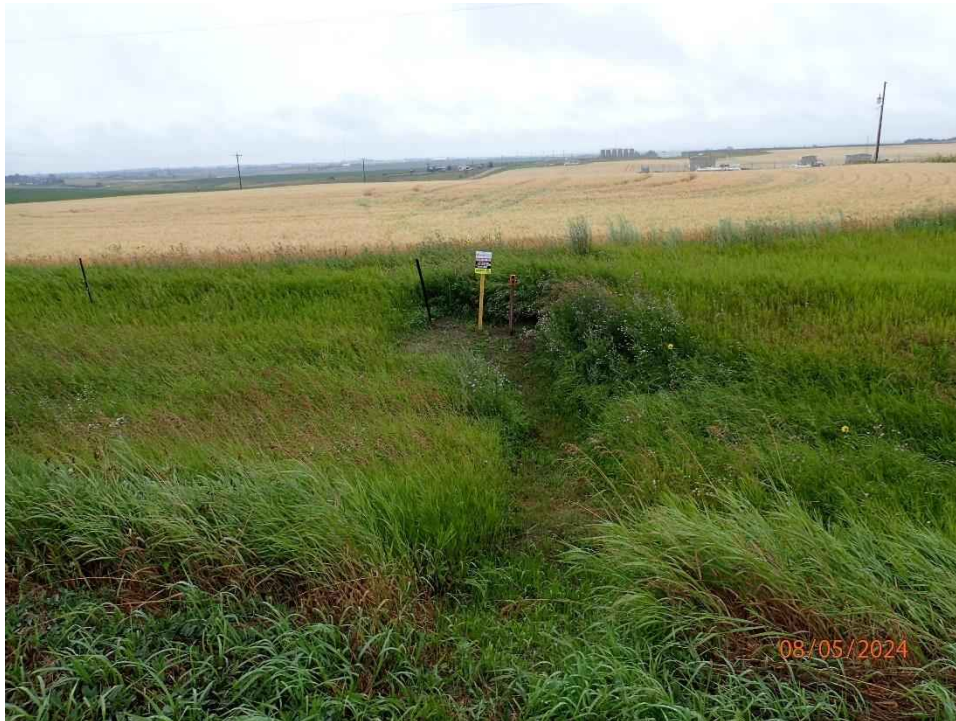
**Photograph: 21**

**Location ID:** RD1A

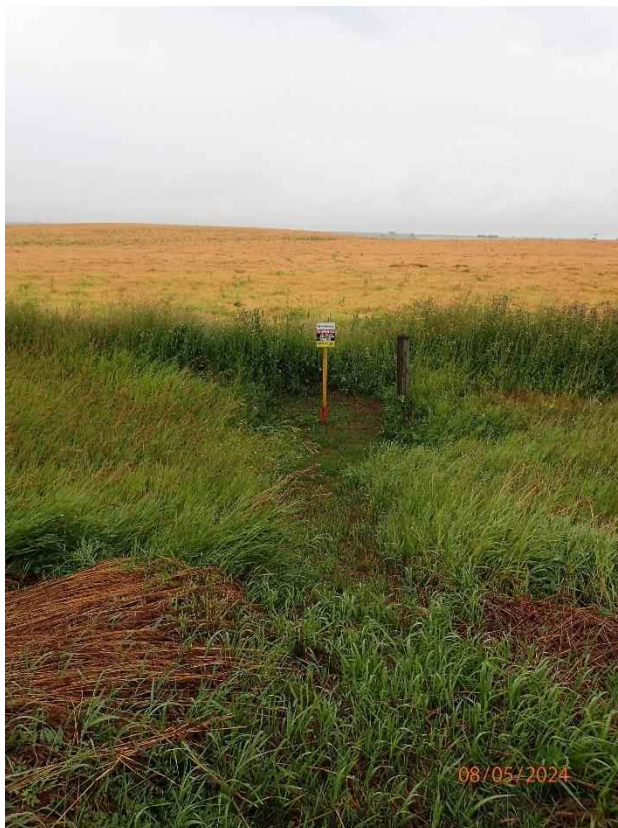
**Photograph: 22**

**Location ID:** RD1B

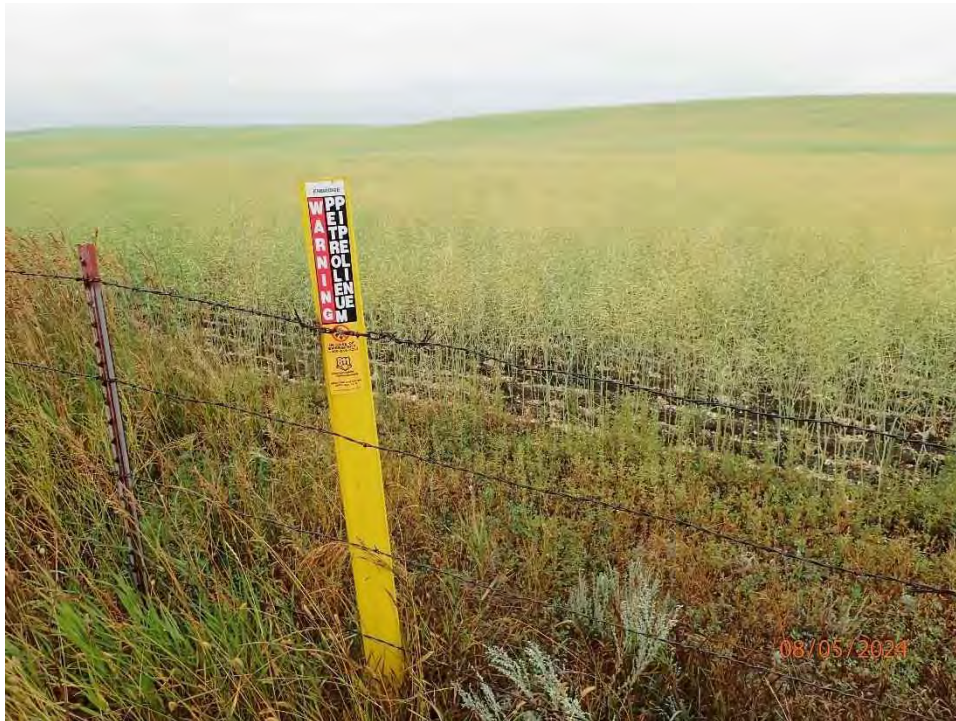
**Photograph: 27**

**Location ID:** F1

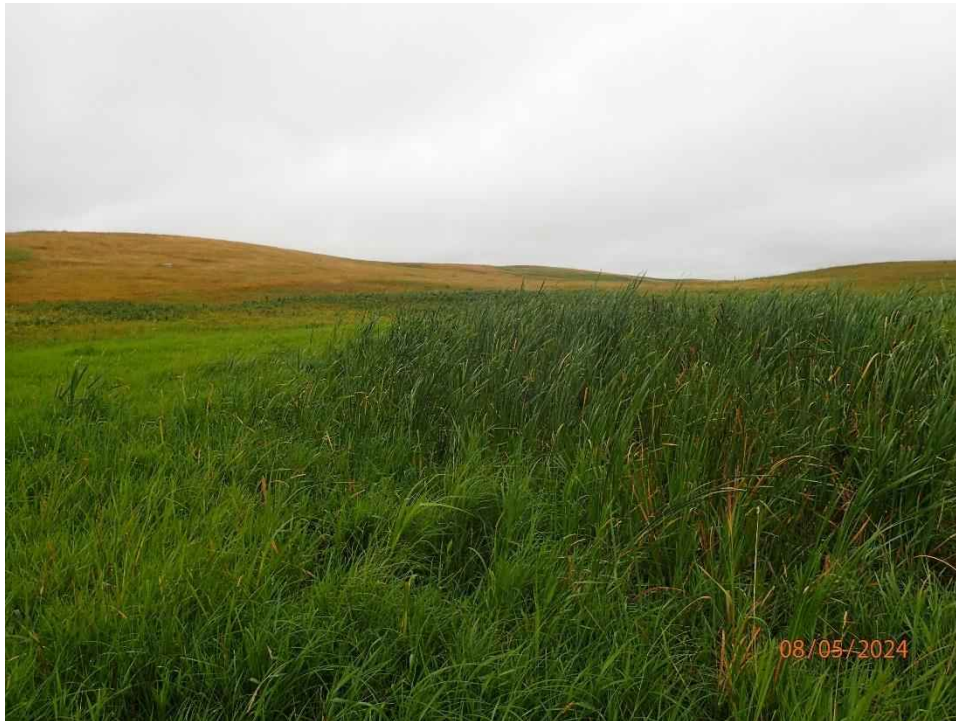
**Photograph: 31**

**Location ID: P2**

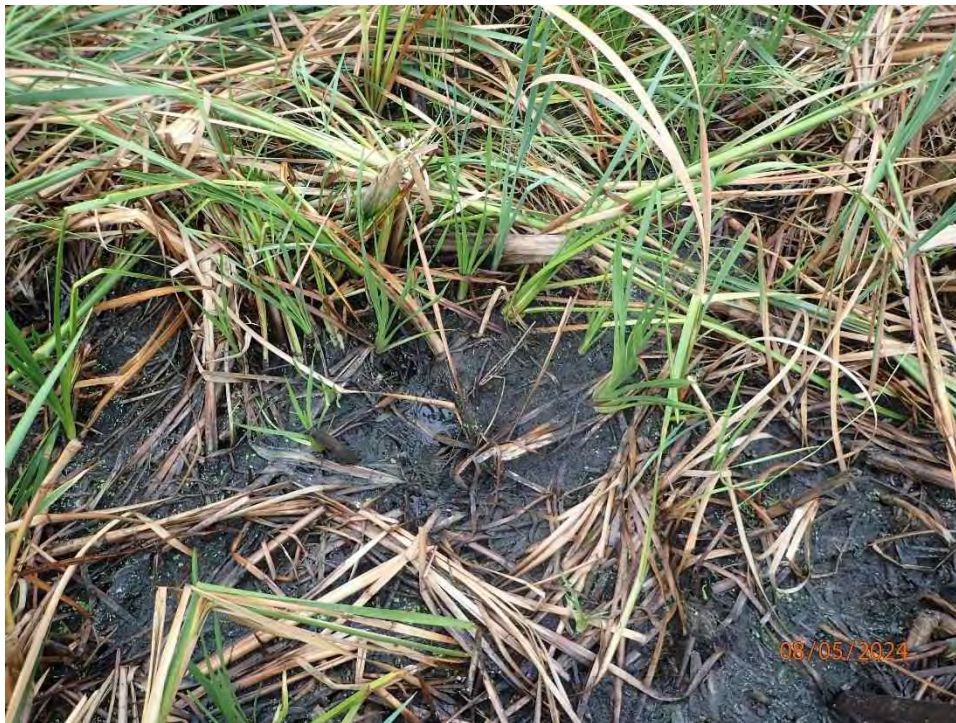
**Photograph: 32**

**Location ID: P2**

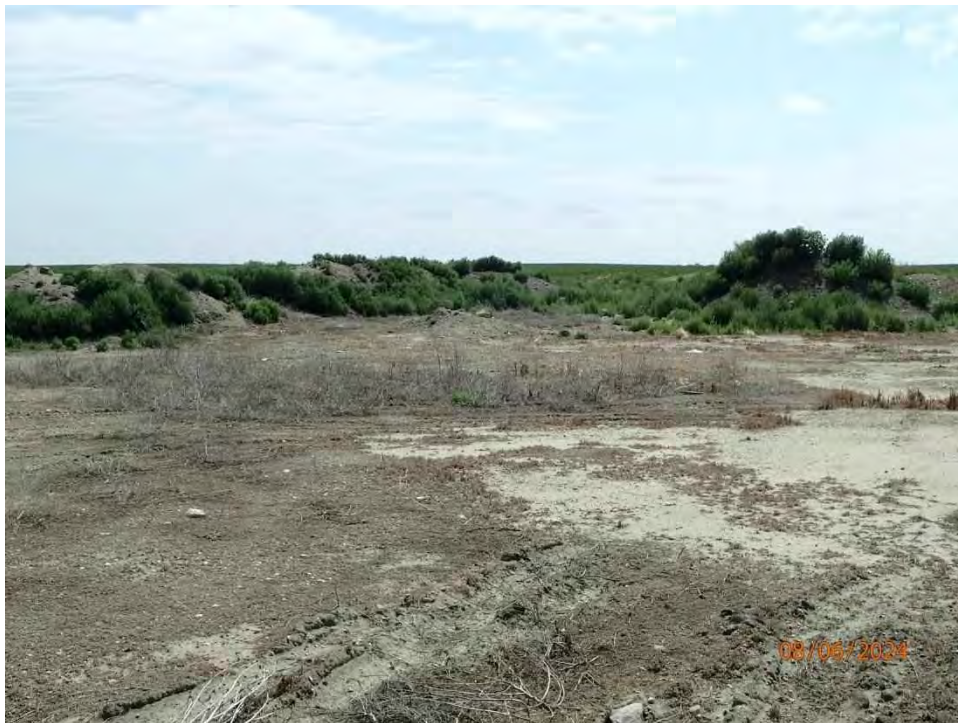
**Photograph: 174**

**Description:** 41 St NW,  
looking south at cleared area  
with spoil piles. No excavated  
pits observed
